Job Stamp:
04-SF-80-13.2/13.9 04-0120F4
SFOBB SAS
San Francisco Co. in San Francisco
Fm 0.6 km to 1.3 km East of Yerba Buena
Tunnel East Portal

Report No. **46.B**

ASSISTANT RESIDENT ENGINEER'S DAILY

Location: W2 Cap Beam	7-day const. cal.: 485	Weather: clear
Remark: ironwork/formwork/cooling pipes for pour 2	Project work day: 695

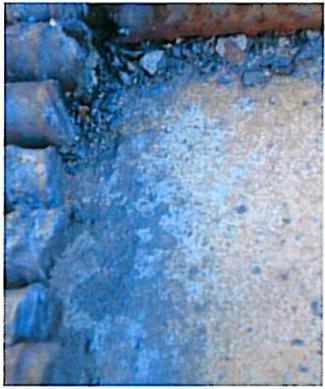
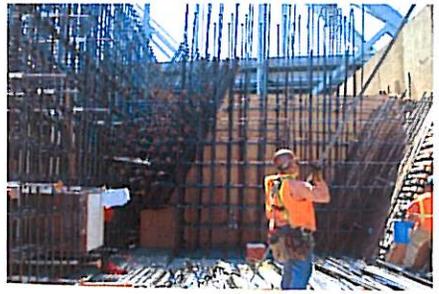
ABF continues to place tieback rods in the east diaphragm. They have not yet closed up the forms, but they mobilized plywood to the southwest void just before lunch. They continued to place cooling pipes in the intermediate diaphragm.
 RPS continues to place verticals in the west diaphragm, on the interior face. I noticed that they cut some rebar while laying on the concrete. The temperature looks to have damaged the concrete, which is at the very least superficial (see pic).
 Matt (CT) noticed that the top later of transverse T-heads that go through the jacking saddle haunch appear to be too high and should be lowered to be embedded in the concrete for this next pour. He has informed RPS that they need to lower them.
 RPS has not yet placed the 8 ducts (1-8) that go in the west transverse diaphragm.
