Job Stamp:
04-SF-80-13.2/13.9 04-0120F4
SFOBB SAS
San Francisco Co. in San Francisco
Fm 0.6 km to 1.3 km East of Yerba Buena
Tunnel East Portal

Report No. **46.B**

ASSISTANT RESIDENT ENGINEER'S DAILY

Location: W2 Cap Beam	7-day const. cal.: 490	Weather: clear
Remark: ironwork/formwork	Project work day: 700	Hi 67F/Lo 43F

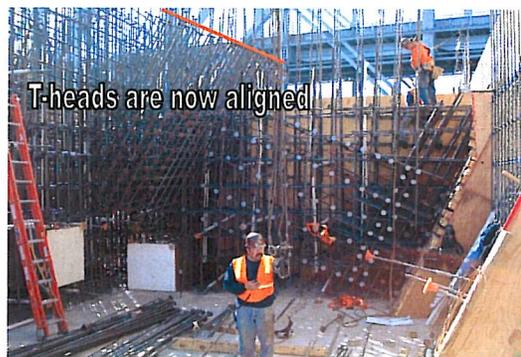
The styrofoam previously seen on the ladder rungs on the inside of the forms have been trimmed and cleaned up.
