Job Stamp:
04-SF-80-13.2/13.9 04-0120F4
SFOBB SAS
San Francisco Co. in San Francisco
Fm 0.6 km to 1.3 km East of Yerba Buena
Tunnel East Portal

Report No. **46.B**

ASSISTANT RESIDENT ENGINEER'S DAILY BRIDGE REPORT

Location: W2 Cap Beam	7-day const. cal.: 491	Weather: clear
Remark: formwork/ironwork	Project work day: 701

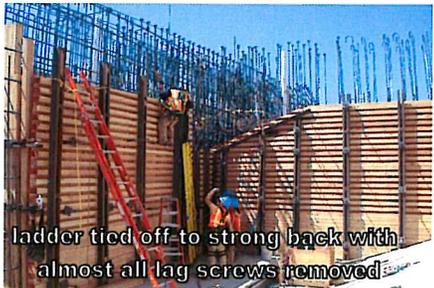
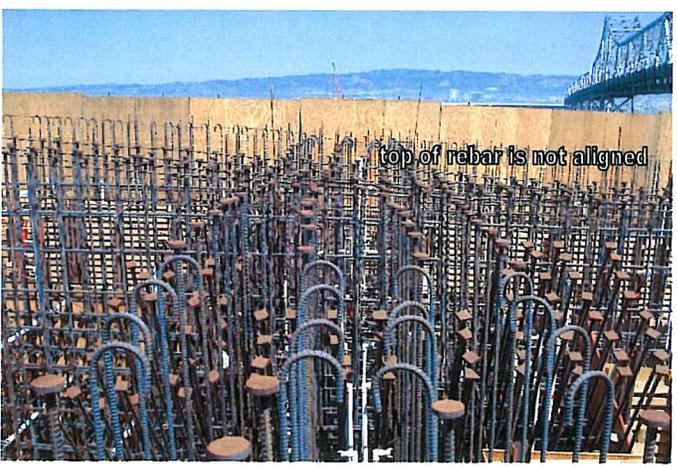
ABF continued to form the bulkhead at the south end of the west wall. They are not complete, they have not yet placed any styrofoam for the keyway at this bulkhead.
Concern arose over the placement of the vertical ironwork in the diaphragms/walls. Looked at from above, they do not align very well. They will have difficulty placing the future horizontal bars under the T-heads and hooks.
