Job Stamp
04-0120F4
SFOBB SAS

Description of Operations @ W2 Cap Beam:

SAN FRANCISCO OAKLAND BAY BRIDGE
EAST SPAN SEISMIC SAFETY PROJECT
SELF ANCHORED SUSPENSION BRIDGE
(SUPERSTRUCTURE AND TOWER)

W2 CAP BEAM
SELF-CONSOLIDATED CONCRETE FLOW MOCK UP
POUR 2 DISCHARGE HOSE LOCATIONS

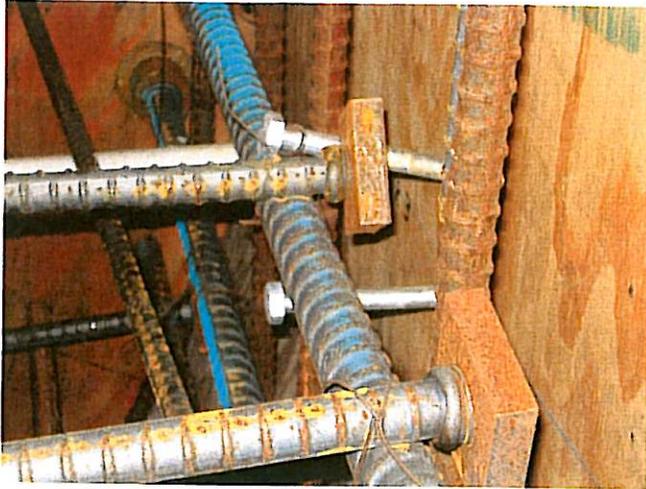
File Name:	DSC01590
Date:	05-06-08
By Int:	M Bruce

Description: Dehumidification bolts close to the jacking saddle opening, where the top bolt isn't normal to the vertical form. ABF was informed several times about this issue prior to placing concrete.

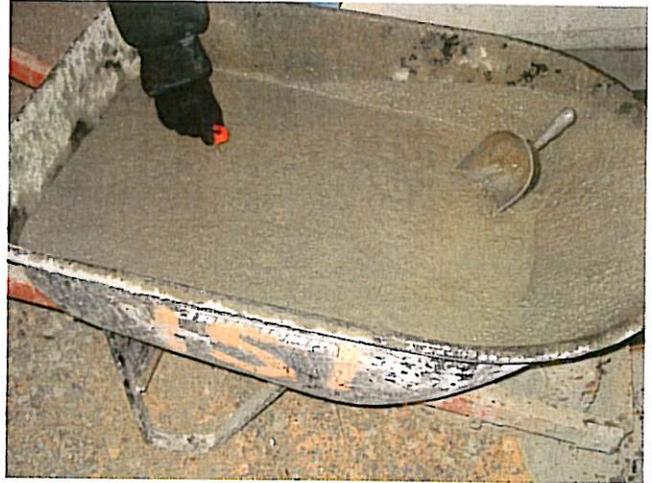
File Name:	DSC01598
Date:	05-06-08
By Int:	M Bruce

Description: SCC from the second truck, which failed the slump flow test.

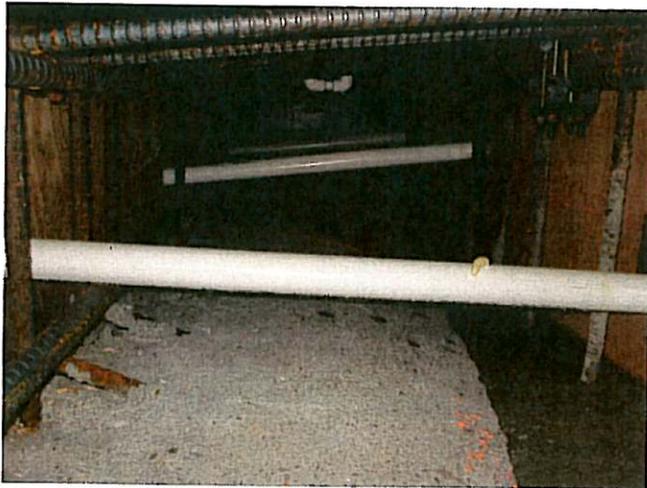
File Name:	DSC01602
Date:	05-06-08
By Int:	M Bruce

Description: SCC placement in the east wall. The leading edge of the previously placed SCC in the east longitudinal diaphragm can be seen on the right hand side of the photo.

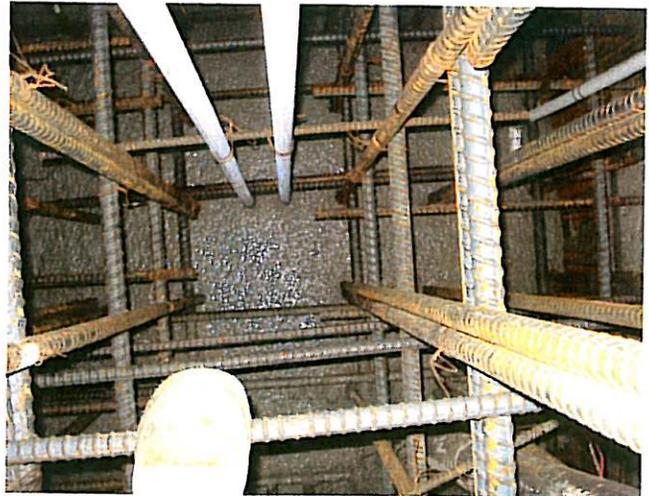
File Name:	DSC01606
Date:	05-06-08
By Int:	M Bruce

Description: Photo taken of the SCC placement near the diaphragm intersection. When the spotlight went out and when I couldn't climb down the rebar in the forms, the digital camera was used periodically to get a visual of the SCC placement.

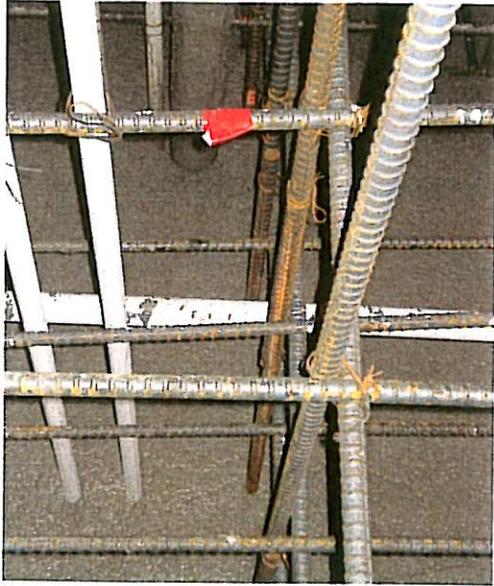
File Name:	DSC01615		
Date:	05-06-08	By Int:	M Bruce
Description: SCC placement in the longitudinal diaphragm.

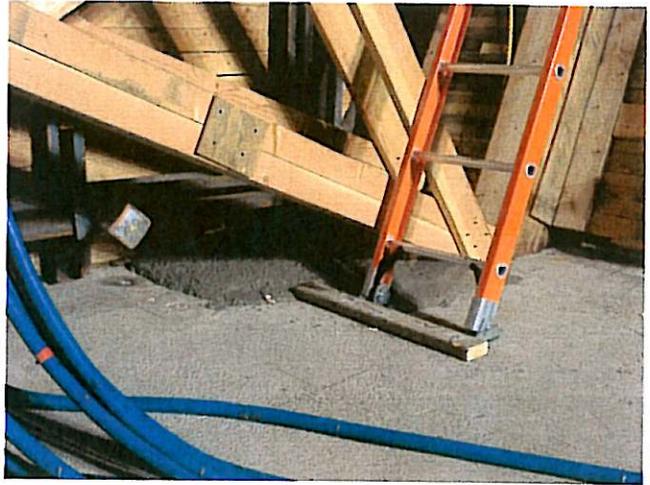
05:21	75	5	
05:31	Noticed leak in longitudinal diaphragm forms near the jacking saddle on the north end and mentioned it to ABF engineer Branden Bedwell, see photo below.

File Name:	DSC01619		
Date:	05-06-08	By Int:	M Bruce
Description: Leak in longitudinal diaphragm forms near the jacking saddle.

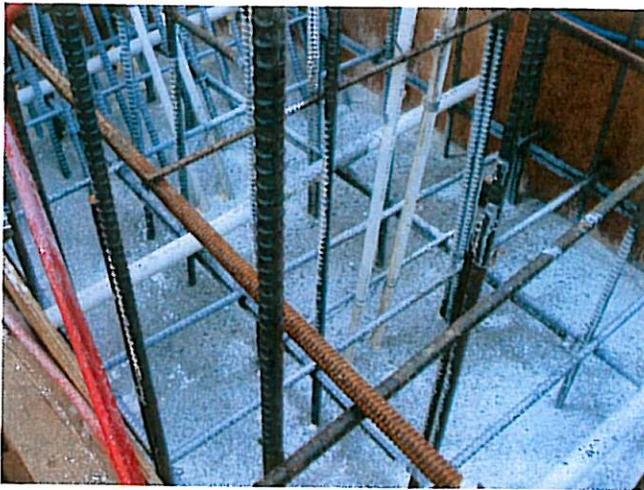
File Name:	DSC01635		
Date:	05-06-08	By Int:	M Bruce
Description: Curing compound at the longitudinal diaphragm near the jacking saddle opening.

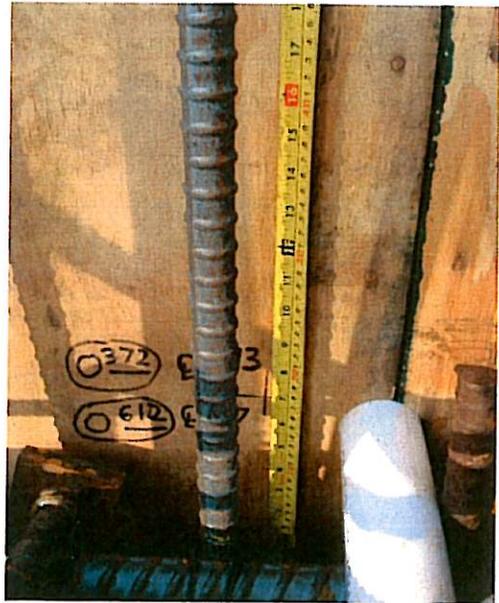
08:03	73-75	9	
08:12	SW wall was completed and I informed ABF forman Nigel Lohse that if any more concrete was placed it might not provide enough cover for duct placement for CBT 3 and 7.

File Name:	DSC01638		
Date:	05-06-08	By Int:	M Bruce
Description: ABF layout of transverse tendons CBT3 and CBT7 approximately at the midpoint of the west wall. ABF foreman Nigel Lohse wanted to pour concrete higher which may not provide enough cover for these ducts.
