STATE OF CALIFORNIA	Job Stamp	7-day Const. Calendar	Day No. 488
DEPARTMENT OF TRANSPORTATION	SFOBB SAS	Project Work Day No.	Day No. 688
Form HC-10A (Rev. 6/80)	04-0120F4	Date	04/14/2008

ASSISTANT RESIDENT ENGINEER'S

Daily for Regional Steel

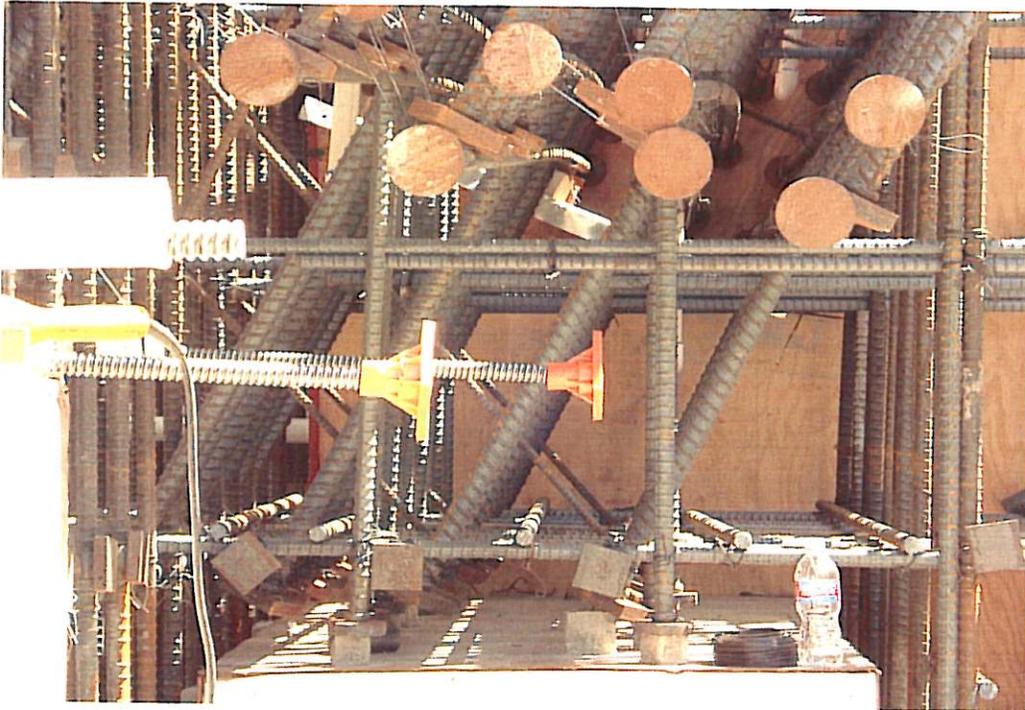
- RSC will need to cut and splice some of the #29 vertical t-heads are either short or too long.
- Today I observed the jacking saddle rebar (#29HV02) were placed (during my absence) at a lower elevation than adjacent jacking saddle rebar (#29HV03) see plan sheet 497S7R1 and 497S8R1. I discussed with Lance Gaige who explained he placed the bars at 80mm above west longitudinal access opening. Lance indicated he would not correct the elevation of #29HV02 bars. Called Alex Sanjines (TYLin) to discuss and indicated he would not be available to discuss until 3:30pm. I waited until 4:15pm was unable to contact Alex. Worked 0.75 hours OT. Will contact Alex tomorrow morning.

Jacking saddle rebar #29HV02 bars at 80mm above west longitudinal access opening. Placed at wrong elevation.

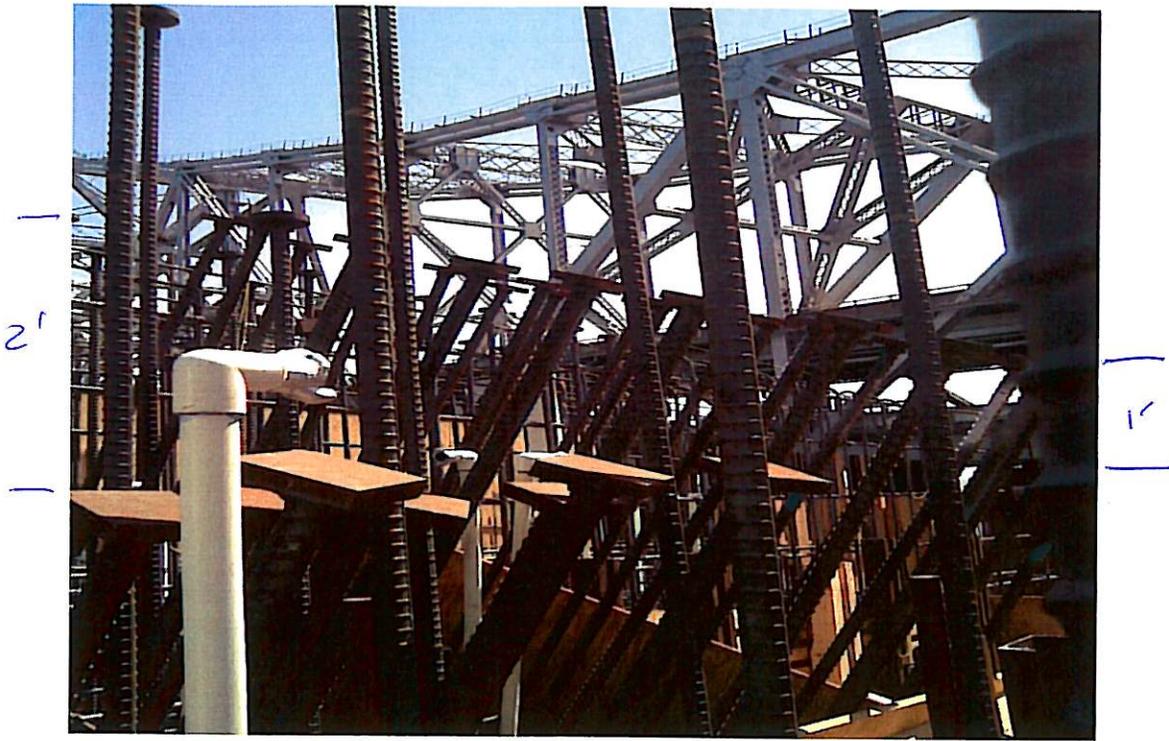
#29HV02 bars at incorrect elevation should be at same elevations as rebar in back of photo.

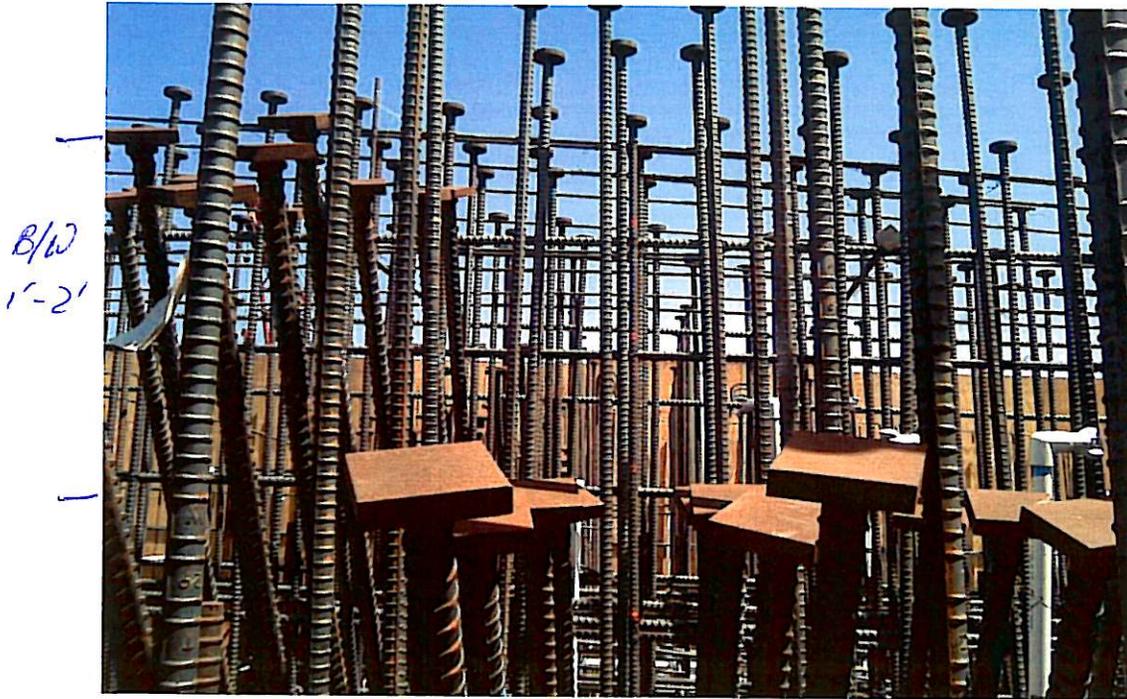
#29HV02 bars at incorrect elevation approximately 300mm lower in front and 600mm in back to adjacent bars.
