Job Stamp:
04-SF-80-13.2/13.9 04-0120F4
SFOBB SAS
San Francisco Co. in San Francisco
Fm 0.6 km to 1.3 km East of Yerba Buena
Tunnel East Portal

Report No. **46.B**

ASSISTANT RESIDENT ENGINEER'S DAILY BRIDGE REPORT

Location: W2 Cap Beam	7-day const. cal.: 498	Weather: clear
Remark: ironwork/formwork	Project work day: 708	Hi 64F/Lo 42F

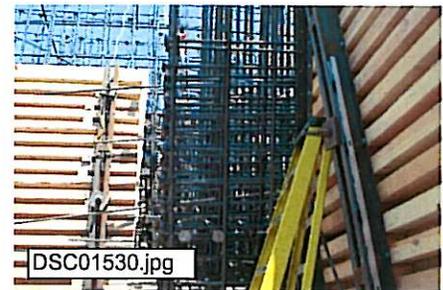
ABF continued to form the bulk head at the south end of the west wall. They continued to brace up the haunch in the southwest void area. They cut back styrofoam from the ladder rungs - the foam was thick enough to inhibit the rungs from imbedding in the concrete.
RPS removed/replaced the #36 transverse bars in the west wall that had the wrong coupler. In the process, they damaged the bulkhead on the north end of the west wall. The ironworkers also re-placed the longitudinal bars in the longitudinal diaphragm -removed by the carpenters while erecting the forms for the intermediate transverse diaphragm (DSC01530).
The ducts in the west wall are okay as placed - provided that they are not moved/damaged before the concrete pour.

According to the special provisions (Section 10-1.75 Miscellaneous Metal) and the standard specifications (Section 75-1.05 Galvanizing, pg 548), the ABF will need to wire brush and repair the zinc coating on the ladder rungs (Galvanized surfaces that are abraded or damaged at any time after the application of zinc coating shall be repaired by thoroughly wire brushing the damaged areas and removing loose and cracked coating, after which the cleaned areas shall be painted with 2 applications of unthinned zinc-rich primer...). During installation, I noticed that the carpenters were slamming the rungs with their hammers. Also, the method that they used to secure the rungs - with nails - they could have damaged the zinc coating.
Furthermore, under Section 10-1.74 NonSkid Surface on page 391 of the Special Provisions, "ladders shall receive a nonskid surface consisting of epoxy mixed with grit."
