Job Stamp:  
04-SF-80-13.2/13.9 04-0120F4  
SFOBB SAS  
San Francisco Co. in San Francisco  
Fm 0.6 km to 1.3 km East of Yerba Buena  
Tunnel East Portal

Report No. **46.B**

**ASSISTANT RESIDENT ENGINEER'S DAILY**

Location: <b>W2 Cap Beam</b> Remark: <b>formwork</b>	7-day const. cal.: 504 Project work day: 714	Weather: clear Hi 62F/Lo 46F
---	---	---------------------------------

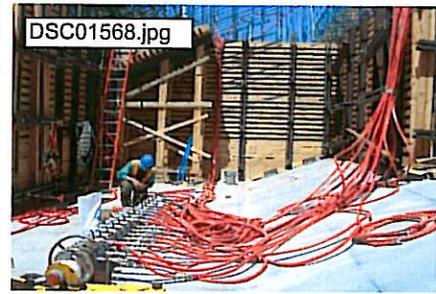
ABF started assembling/connecting the waterlines to the manifold in the southeast void area (DSC01568). They have not yet tested the system. They continue to work on the supply line down below on the ground. I caught Branden (ABF engineer) climbing the ladder rungs (DSC01567); he was also climbing this without being tied off. The ladder rungs are only secured with nails.
