Job Stamp:  
04-SF-80-13.2/13.9 04-0120F4  
SFOBB SAS  
San Francisco Co. In San Francisco  
Fm 0.6 km to 1.3 km East of Yerba Buena  
Tunnel East Portal

Report No. **46.B**  
Date the Shift Began: **5/6/08**  
 NIGHTWORK **TUESDAY**  
Shift Hrs Start **1:00** Stop **9:00**  
Engineer's Hrs Start **1:00** Stop **9:00**

**ASSISTANT RESIDENT ENGINEER'S DAILY BRIDGE REPORT**

Location: <b>W2 Cap Beam</b>	7-day const. cal.: 510	Weather: no fog in immediate area
Remark: <b>Concrete pour 2</b>	Project work day: 720	Hi 50F/Lo 48F

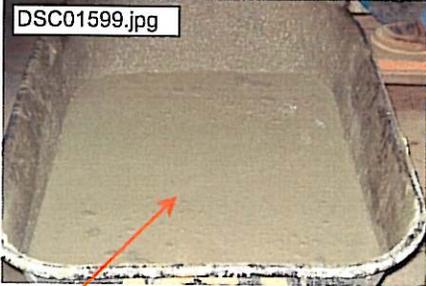
DSC01599.jpg

Only a watery mortar and air bubbles are seen on the surface.

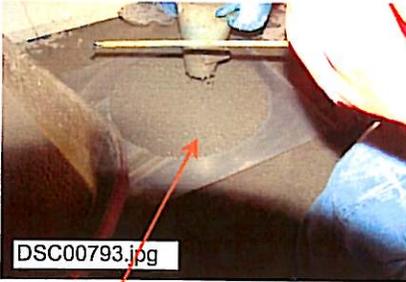
DSC00793.jpg

Concrete was more consistent.

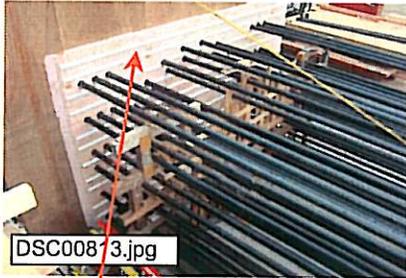
DSC00813.jpg

Formwork with styrofoam and keyway

From yesterday's diary (5/5), I mentioned that the forms were slid onto the HS bolts of the Hinge K assembly (DSC00813). ABF will be working on the Hinge K assemblies in the next few days while they wait for the concrete to cure and the thermal control to finish.
