Job Stamp:
04-SF-80-13.2/13.9 04-0120F4
SFOBB SAS
San Francisco Co. in San Francisco
Fm 0.6 km to 1.3 km East of Yerba Buena
Tunnel East Portal

Report No. **46.B**
Date the Shift Began: **5/8/08**
 NIGHTWORK **THURSDAY**
Shift Hrs Start **7:00** Stop **15:30**
Engineer's Hrs Start **7:00** Stop **15:30**

ASSISTANT RESIDENT ENGINEER'S DAILY BRIDGE REPORT

Location: W2 Cap Beam	7-day const. cal.: 512	Weather: clear
Remark:	Project work day: 722	Hi 61F/Lo 50F

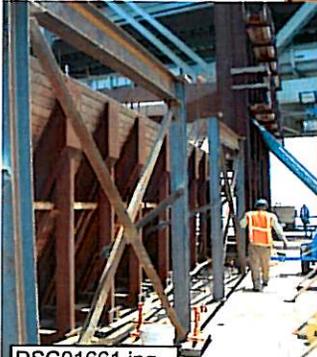
DSC01661.jpg

SCC slump flow apparatus and shovel returned back to Hayward office.
ABF installed and welded the falsework supports for the Hinge K assemblies on the south end of the cap beam (DSC01661). They hope to mobilize/lift the assembly tomorrow.
In sliding the timber formwork with drilled holes for the HS Macalloy rods, ABF damaged the densyl tape on the rods (DSC01643 & DSC01644).
RPS placed a few ducts but did not "set" them on the south end of the cap beam (DSC01646). During a lifting/landing operation of the ducts from the ground, RPS landed their ducts on the PVC cooling pipe output. I asked them not to do that again because the potential of the PVC fracturing under the load.

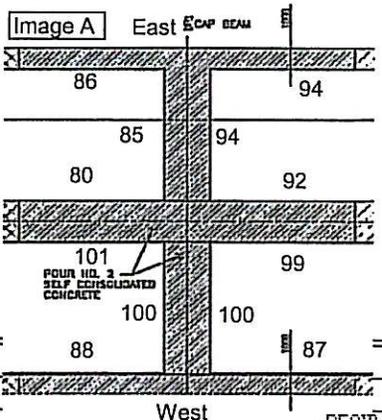
Formwork surface temperatures (Image A) @ 1403. (Deg F)
In/Out temperatures at manifold
44 deg F/44 deg F
