Job Stamp:
04-SF-80-13.2/13.9 04-0120F4
SFOBB SAS
San Francisco Co. in San Francisco
Fm 0.6 km to 1.3 km East of Yerba Buena
Tunnel East Portal

ASSISTANT RESIDENT ENGINEER'S DAILY BRIDGE REPORT

| Location: W2 Cap Beam | 7-day const. cal.: 520 | Weather: clear |

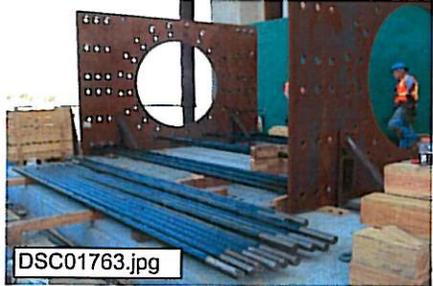
ABF continued to place HS Macalloy rods in the 2nd Hinge K assembly (DSC01763). By the end of the day, they had three rows of bars complete. They are using the same means/methods used for the 1st assembly.
 The entire cooling system has been removed (cooling hoses, manifolds/PVC pipes leading to manifolds) from the void areas.
 There are noticeable locations bad consolidation of the concrete. In particular, on the south bulkhead of the intermediate transverse diaphragm - towards the top of the pour and at the bottom edge of the styrofoam keyways (DSC01767). This problem may be a result of not enough wetting of the forms prior to the concrete pour. There could be too much surface tension for the concrete to flow and adequately consolidate.
 The blockouts for ducts #23 & 24 turned out okay. With the styrofoam removed, it looks like coupling to this duct will not be a problem (DSC01764), although no one has yet removed the tape to see if concrete has gotten inside.
