TOLL PROGRAM/DIST. 4 CONSTR.

Job Stamp:
04-SF-80-13.2/13.9 04-0120F4
SFOBB SAS
San Francisco Co. in San Francisco
Fm 0.6 km to 1.3 km East of Yerba Buena
Tunnel East Portal

Report No. **46.B**
Date the Shift Began: **6/20/08**
 NIGHTWORK **FRIDAY**
Shift Hrs Start **7:00** Stop **15:30**
Engineer's Hrs Start **7:00** Stop **15:30**

ASSISTANT RESIDENT ENGINEER'S DAILY BRIDGE REPORT

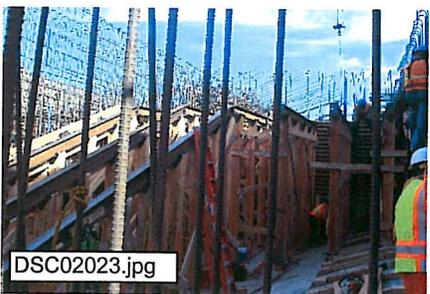
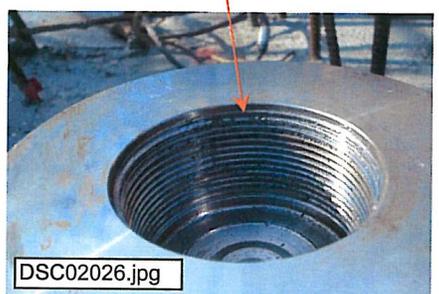
T-heads were applied to three of the column cages in the north column area. The northwest column cage of the four has not had the T-heads "torqued." They are in the process of adjusting the hoops - before they will torque the T-heads. There was one T-head that needed the threads filed before proceeding (southeast column cage in north set). The female portion's threads were damaged and will need to be replaced (DSC02026). The male portion is the one that needs to be filed. There are two in the southwest cage in the north column area that have not been torqued; they are waiting to file the threads on these as well), the precise location has been located by Pam. The crew ended their shift around 1300.

damaged threads
