TOLL PROGRAM/DIST. 4 CONSTR.

Job Stamp:
04-SF-80-13.2/13.9 04-0120F4
SFOBB SAS
San Francisco Co. in San Francisco
Fm 0.6 km to 1.3 km East of Yerba Buena
Tunnel East Portal

Report No. **46.B**

ASSISTANT RESIDENT ENGINEER'S DAILY BRIDGE REPORT

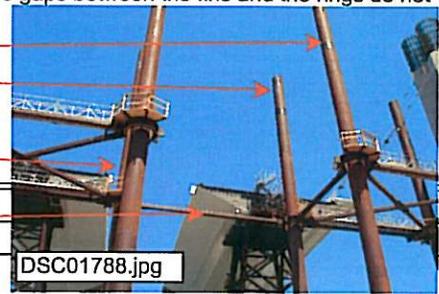
DSC01788.jpg
TE/CT
Title

Weekly meeting with ABF today; Mtg next week will be at 1100.
E2: ABF erected two steel pipe posts (#7&8)(DSC01788); the sand jacks were sealed. Welding of the fins on the posts to the intermediate platform ring is in progress. Sighting the posts against the column, the posts look like they are out of plumb. The gaps between the fins and the rings do not look noticeably large. One of the remaining sections was lifted into position between posts 6 & 8 (DSC01788).

Post 7
Post 8
Post 6
