Job Stamp:  
04-SF-80-13.2/13.9 04-0120F4  
SFOBB SAS  
San Francisco Co. in San Francisco  
Fm 0.6 km to 1.3 km East of Yerba Buena  
Tunnel East Portal

Report No. **46.B**

**ASSISTANT RESIDENT ENGINEER'S DAILY BRIDGE REPORT**

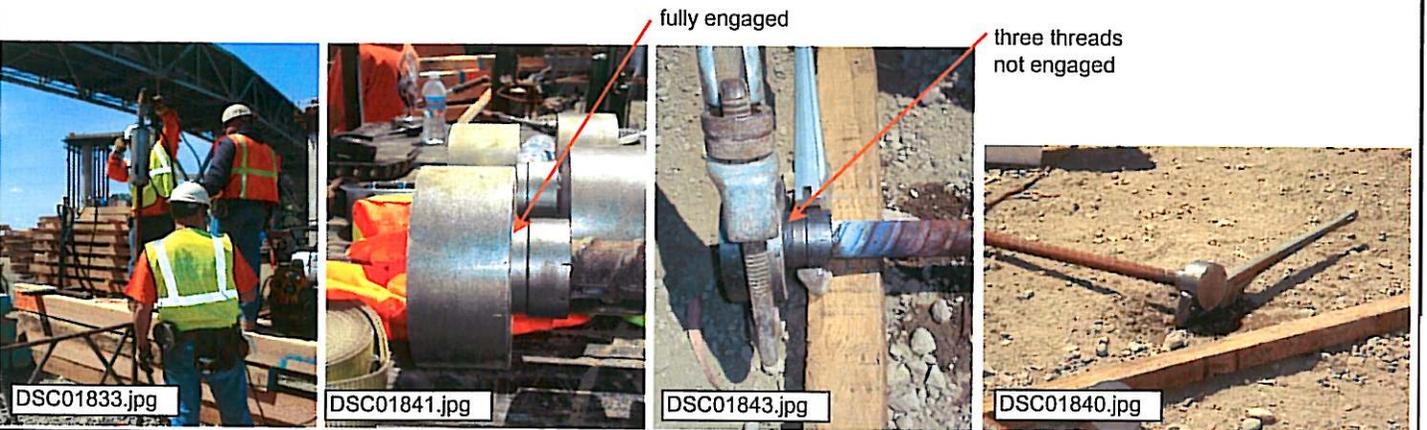
In observing the ironworkers assemble specimens for T-head attachments: The ironworkers had the correct setup (DSC01833). The operator (Joe - qualified to attach T-head) had difficulty attaching the T-head onto two of the bars. It looked as though he was able to get the threads to align and for the male/female to attach smoothly. However, the threads would somehow misalign and the torque wrench would reach 400 ft-lb before the threads would terminate entirely. DSC01841 shows specimens that have been assembled correctly, i.e. showing no thread on the male. DSC01843 on the other hand shows several threads that have not been engaged - have not terminated; at this point the torque had already reached 400 ft-lb. The possibility that the T-heads were attached too quickly, i.e. before the rebar had cooled down enough, would not be a great argument since the two pieces would be heating up (threads expanding at the same rate) the same amount. Before I realized it happened, the operator poured water onto one of the specimens in which he had difficulty removing the T-head - quenching it (DSC01840). This would in effect alter the lattice structure of the steel - making it more brittle. I later informed Joe that it wasn't a good idea to do that. Two of the male/female couples were removed and wasted. They had a tremendous amount of difficulty removing the T-head because a lot of the threads were stripped (shavings seen after the pieces were detached).
