TOLL PROGRAM/DIST. 4 CONSTR.

Job Stamp:  
04-SF-80-13.2/13.9 04-0120F4  
SFOBB SAS  
San Francisco Co. in San Francisco  
Fm 0.6 km to 1.3 km East of Yerba Buena  
Tunnel East Portal

**ASSISTANT RESIDENT ENGINEER'S DAILY BRIDGE REPORT**

Location: <b>W2 Cap Beam</b>	7-day const. cal.: <b>537</b>	Weather: <b>party cloudy</b>
Remark: <b>Hinge K, sandblast, cleanup</b>	Project work day: <b>747</b>	<b>Hi 62F/Lo 50F</b>

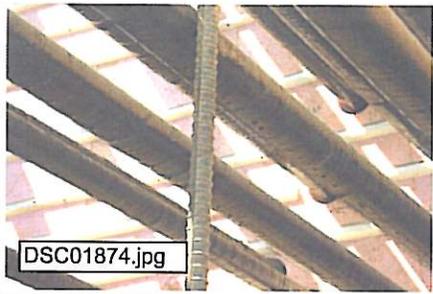
ABF has requested that CT inspect their sandblasting before they mobilize their equipment away off the cap beam. Gil (CT) has told me that they have been told that they need to clean the denso paste off the mild steel reinforcement which had dripped from the Hinge K assembly. DSC01874 shows the denso paste formed as droplets ready to drip down. Per Section 52-1.05 of the 1999 std spec, they are required to clean the denso paste off. Given the situation, they would not be done with the sandblast equipment.

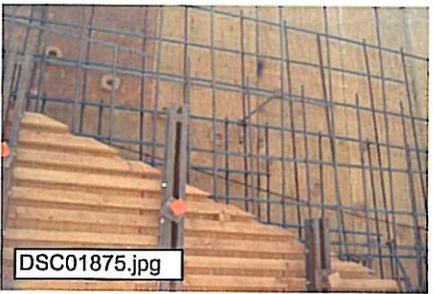
I noticed the have located the locations of the continuity tendons on the east wall; they are marked with wooden rings on the east panel (DSC01875).

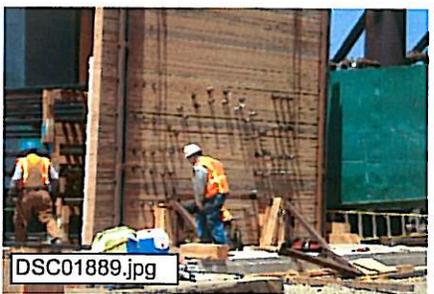
ABF continued to sandblast the top of the concrete of pour 2, cleanup the sand with a vacuum and other debris. Down below, the carpenters completed drilling holes in their form and placed keyway strips and lifted the forms into place toward the end of the day (DSC01889).
