Job Stamp:
04-SF-80-13.2/13.9 04-0120F4
SFOBB SAS
San Francisco Co. in San Francisco
Fm 0.6 km to 1.3 km East of Yerba Buena
Tunnel East Portal

Report No. **46.B**
Date the Shift Began: **6/3/08**
 NIGHTWORK **TUESDAY**
Shift Hrs Start **7:00** Stop **15:30**
Engineer's Hrs Start **7:00** Stop **15:30**

ASSISTANT RESIDENT ENGINEER'S DAILY BRIDGE REPORT

Location: W2 Cap Beam	7-day const. cal.: 538	Weather: cloudy/windy
Remark: lift Hinge K, crack survey	Project work day: 748	HI 64F/Lo 52F

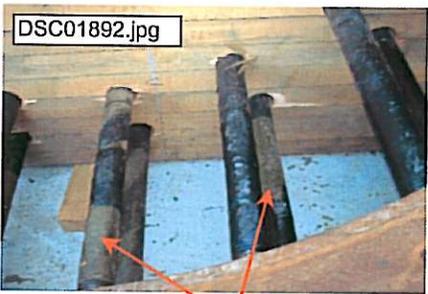
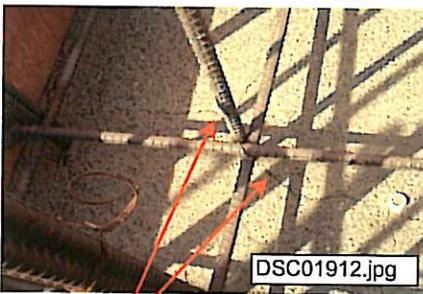
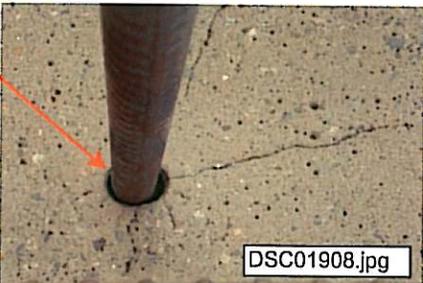
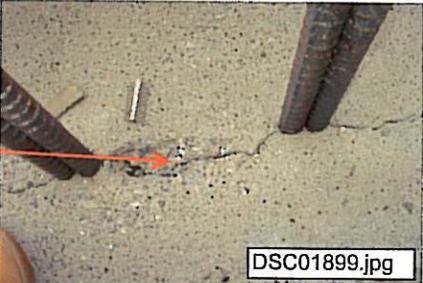
Field meeting with ABF foreman Nigel to look at the construction joint after ABF has been sandblasting and removing the curing compound. John Beede/Ron Matin/Pam Garnier/Lalit Mathur and myself (all CT) were there with Nigel and Branden from ABF. We pointed out a few locations that still had concrete cure remaining on the concrete. I addressed the curing compound on the steel reinforcement that still needed to be removed (09:30). Nigel acknowledged and said they will be removing that with a wire wheel. I also mentioned that they will need to remove the denso paste under the Hinge K assemblies and he also acknowledged that (he mentioned that ABF is proposing using saran wrap around the bolts to prevent any more dripping). Ron and John asked ABF to methacrylate a few minor superficial cracks on the east side of the intermediate diaphragm in the longitudinal diaphragm area. The cracks were propagating at a 45 deg angle from the vertical reinforcement (DSC01912) and along the line of reinforcement (DSC01899). They were asked to pour epoxy on the cracks in a way of determining how deep these cracks are (They will be notifying us before they do this). Further repair will be determined based on the results. ABF was asked to bushel the concrete (6-8 inch band) at the furthest reachest of the SCC concrete from the placing tube. Overall, the cracks were not of a major concern; they appeared to be shrinkage cracks and not thermal cracks. I noticed holes around the rebar in the east wall (25L5L01). These bars were placed for partial embedment in pour 2. With the hole around the circumference of the bar (DSC01908), it looks as though the bar was moved during the setting of the concrete. A few more of the rods had damage to the densyl tape (DSC01892). ABF raised the 3rd Hinge K assembly into position today - south side of W-line.
