Job Stamp
04-0120F4
SFOBB SAS

ASSISTANT RESIDENT ENGINEER'S **CONTRACTOR – ABFJV, Sub RPS**

Description of Operations @ W2 Cap Beam:

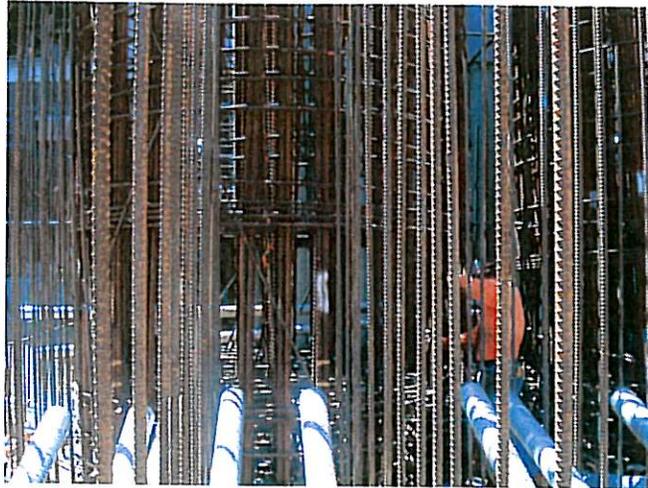
File Name:	DSC01941		
Date:	06-05-08	By Int:	M Bruce

Description: Adjusted the #25 hoops on the northeast cage at W2E to prepare for T-Head installation on the cut #43 vertical bars in the column cages. Previously installed ducts were removed to facilitate this operation.

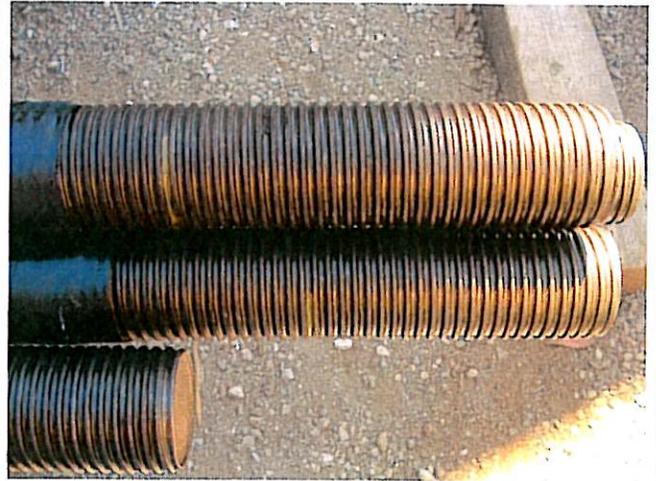
File Name:	DSC01944		
Date:	06-05-08	By Int:	M Bruce

Ron Matin and myself went to investigate the deficient Macalloy rods using digital calipers. The yellow mark on the rod denotes where the nut locked on the threads, see photo below. The following table is the measurements taken on the Macalloy rods with the digital calipers:

Rod Length where the nut locked	Bar Diameter before yellow mark	Bar Diameter after yellow mark	Thread Diameter before yellow mark	Thread Diameter after yellow mark
130	70.98	71.42	76.05	76.19
155	71.46	71.42	75.42	75.77
190	71.33	70.94	76.02	75.89
205	71.38	71.39	75.13	75.75

Notes: 1.) There appeared to be no visual damage to the threads of the Macalloy rods.
2.) The lead dimension on the rod was measured to be approximately 8mm.
3.) Since James Duxbury and Alex Sanjines were unavailable; myself and Ron Matin spoke to Tom Ho of TY-Lin about the configuration (Transmittal 05.03.02-000295) of the extra high strength Macalloy rods. At this time 9 extra high strength rods are available with 12 locations remaining. He said it was OK to use the rods with lower tensile strength in locations 4, 24, & either 39 or 73.

Description: The 4 extra high strength Macalloy rods (all have a bar stamp of 3) with deficient threads. The yellow mark on the threads denotes where the nut locks on the rod. ABF foreman Nigel Lohse informed myself, and Ron Matin that they tried a few different techniques to advance the nut on the threads as nothing worked. The techniques used were to hit the nut and use a spud wrench to advance the nut, filing down the threads. Ron suggested to Nigel that the nuts should be tested on the stressing end of the Macalloy rods. Gil informed me that he made a similar suggestion to ABF project manager Jim Davidson.
