Job Stamp:
04-SF-80-13.2/13.9 04-0120F4
SFOBB SAS
San Francisco Co. in San Francisco
Fm 0.6 km to 1.3 km East of Yerba Buena
Tunnel East Portal

ASSISTANT RESIDENT ENGINEER'S DAILY BRIDGE REPORT

Location: W2 Cap Beam	7-day const. cal.: 544	Weather: clear/warm
Remark: Ironwork/formwork	Project work day: 754	Hi 83F/Lo 52F

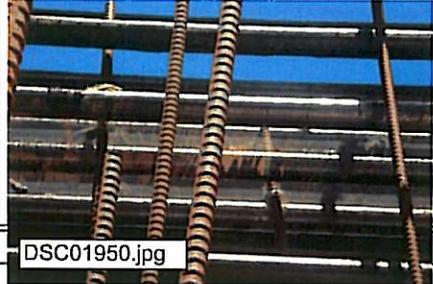
DSC01950.jpg

ABF has wrapped saran wrap around a small area (mockup?) of the HS Macalloy rods (DSC01950). They have started to remove some of the access opening blockouts in the diaphragms (DSC09155).
