Job Stamp:  
04-SF-80-13.2/13.9 04-0120F4  
SFOBB SAS  
San Francisco Co. in San Francisco  
Fm 0.6 km to 1.3 km East of Yerba Buena  
Tunnel East Portal

Report No. **46.B**  
Date the Shift Began: **6/11/08**  
 NIGHTWORK WEDNESDAY  
Shift Hrs Start **7:00** Stop **15:30**  
Engineer's Hrs Start **7:00** Stop **15:30**

**ASSISTANT RESIDENT ENGINEER'S DAILY BRIDGE REPORT**

Location: <b>W2 Cap Beam</b>	7-day const. cal.: <b>546</b>	Weather: <b>clear/warm</b>
Remark: <b>Hinge K lift, T-heads</b>	Project work day: <b>756</b>

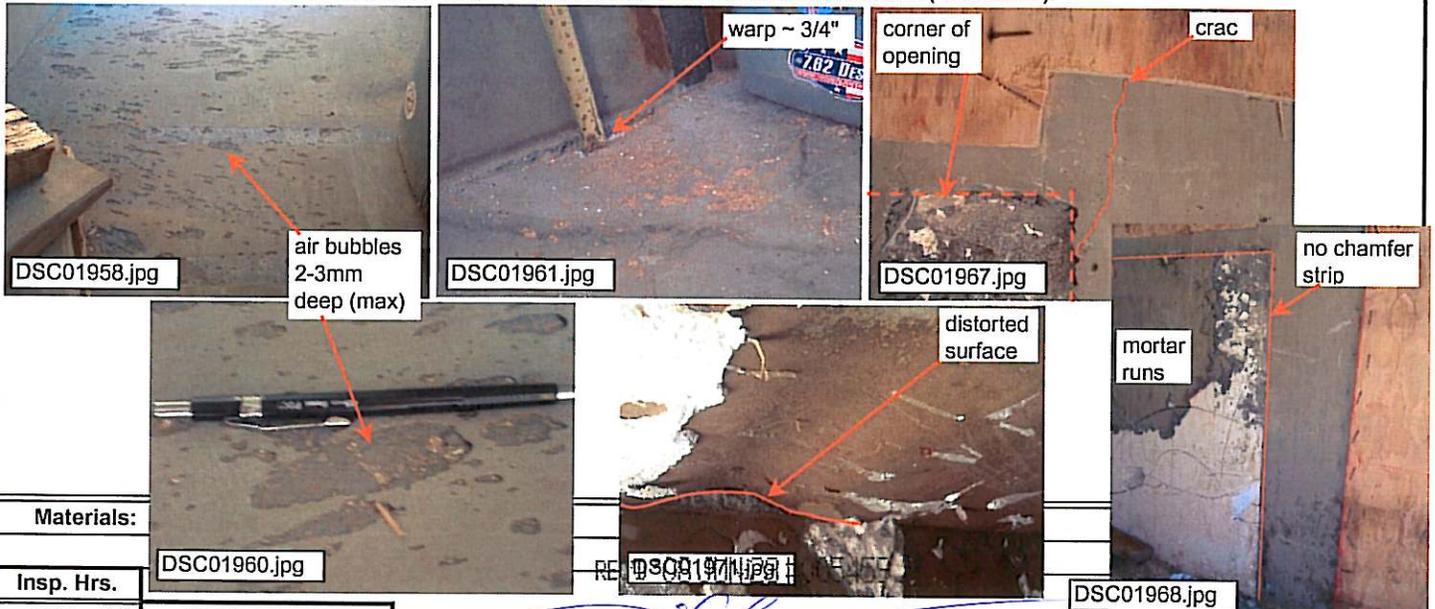
<b>Materials:</b>	
DSC01960.jpg	
<b>Insp. Hrs.</b>	
REG: <b>8.0</b>	<b>INTERMITTENT INSPECTION</b>
OT: <b>0.0</b>

I missed the weekly meeting with ABF today. I asked Pam to ask Jim Davidson (ABF project manager) what their plans were for screeding the concrete. Pam states that they are talking that over with Conco (concrete placement sub.).  
In the morning, I shot grades for the northern Hinge supports on the west, to track settlement over time, if any.  
While at the top of E2 (old), I talked to a surveyor sub contractor - Jason, and he says that the entire W2 has settled about 3 to 4mm overall during construction.  
DSC01958 & DSC01960 show the bottom surface of the access opening on the south side in the transverse diaphragm. These may be minor air bubbles trapped underneath during the pour. DSC01961 is in the same access opening and shows how the masonite of the void forms warped and distorted the concrete. In the west access opening of the longitudinal diaphragm, I observed a minor crack at the top right corner of the opening (DSC01967) and I've noticed that chamfer strips were forgotten at these openings (DSC01968), noticeably by the mortar runs; there were no noticable rock pocks above the mortar runs. The foreman (Nigel) mentioned they weren't in the plans and I told him that it's in the standard specifications (Section 51-1.05 Forms - pg. 349). The corner is likely to be damaged during removal of the formwork and feeding material/equipment through these openings once the void formwork is complete. The surface in this access opening was not as smooth as the previous one, there were several locations of warped masonite and distorted concrete surfaces (DSC01971).
