Job Stamp:
04-SF-80-13.2/13.9 04-0120F4
SFOBB SAS
San Francisco Co. in San Francisco
Fm 0.6 km to 1.3 km East of Yerba Buena
Tunnel East Portal

ASSISTANT RESIDENT ENGINEER'S DAILY BRIDGE REPORT

Location: W2 Cap Beam	7-day const. cal.: 548	Weather: clear/warm
Remark: Hinge K bolts/FW lost deck	Project work day: 758	Hi 70F/Lo 54F

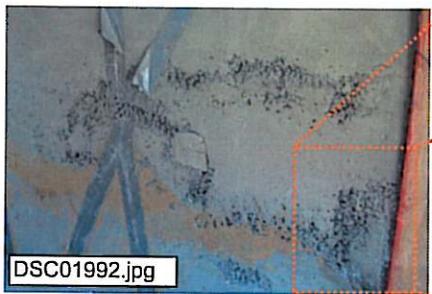
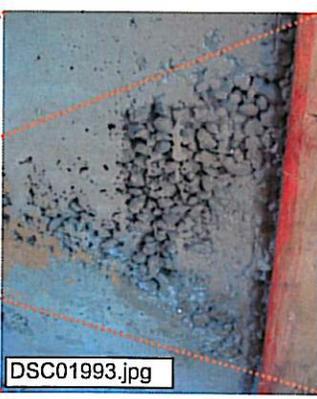
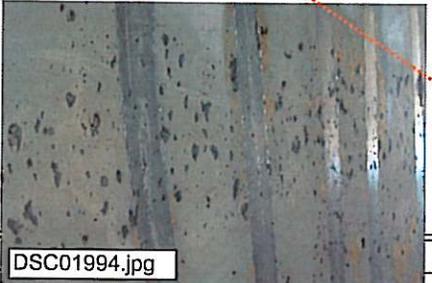
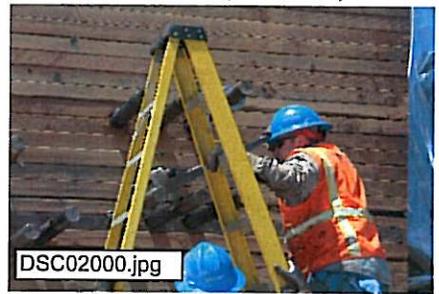
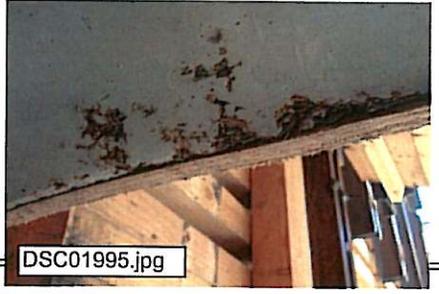
ABF removed the Hinge assembly on the south side of the W-line and placed it back on the ground. They used the rest of the day putting the nuts on the bolts. They decided that if they were able to put the nut all the way on and off, then the rod was a "keeper." Two carpenters were dedicated to this operation. I monitored carpenters place nuts on the HS Macalloy rods from about 1215 to 1415. I observed them having problems twisting the nuts on rods 62 and 23. They used a pipe wrench to screw the nuts on these rods. At one point, they both were needed to twist the nut on rod number 62. In DSC02000, the carpenter is having a hard time cranking the nut on number 23.

The access opening in the longitudinal diaphragm on the west side of the transverse diaphragm has had the masonite removed. This opening did not look as good as the first. There is evidence of bad consolidation in the east side of the opening (DSC01992 & DSC01993). In the west side of the opening wall there are numerous bug holes; these holes are significantly larger than the first access opening (DSC01994). At the top edge on the south side of the opening, there is evidence of debris that was never removed from the forms. It is cast into the concrete (DSC01995).
