Job Stamp 04-0120F4 SFOBB SAS
-------------------------------------

**ASSISTANT RESIDENT ENGINEER'S CONTRACTOR – ABFJV, Sub RPS**

**Description of Operations @ W2 Cap Beam:**

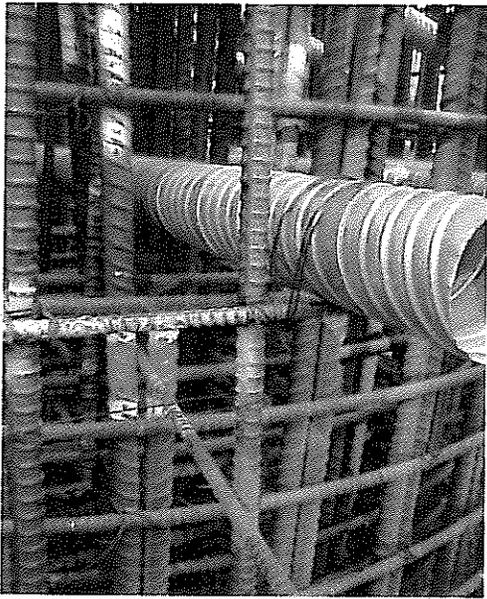
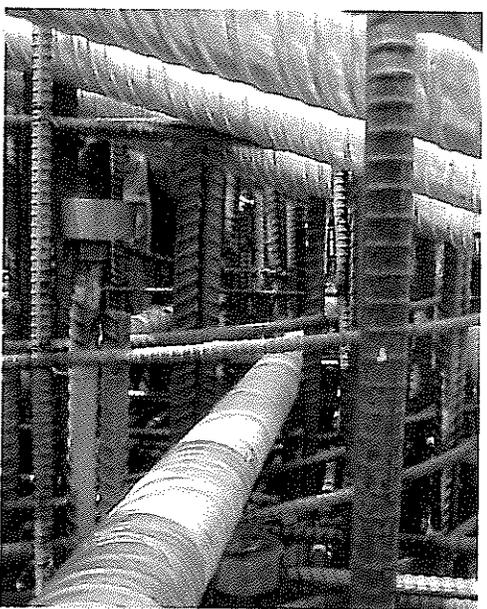
File Name: June-24-2008 W2 Cap 002		File Name: June-24-2008 W2 Cap 005	
Date: 06-24-08	By Int: M Bruce	Date: 06-24-08	By Int: M Bruce
Description: Photo of continuity tendon E-25B at the east support bars. A #16 support bar (painted orange) was placed in between the #43 vertical bars and tied to a #25 vertical bar to prevent the #43 vertical bar from moving.		Description: Photo of continuity tendon E-23B where 4 #43 vertical bars in the NE-cage were hogged back. This was done with a come-along to move and then secure the bars from moving.

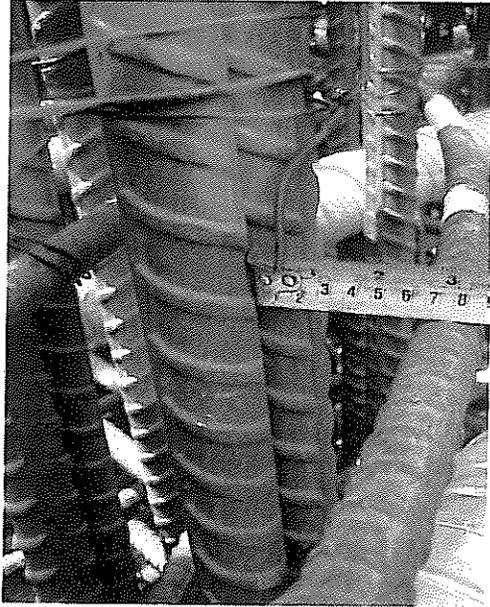
File Name:	June-24-2008 W2 Cap 007
Date:	06-24-08
By Int:	M Bruce

Description: Photo taken of E-22B where 2 outer diameter #43 vertical bars 3 were hogged back 65mm to enable a smooth profile of the tendon through the NE-cage.

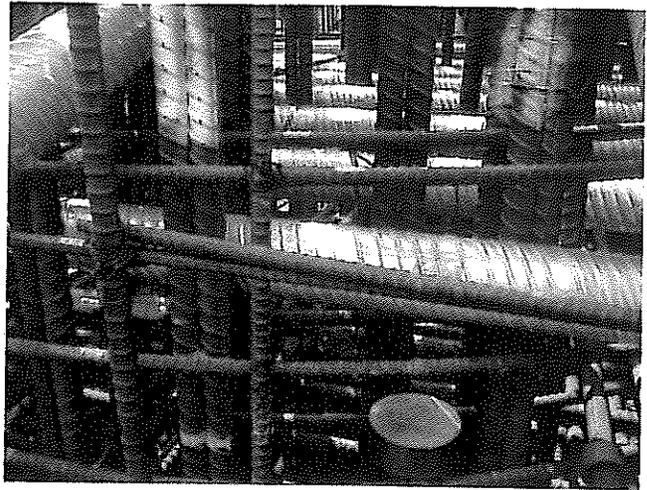
File Name:	June-24-2008 W2 Cap 008
Date:	06-24-08
By Int:	M Bruce

Description: Work done in the NE cage for tendon E-22B. The spacer bar can be seen on the left painted orange on the #25 inner hoop 6 rows up from the base slab concrete. The pair of #43 vertical bars (seen in picture to the left as well) was adjacent to the circular T-head marked 06/13 (1) in blue paint.

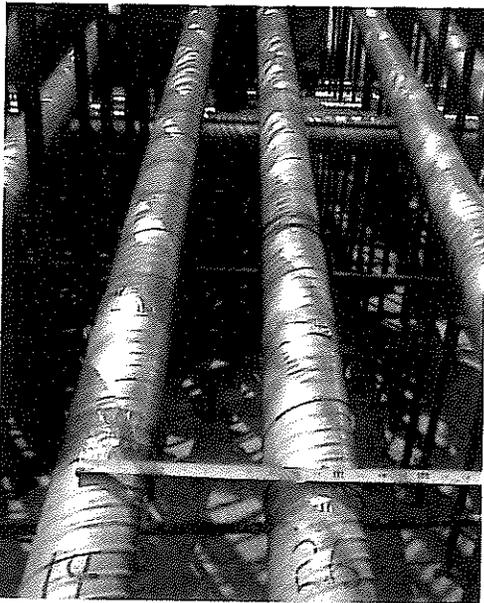
File Name:	June-24-2008 W2 Cap 009
Date:	06-24-08
By Int:	M Bruce

- Began to profile CBT-26 which has some issues for TY-Lin designers to address in my opinion. It was at this moment when RPS foreman Bob Bognus directed Victor and Tim to stop profiling the ducts at 11:35am. He acted in an rude and unprofessional manner (yelling, trying to bully, patronize) at which point I walked away and told him to speak with my supervisor.

Description: CBT 26 is out of tolerance approximately by 25mm to the east. The spacing between CBT-14 and CBT-26 is 300mm. CBT-14 is straight and for the most part has a smooth profile. The ironworkers attempted to move CBT-26 with no success. The most probable solution to move the duct is to cut more #43 vertical bars. TY-Lin will be consulted for this situation.

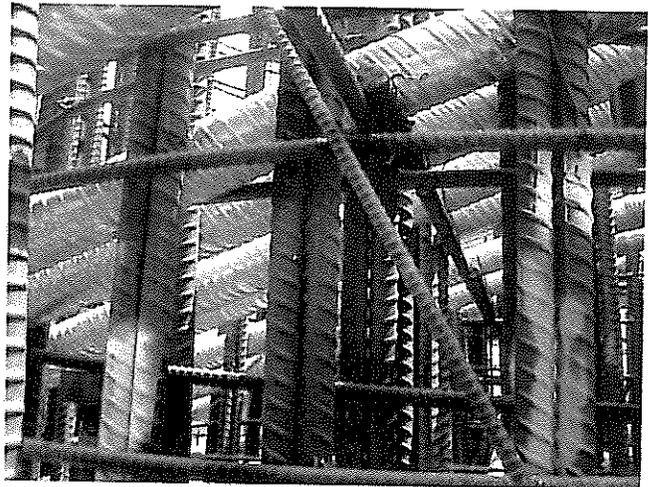
File Name:	June-24-2008 W2 Cap 010
Date:	06-24-08
By Int:	M Bruce

Description: CBT-26 is the first duct in between the outer and inner diameters of the #43 vertical bars. Two pairs (spray painted white) have been called out on plan sheet 486S2 to be cut for the transverse tendon.
