Job Stamp	
04-0120F4	
SFOBB SAS

Const. Calendar:	561			
Project Work Day No.:	771			
Date	06/26/2008			
Inspectors	Start	12:10	Stop	14:40
Hours				
Shift Hours		07:00		15:30

ASSISTANT RESIDENT ENGINEER'S **CONTRACTOR – ABFJV, Sub RPS**

Description of Operations @ W2 Cap Beam:

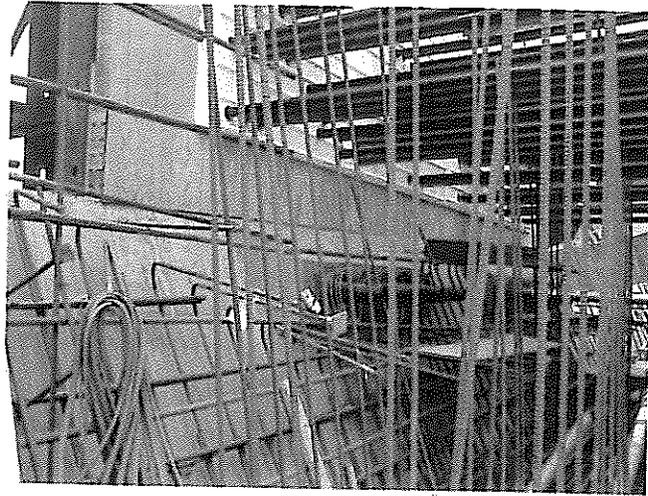
File Name:	June-26-2008 W2 Cap 001
------------	-------------------------

Description: Infill formwork between the Hinge K forms near W2W which was completed today.

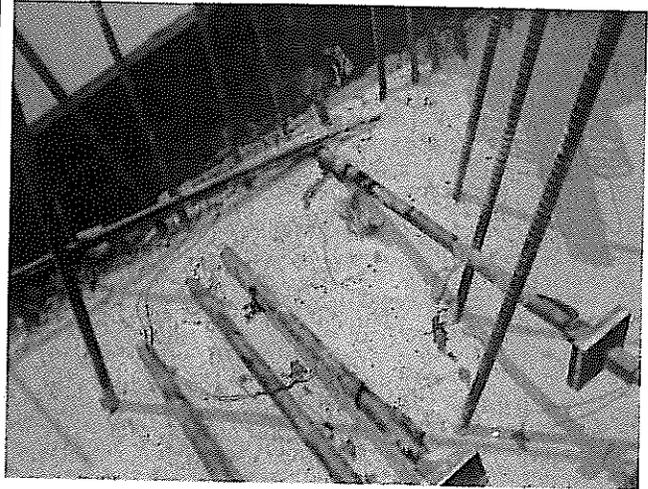
File Name:	June-26-2008 W2 Cap 002
------------	-------------------------

Description: This photo was taken of the deviation saddle erection support rods while doing surveying at W2W. Similar to the Macalloy rods these rods also have denso paste dripping/melting due to the ambient weather conditions. Gil mentioned this problem in the SAS staff meeting.
