Job Stamp 04-0120F4 SFOBB SAS

Const. Calendar:	568			
Project Work Day No.:	778			
Date	07/03/2008			
Inspectors	Start	08:20	Stop	11:30
Hours				
Shift Hours	07:00		15:30

Description of Operations @ W2 Cap Beam:

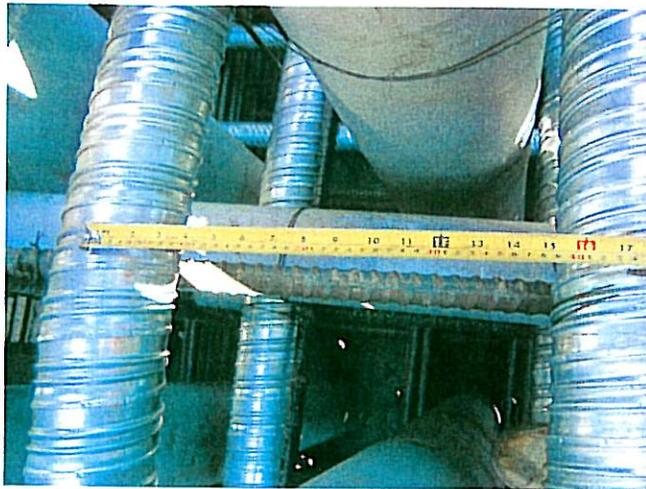
- Continued to profile CBT-23,24,30, and 31 near W2E with the assistance of ABF surveyors, see photos below for issue related to these tendons.
- Began to place support bars for the continuity tendons E-22B through E29B in the column cages. The ironworkers did not place any L-bars at W2E as planned.
- Began to layout location where the L-bars will go through the W2E column cages.

File Name:	July-03-2008 W2 Cap 002		
Date:	07-03-08	By Int:	M Bruce
Description: CBT-23, 24, 30, and 31 transverse tendons near the centerline of pier W2E. The tendons are bearing directly against the cable tie down pipes in the horizontal direction per plan. The Special Provisions states that there needs to be 25mm clear cover between PT ducts.

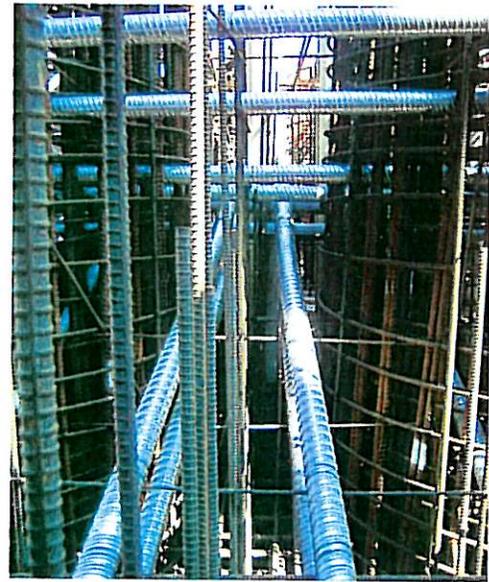
File Name:	July-03-2008 W2 Cap 004		
Date:	07-03-08	By Int:	M Bruce
Description: Photo taken of the CBT-23, 24, 30, and 31 transverse tendons near W2E looking north. ABF surveyors performed the QC to assist the ironworkers with laying out the tendons.

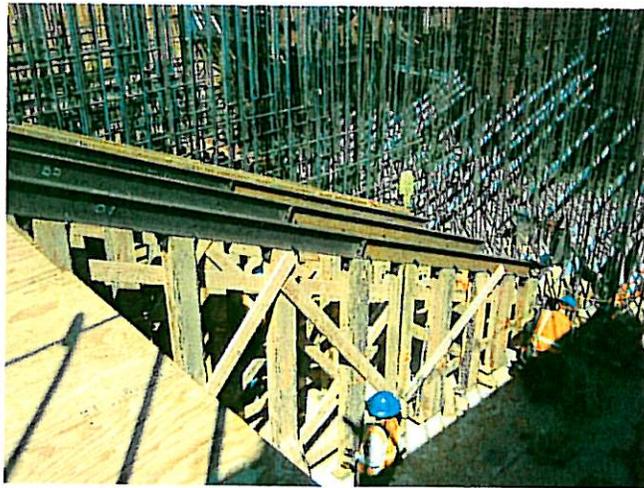
File Name:	July-03-2008 W2 Cap 005		
Date:	07-03-08	By Int:	M Bruce
Description: Erecting void area falsework bents (posts+cap beam) for the sloped area of the northeast quadrant. The cracks in this quadrant have yet to be repaired as more formwork is built. A crack repair plan has been submitted. The southeast quadrant is now considered a "confined space" and the northeast is about to become one.

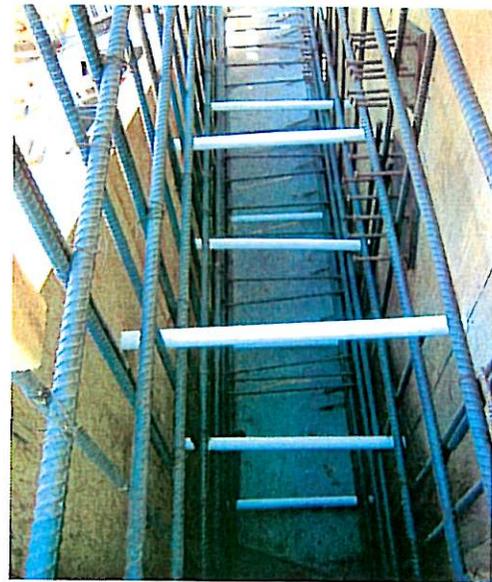
File Name:	July-03-2008 W2 Cap 006		
Date:	07-03-08	By Int:	M Bruce
Description: Horizontal ties have not been placed in the northeast wall sloped section even though the forms have been erected.
