Job Stamp 04-0120F4 SFOBB SAS

ASSISTANT RESIDENT ENGINEER'S **CONTRACTOR – ABFJV, Sub RPS**

Description of Operations @ W2 Cap Beam:

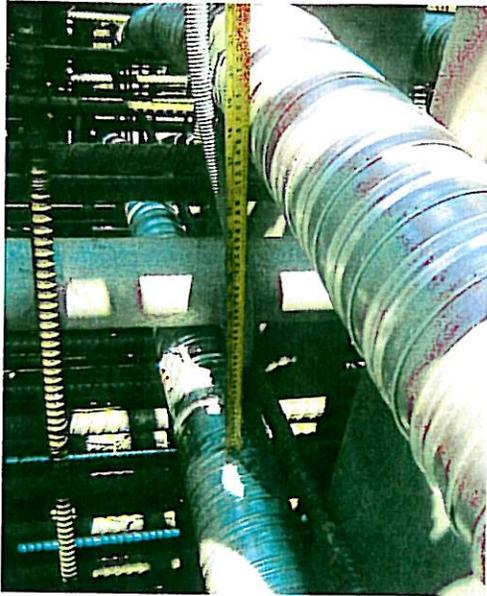
File Name:	July-08-2008 W2 Cap 001
Date:	07-08-08
By Int:	M Bruce

Description: Photo of corrected CBT-23 elevation/spacing at 500mm where it was at 470mm in morning.

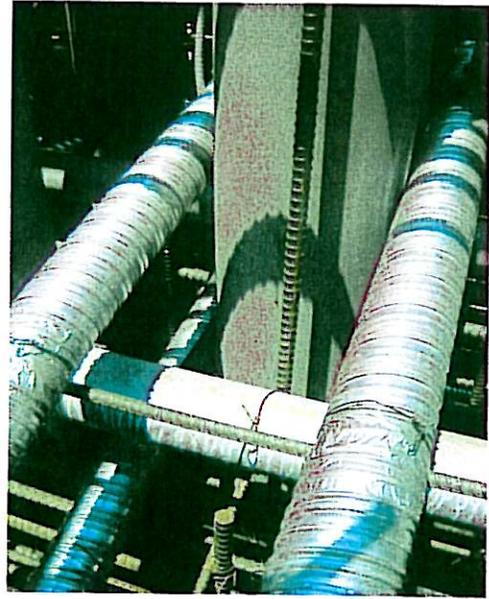
File Name:	July-08-2008 W2 Cap 002
Date:	07-08-08
By Int:	M Bruce

Description: Photo of CBT-23, 24, 30, and 31 where the tendons bear directly against the cable tie down pipes. TY-Lin to be consulted to see if this condition is acceptable. The Special Provisions state that ducts must have 25mm clear spacing.

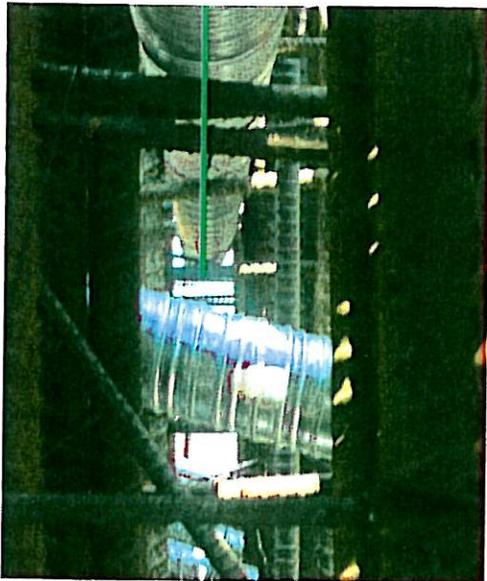
File Name:	July-08-2008 W2 Cap 003
Date:	07-08-08
By Int:	M Bruce

Description: Photo of E-33B taken from inside the southwest column cage looking east. It was difficult to inspect the straightness of the ducts in the column cages. Climbing into the cages, above and around the cages had to be done to get a better view of the tendons. The green line denotes the centerline of the tendon.
