Job Stamp 04-0120F4 SFOBB SAS

ASSISTANT RESIDENT ENGINEER'S **CONTRACTOR – ABFJV, Sub RPS**

Description of Operations @ W2 Cap Beam:

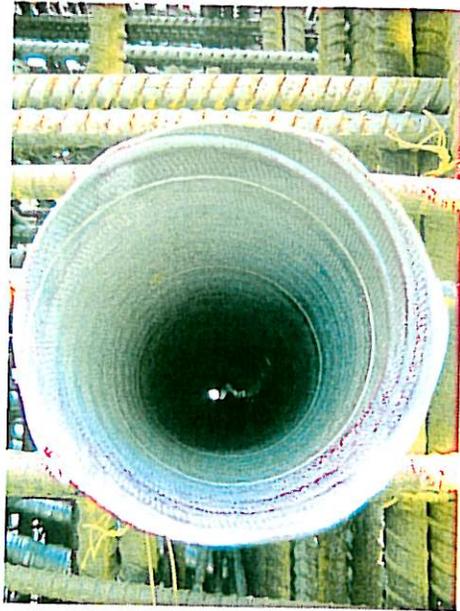
File Name: July-11-2008 W2 Cap 002
 Date: 07-11-08 By Int: M Bruce

Description: Continuity tendon E-35B looking east. The best way found to judge the tendon profile was to look down the tendon from one end to the other where any kinks or sags could be easily seen. It was difficult to judge the profile of tendons by other techniques through the column cages in the previous days. This is a photo of a tendon that has a decent profile as the other side can be seen given the circular shape.

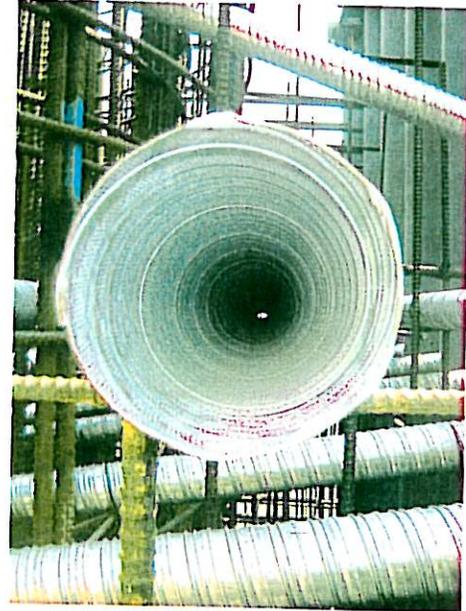
File Name: July-11-2008 W2 Cap 014
 Date: 07-11-08 By Int: M Bruce

Description: Continuity tendon W-32B looking east. There is a semicircular shape at the end of the tendon, which means that there is a sag somewhere in the duct. I recommended to the ironworkers that this method could be used to profile the tendons.

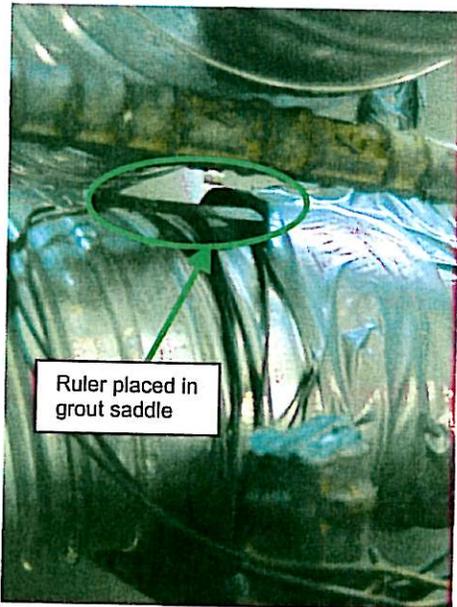
File Name: July-11-2008 W2 Cap 010
 Date: 07-11-08 By Int: M Bruce

Ruler placed in grout saddle

Description: Photo taken of the questionable seal between the grout saddle and the duct for CBT-28 at pier W2E. A ruler was easily placed in the side of the duct tape which didn't seal the edge of the saddle. The method ABF used to install the grout tubes for CBT23-36 was to drill a hole in the duct, then seal the grout saddle with tube over the duct using duck tape.

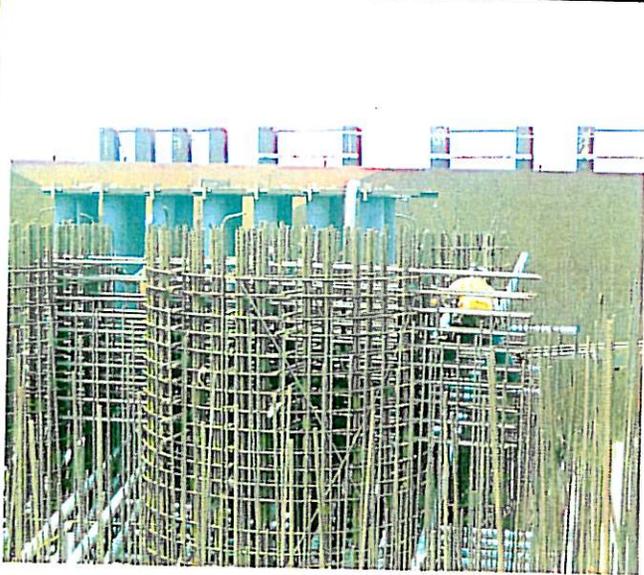
File Name: July-11-2008 W2 Cap 020
 Date: 07-11-08 By Int: M Bruce

Description: L-bar placement in pier W2W east cages at the top portion of the column cages.

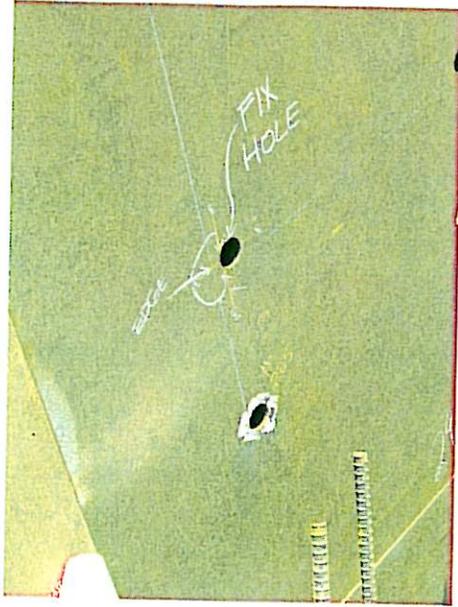
File Name:	July-11-2008 W2 Cap 021
Date:	07-11-08
By Int:	M Bruce

Description: Deviation saddle anchor rod hole (near CBT-28 on the north side near W2W) that needs to be fixed.

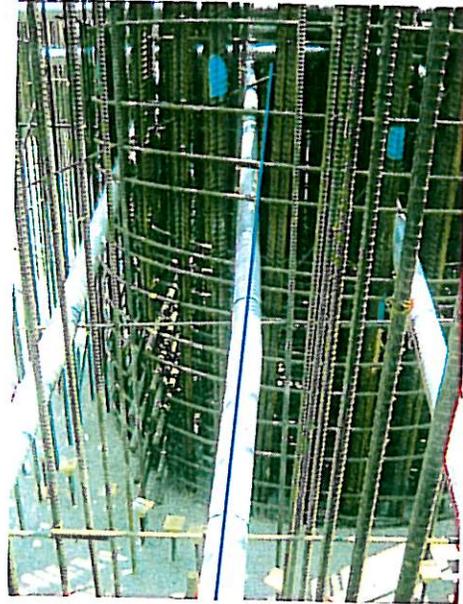
File Name:	July-11-2008 W2 Cap 022
Date:	07-11-08
By Int:	M Bruce

Description: Transverse tendon CBT-34 near W2W looking south that needs to be straightened out. The blue line represents the centerline of the tendon. There were other transverse and longitudinal tendons that need to be straightened out.

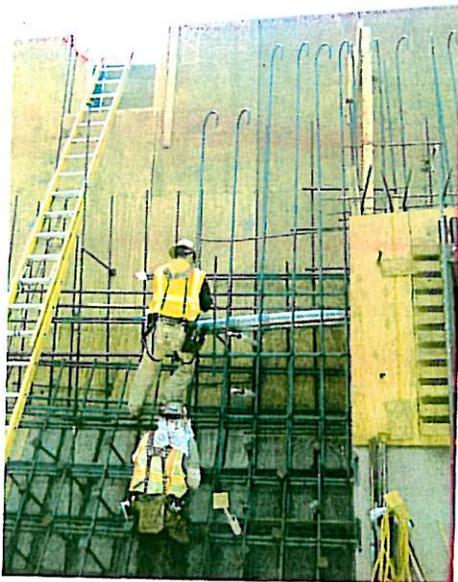
File Name:	July-11-2008 W2 Cap 023
Date:	07-11-08
By Int:	M Bruce

Description: Reinforcement being placed at the sloped portion of the southwest wall.
