Job Stamp:
04-SF-80-13.2/13.9 04-0120F4
SFOBB SAS
San Francisco Co. in San Francisco
Fm 0.6 km to 1.3 km East of Yerba Buena
Tunnel East Portal

Report No. **46.B**

ASSISTANT RESIDENT ENGINEER'S DAILY BRIDGE REPORT

Location: W2 Cap Beam	7-day const. cal.: 558	Weather: overcast
Remark: Lost deck/T-bars/ducts	Project work day: 768	Hi 59F/Lo 52F

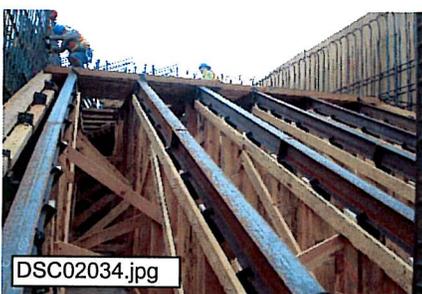
ABF continued to form the lost deck in the southeast void area (DSC02034). I asked Nigel (ABF foreman) what his plans were for the manhole in the deck. He was unsure how he would transition between a flat wall and the round manhole. In the office, I found that ABF had previously requested to use a square manhole (RFI 501R00-R03), which has been approved. I went to the field to notify Nigel and Branden (~1255) that ABF requested the use of a square manhole but he informed me that ABF has already ordered the round detail and it would be at the warehouse at Pier 7. Neither Nigel nor Branden (ABF engineer) knew about this RFI. An ABF carpenter told me that they will be building the lost deck in the northeast void area next.

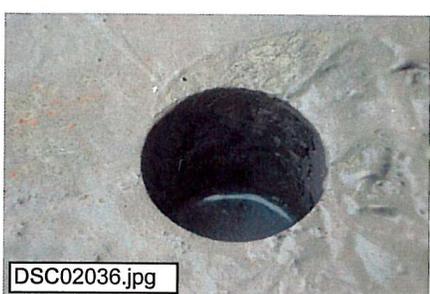
Pam (CT) informed me that ABF has taken cores of the cracks in the deck this morning (DSC02036). ABF's survey crew checked the elevation of the vertical hooks in the concrete of pour 2. They determined that these bars were too low. They are at 80mm from top of concrete when they should be 55mm.
