Job Stamp:
04-SF-80-13.2/13.9 04-0120F4
SFOBB SAS
San Francisco Co. in San Francisco
Fm 0.6 km to 1.3 km East of Yerba Buena
Tunnel East Portal

Report No. **46.B**
Date the Shift Began: **6/27/08**
 NIGHTWORK **FRIDAY**
Shift Hrs Start **7:00** Stop **15:30**
Engineer's Hrs Start **7:00** Stop **15:30**

ASSISTANT RESIDENT ENGINEER'S DAILY BRIDGE REPORT

Description of Operation:
ABF - continue to form lost deck in southeast void/continue lost deck supports in northeast void

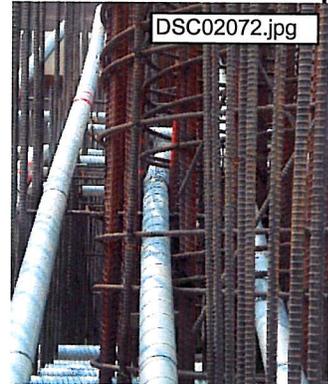
Field meeting w/T.Y.Lin/ABF/RPS/CT to discuss the placement of the ducts and the tolerances. CT pointed out that the ducts had kinks that needed to be taken out (i.e. DSC02072). Although T.Y.Lin said that they were okay with one inch of tolerance in the vertical, CT mentioned that we did not want kinks if they were avoidable. The transverse tendon inflection points, according to the plans, are not at the same elevation. ABF, however took the difference of the inflection points, in the cable tie down area, between the east-most and west-most tendons, and averaged the elevations. This issue was brought up in Wednesday's meeting with ABF. T.Y.Lin, today said that they were okay with this. CT emphasized that we were looking for a smooth profile and that it would be appreciated if ABF/RPS can do what they can to provide this. Gil (CT) says that if any of the ducts need to be adjusted because of the column cage vertical rebar, CT will be willing to pay for the labor. ABF, RPS, and T.Y.Lin all agreed that conditions like that shown in DSC02072 were not acceptable.

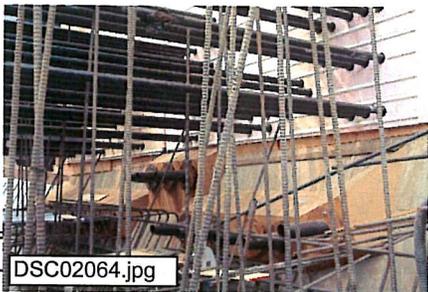
ABF continued to form the lost deck under pour 3 in the southeast void (DSC02067). They continued to mobilize prefabricated lost deck supports to the northeast void area (DSC02070) and their survey crew was there to aid placement. They crews are having to torch the ends of the tieback rods that support the intermediate transverse diaphragm in order to clear the lost deck posts. With all of the lost deck supports coming in, it would be hard for ABF to address the cracks in the soffit the area is this congested. ABF has finished closing the horizontal gap in the forms in the Hinge area on the E-line (DSC02064). The wall panel on the west side of the intermediate transverse diaphragm, on the south end, is set (DSC02065). ABF is also removing tie back rods that were left in the pvc holes from pour 2.
