Job Stamp:  
04-SF-80-13.2/13.9 04-0120F4  
SFOBB SAS  
San Francisco Co. in San Francisco  
Fm 0.6 km to 1.3 km East of Yerba Buena  
Tunnel East Portal

Report No. **46.B**

**ASSISTANT RESIDENT ENGINEER'S DAILY**

Location: <b>W2 Cap Beam</b>	7-day const. cal.: <b>579</b>	Weather: <b>hazy</b>
Remark: <b>ironwork/lost deck/wall form</b>	Project work day: <b>789</b>	Hi <b>69F</b> / Lo <b>60F</b>

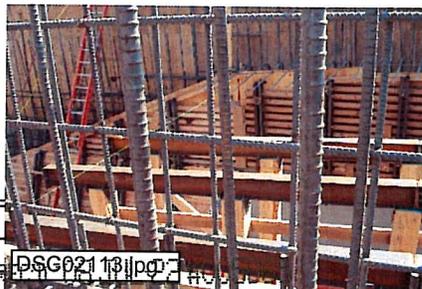
After they closed up the wall, they started to work on the lost deck supports in the same void (DSC02113).

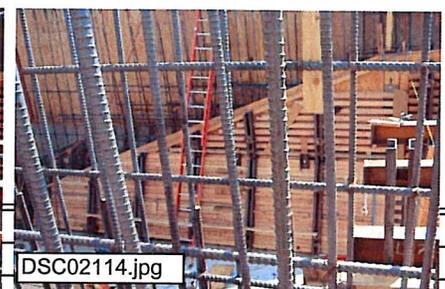
After minor problems with the crane this morning (boom would not move down until kicked several times - according to Nigel), ABF was able to mobilize forms to close up the west wall (DSC02114), south of the longitudinal diaphragm. The ironwork was approved after minor cutting of reinforcement that was resting on the wood forms. I mentioned to Nigel (ABF foreman) that the ironwork was okay as placed as long as they extended to the continuity blockouts that have not been placed.
