Job Stamp 04-0120F4 SFOBB SAS

Description of Operations @ W2 Cap Beam:

EA	04-0120F4
Co-Rte-KP (PM)	SF-080-13.2/13.9 (8.2/8.7)
Structure Rep.	Rick Morrow

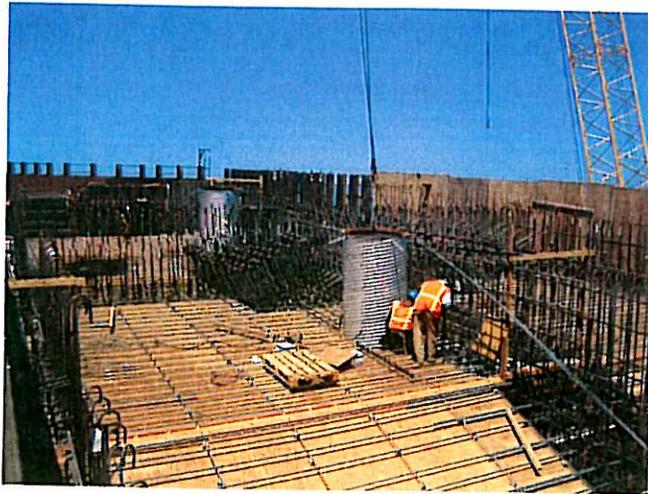
File Name:	July-31-2008 W2 Cap 001
Date:	07-31-08
By Int:	M Bruce

Description: Photo taken from the southwest end of the W2 cap beam. Progress to date includes the installation of the manhole/access opening blockouts and the 25L5L01 bar placement.

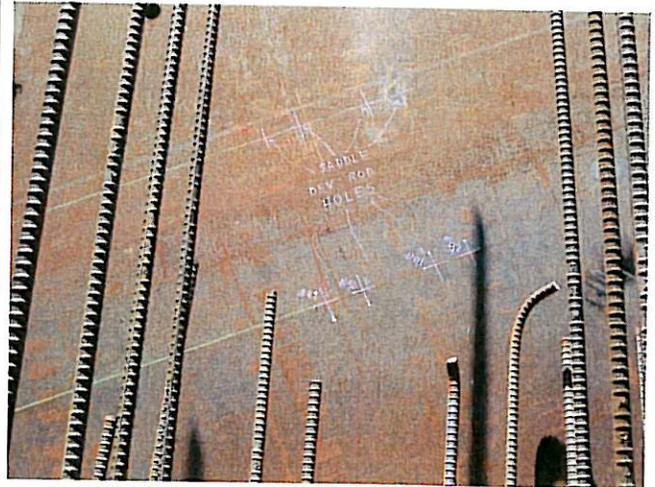
File Name:	July-31-2008 W2 Cap 002
Date:	07-31-08
By Int:	M Bruce

Description: Photo taken of layout for deviation saddle rods at the W2W. To my knowledge there is no submittal for the embedded items presumably used for the deviation saddle erection.

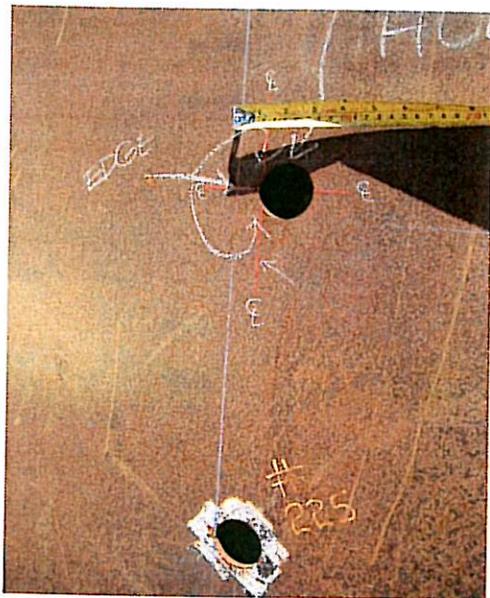
File Name:	July-31-2008 W2 Cap 005
Date:	07-31-08
By Int:	M Bruce

Description: Photo of a hole drilled incorrectly for a deviation saddle anchor bolt. The hole is approximately 30mm to the east from its theoretical location. This same hole was mentioned in another diary. Polystyrene placement continues near W2W.

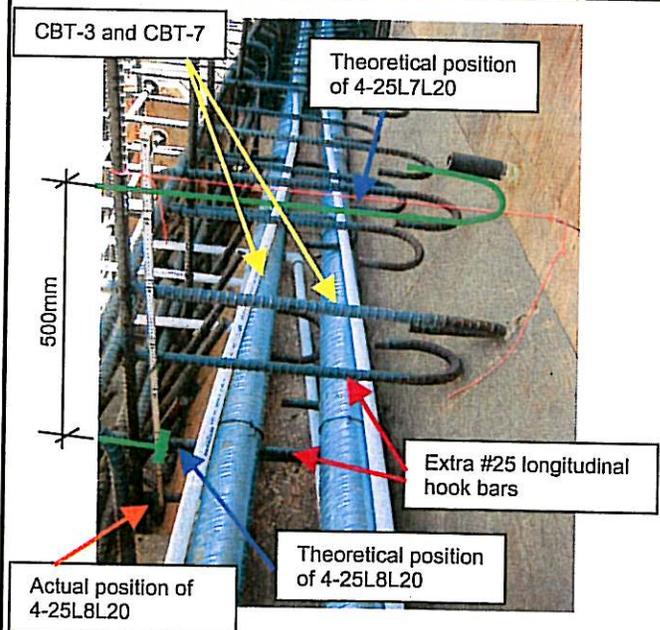
File Name:	July-31-2008 W2 Cap 006
Date:	07-31-08
By Int:	M Bruce

Description: Rebar placement of #25 hooked bars at the longitudinal diaphragm near the jacking saddle. There is two extra rows of #25 hooked bars and #25 horizontal T-heads as seen in the photo above. The pink stringline denotes approximate position of bar 4-25L7L20. The detailing of sheets 497S4R1 and 497S5 are confusing regarding the exact position of these bars.
