| EA | 04-0120F4 |
| Co-Rte-KP (PM) | SF-080-13.2/13.9 (8.2/8.7) |
| Structure Rep. | Rick Morrow |

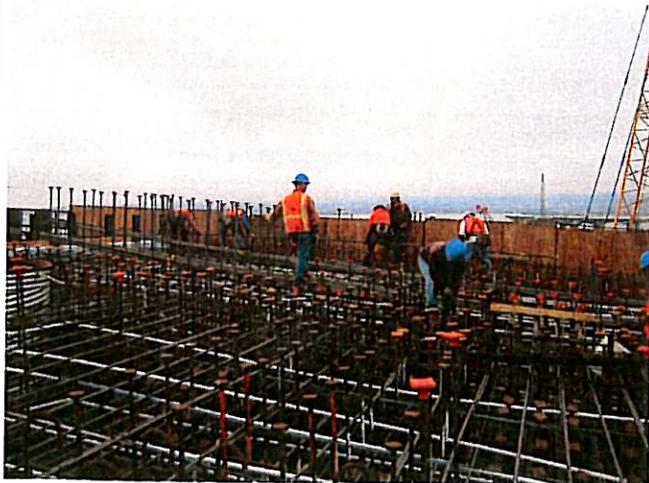
| File Name: | Aug-8-2008 W2 Cap 003 | | |

Description: Ironworkers mobilizing #43 bars that were detailed in RFI 1464R01. ABF laborers can also be seen in the photo placing caps on the vertical dowels.

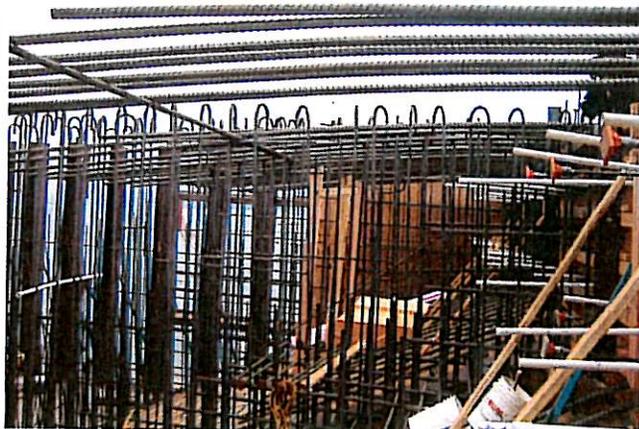
| File Name: | Aug-8-2008 W2 Cap 005 | | |

Description: Support frame built in the northeast quadrant for the vertically bundled #43 transverse bars in the top mat of pour 3.

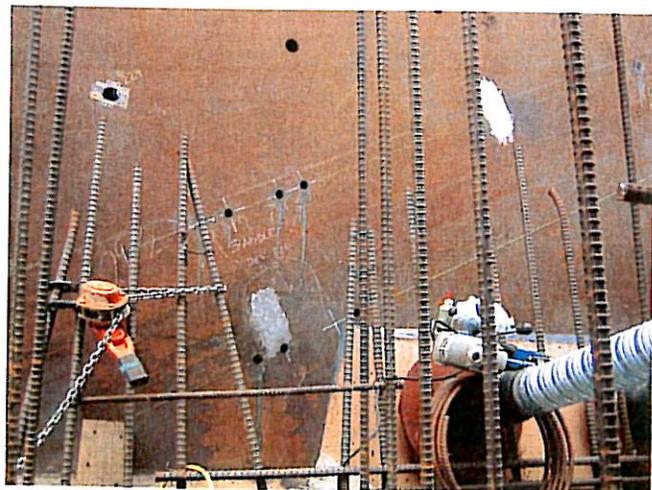
| File Name: | Aug-8-2008 W2 Cap 006 | | |

Description: Drilled holes in the W2W deviation saddle forms for the temporary support rods to be used for the saddle erection.

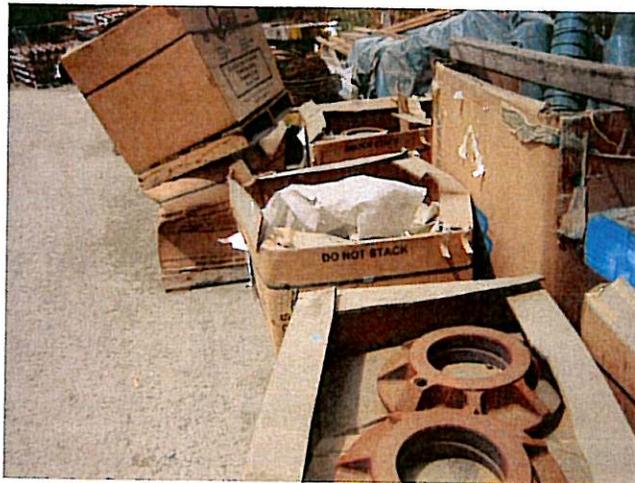
| File Name: | Aug-8-2008 W2 Cap 009 | | |

Description: Improper storage of bearing plates, trumpets and vertical rods. There is a significant amount of dirt on the material as well as built up rust on the plates. ABF has been informed in the past about this issue numerous times.
