Job Stamp 04-0120F4 SFOBB SAS

ASSISTANT RESIDENT ENGINEER'S **CONTRACTOR – ABFJV, Subs Conco and RPS**

Description of Operations @ W2 Cap Beam:

EA	04-0120F4
Co-Rte-KP (PM)	SF-080-13.2/13.9 (8.2/8.7)
Structure Rep.	Rick Morrow

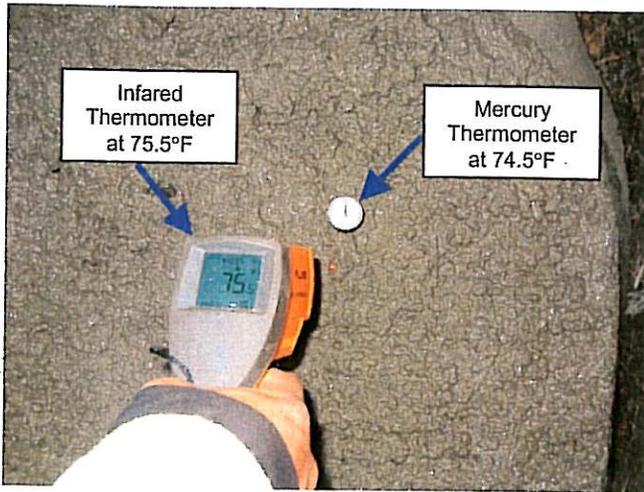
File Name:	Aug-21-2008 W2 Cap 006
Date:	08-21-08
By Int:	M Bruce

02:12			First trucks arrived onsite and set up to discharge at both east and west pumps.
02:22			The temperature of the concrete in the wheelbarrows from both east and west pumps obtained by the infrared thermometer was 75.5°F. This temperature of the mercury thermometer was 74.5°F, see photo below for details.

Description: Temperatures of concrete taken from the first trucks set up near both the east and west pumps. The temperature differential as seen in the photo above was approximately 1°F

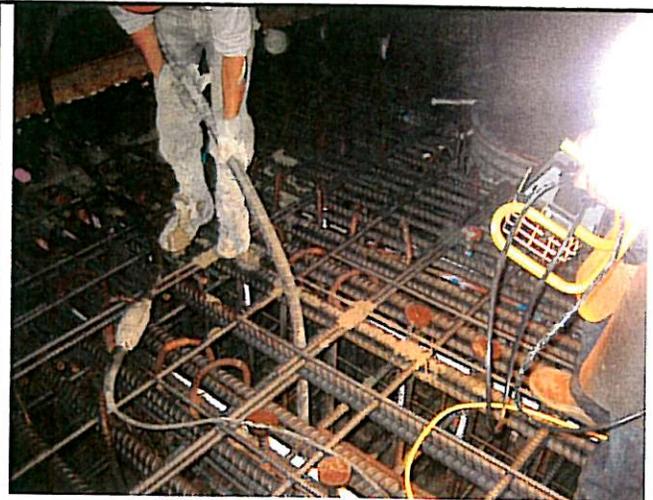
File Name:	Aug-21-2008 W2 Cap 011
Date:	08-21-08
By Int:	M Bruce

2. The lighting in the morning hours was inadequate in my opinion for inspection and safety.
3. Overall the placement of concrete went well as the flow looked consistent with no segregation and vibration was done proficiently.

Description: Conco laborer seen vibrating concrete near the north manhole, west side of the W2 cap beam. As mentioned above the lighting was not adequate as the ironworker onsite helped carry a floodlight around.

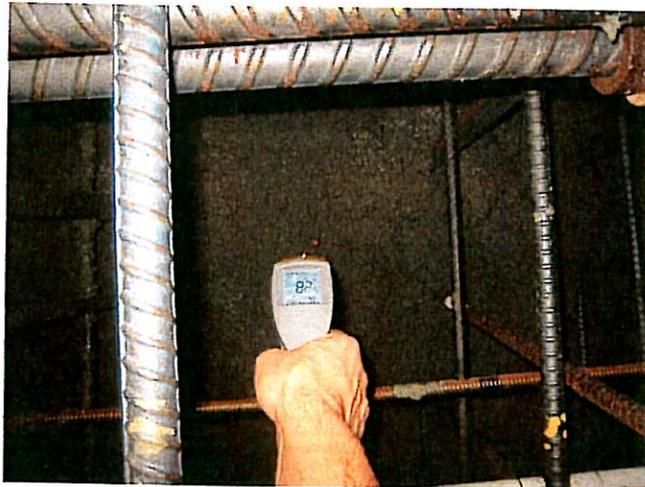
File Name:	Aug-21-2008 W2 Cap 017
Date:	08-21-08
By Int:	M Bruce

03:40	83	East longitudinal diaphragm (east pump)

Description: Temperature taken at 3:40am in the east longitudinal diaphragm as concrete was just placed in this section.

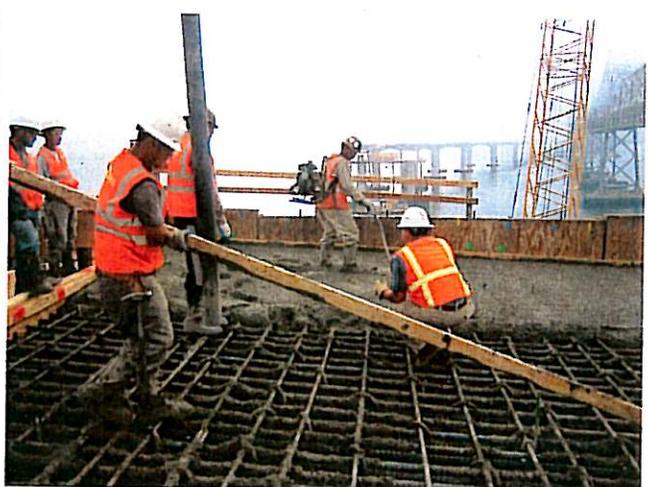
File Name:	Aug-21-2008 W2 Cap 027
Date:	08-21-08
By Int:	M Bruce

08:47	Under the supervision of Mark MacDonald the Conco laborers began to revibrate the 1 st TOCL.		
08:57	Began smooth finish on the 1 st TOCL and Mark MacDonald was informed by Gil and myself of the language in the specification to revibrate the concrete as late as the concrete will respond again. After me and Gil told MacDonald the spec Nigel asked about the depth of vibration to which we told him it was below the first layer of top mat reinforcing.

Description: Conco laborers seen vibrating the first TOCL (top of concrete layer) near the east forms. Mark MacDonald is seen in the photo directing the laborers to vibrate the last lift approximately 15 minutes after the concrete was placed.

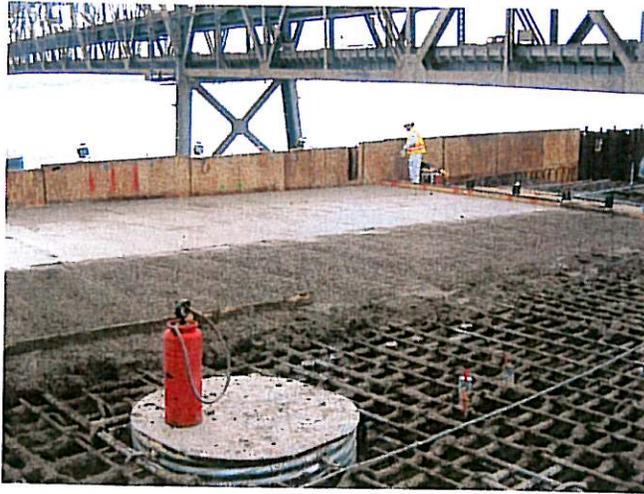
File Name:	Aug-21-2008 W2 Cap 031
Date:	08-21-08
By Int:	M Bruce

Description: Photo of the 3rd TOCL rough finished at 9:45am.

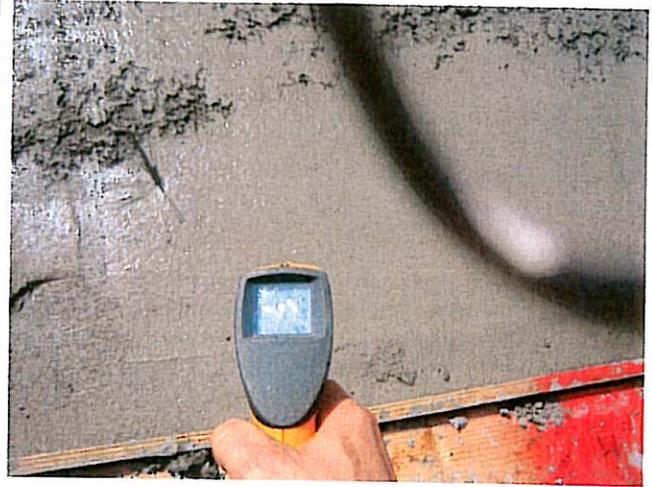
File Name:	Aug-21-2008 W2 Cap 033
Date:	08-21-08
By Int:	M Bruce

10:05			Conco laborers began to revibrate the 3 rd TOCL.
10:18	91	North end of 1 st TOCL	Taken before water was sprayed on TOCL.
10:19	88	South end of 1 st TOCL	Taken before water was sprayed on TOCL.

10:22			Conco laborers starting to place the 4 th TOCL from the north end to the south end.
10:23	85	Center of 4 th TOCL in between manholes	
10:38	88	North end of 1 st TOCL in same location as reading at 10:18am.	Taken after water was sprayed on TOC. I told Nigel the importance of keeping the concrete surface moist mentioning the temperature change that I recorded with the infrared gun.

Description: Temperature of 91.5°F taken on north end of the 1st TOCL at 10:18am prior to water being sprayed on the surface.

09:46	82	North end of the 3 rd TOCL	
09:50			Finished placing the 3 rd TOCL and rough finishing of this section was underway. I noticed evaporation from the first two TOCL from the east and discussed it with Gil. We informed foreman Nigel Lohse to spray water on the finished surfaces. They agreed to spray water however they had no intention of doing so had we not recommended them to spray the water.

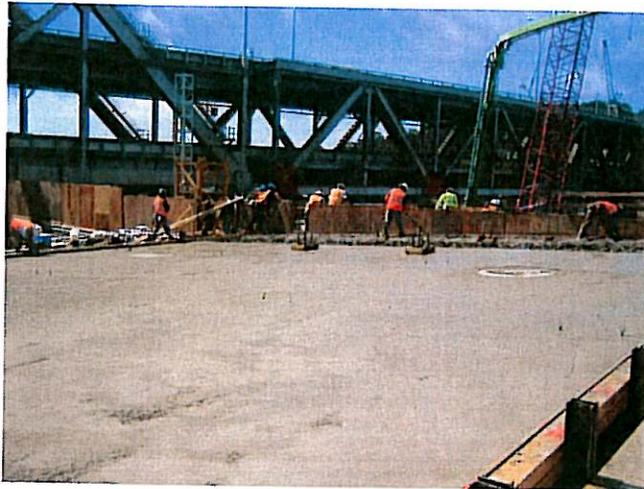
File Name:	Aug-21-2008 W2 Cap 034
Date:	08-21-08
By Int:	M Bruce

11:45			Conco laborers finished placing the 6 th TOCL from the north end to the south end.
12:00			Conco laborers began to revibrate the 6 th TOCL.
12:10			I left the jobsite as curing compound wasn't sprayed on any portion of the concrete and curing mats weren't placed.

Description: Final top of concrete layer on the west end of the W2 cap beam. Water spray was being applied intermittently and no curing compound was applied while finishing operations commenced.

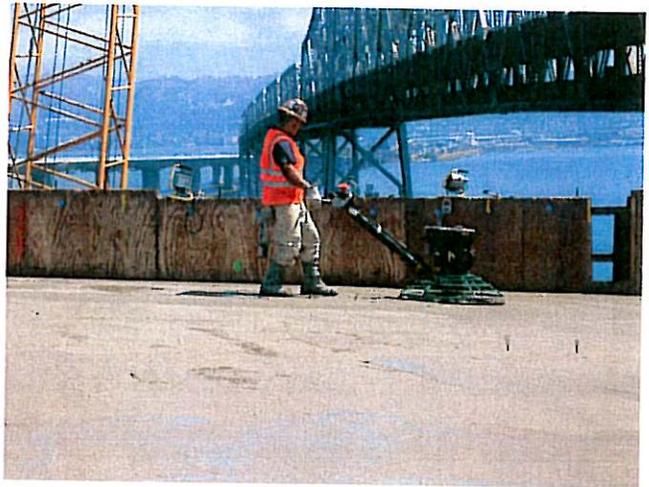
File Name:	Aug-21-2008 W2 Cap 035
Date:	08-21-08
By Int:	M Bruce

Description: Mechanical trowel work done on the east end of the W2 cap beam while the concrete wasn't completely set.
