Job Stamp 04-0120F4 SFOBB SAS

Assistant Structure Rep.'s Daily Report

Location & Description of Operation	SAS-Temporary towers, Tower A & B Erection
Weather	HI: 67 F Low: 57 F Partly cloudy

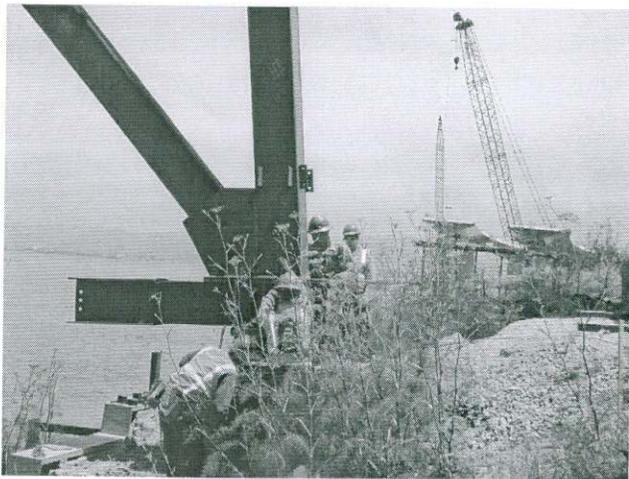
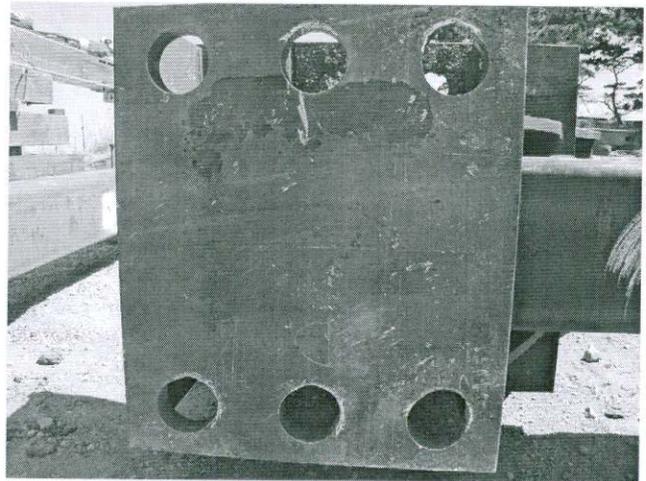
- Daily activity of contractors
 - ABF crews start to assemble the first section, which has vertical members, internal bracing members and link beam (see Figs 1 and 2).
 - ABF checked whether the holes of the lowest member at A2 foundation is fitting into the existing anchor bolts. Some holes of the base plate are grinded further to accommodate the discrepancy between the designed and actual locations (see Figs 3 and 4).
 - One truck is on-site to deliver tower A west-line members.
 - See Art Pannu's diary for additional contractors' activities and comments.

Figs 3 and 4. ABF checked whether the base plate is fitting into the existing anchor bolts.

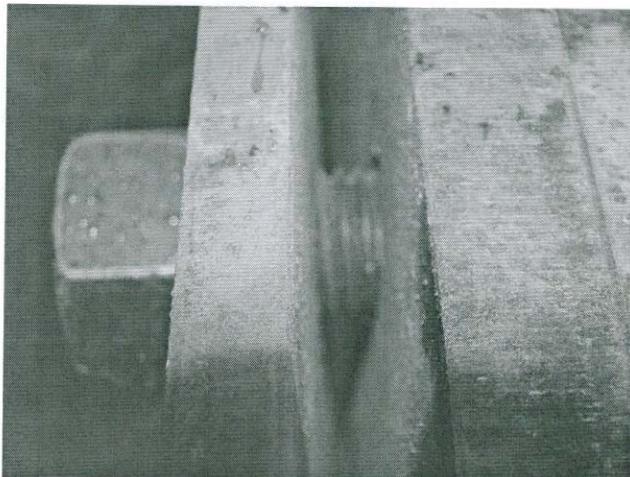
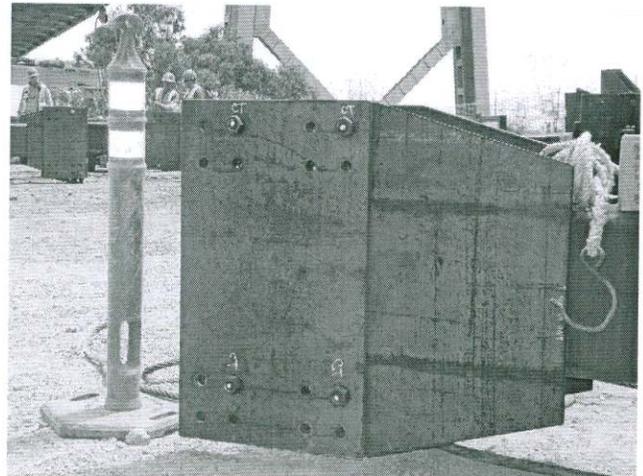
- Note
 - Noticed that the thread area of bolt is located at shear plane and talked to Ed, a foreman, about it. He refused to correct it referring to John, ABF engineer. Inform Art regarding this issue. Later Mark and Art visited the site and checked it. They are marked (see Figs 5 and 6).
 - Noticed that most gusset plates are bended (see Fig 7).
 - One truck from PA delivers members of the tower A west line.
 - 2 hours O.T.

Figs 5 and 6. The thread area of the bolt is located at the face of shear plane. They are marked with white and letter CT.

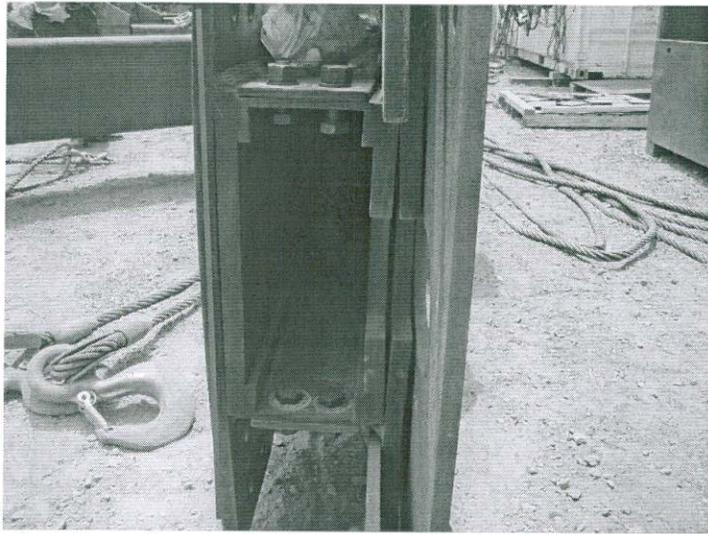
Fig 7. The gusset plate are bended due to welding. The red line indicates the ideal position.
