Job Stamp	
04-0120F4	
SFOBB SAS

### Assistant Structure Rep.'s Daily Report

Location & Description of Operation	SAS-Temporary towers, Tower A & B Erection
Weather	HI: 67 F Low: 57 F Partly cloudy

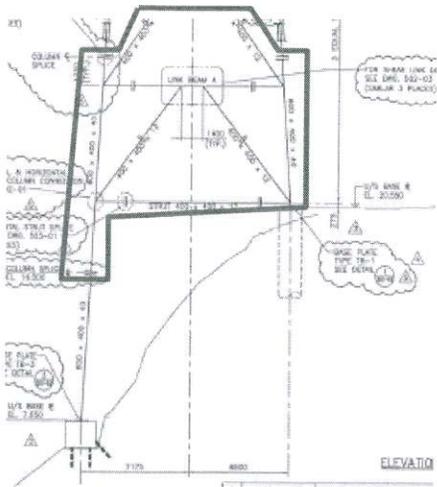
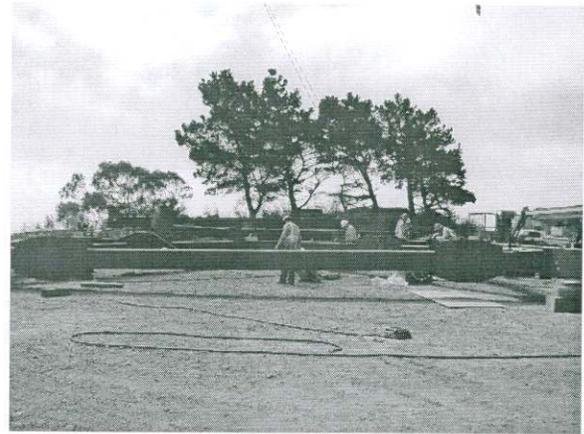
- Daily activity of contractors
  - ABF crews start to assemble the first section of the tower A west line, which has a strut member and a link beam (see Figs 1 and 2 for locations and photos).
  - ABF crews replace 3 ½ inch bolts with 4 inch bolts to meet the requirement that the thread area of the bolt shouldn't be located at the shear plane (see Figs 3 and 4).
  - ABF used a regular wrench to make snug-tight condition and an impact wrench to pretension bolts (see Fig 5).
  - One truck is on-site to deliver tower A west-line members (see Fig 6). The plate number is PA XCG-6348.
  - See Art Pannu's diary for additional contractors' activities and comments.

Figs 1 and 2. The location where ABF starts to assemble on site and the photo taken in the field.

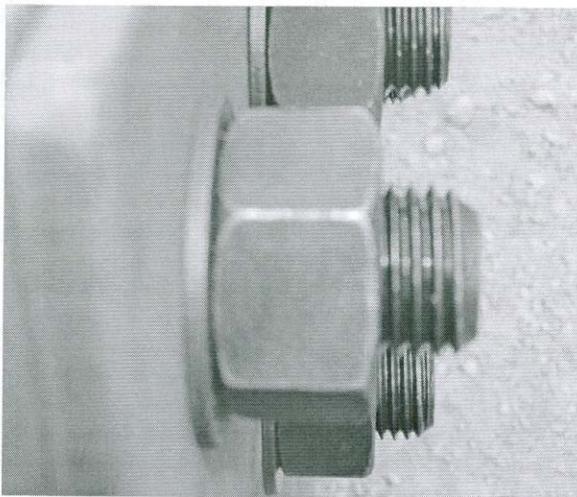
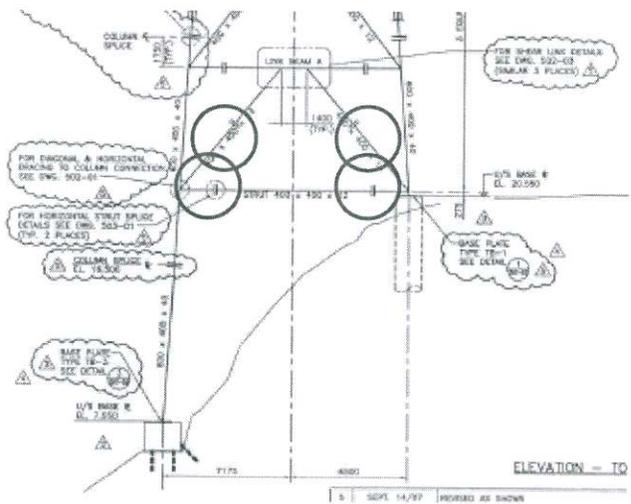
- Note
  - Total number of bolts replaced is 128 (see Figs 3 and 4).
  - 2 hours O.T.

Figs 3 and 4. Bolts are replaced with longer bolts at locations in red circle

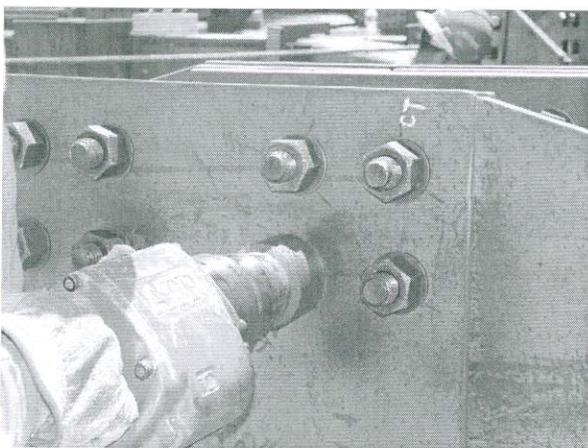
Fig 5. ABF crews pretensioned bolts using impact wrench.
