Job Stamp
04-0120F4
SFOBB SAS

Assistant Structure Rep.'s Daily Report

Location & Description of Operation	SAS-Temporary towers, Tower A & B Erection
Weather	HI: 66 F Low: 56 F Partly cloudy

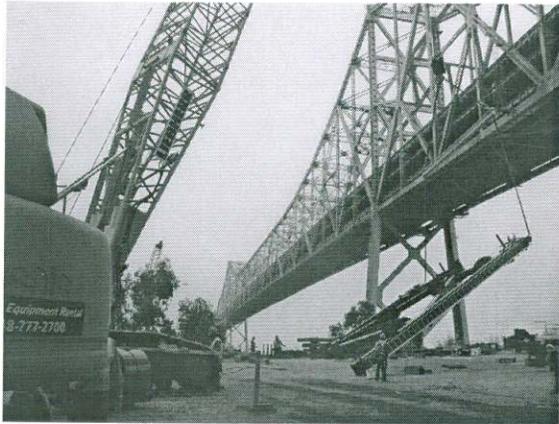
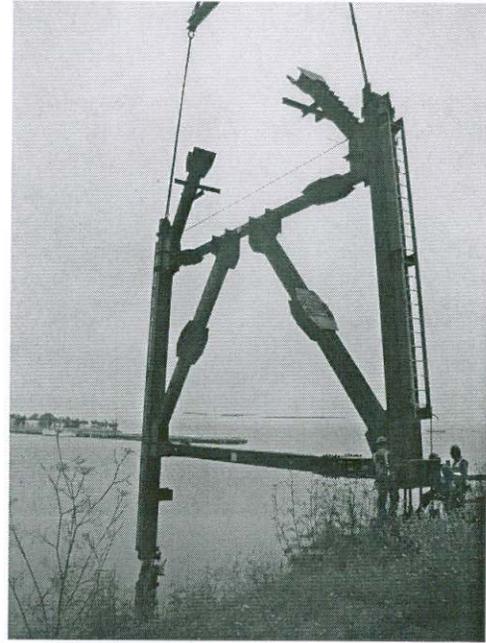
- Daily activity of contractors
 - ABF erected the first assembled section, which contains one link beam and strut member, into the existing vertical member (see Fig 1 and 2).
 - ABF surveyors checked the position of the section before it is released.
 - ABF pretensioned bolts at spliced zone of the tower A1 (see Figs 3 and 4).
 - See Art Pannu's diary for additional contractors' activities and comments.

Figs 1 and 2. ABF erected the first section of the tower A west line.

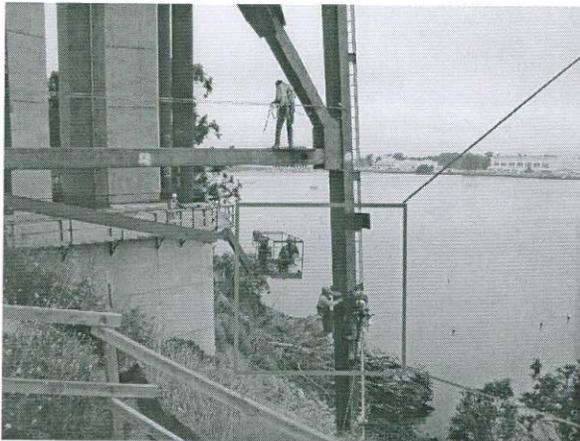
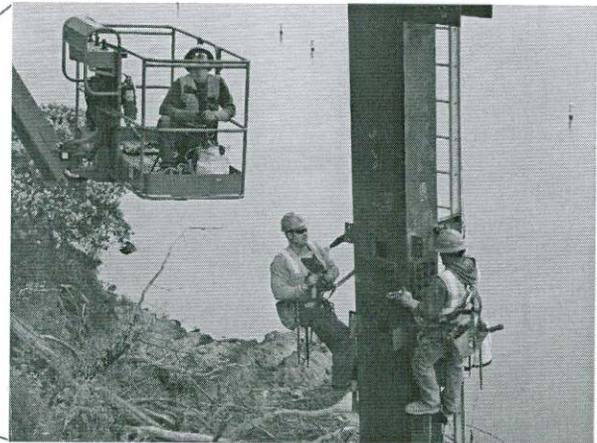
Figs 3 and 4. ABF crews installed bolts with pretensioning.

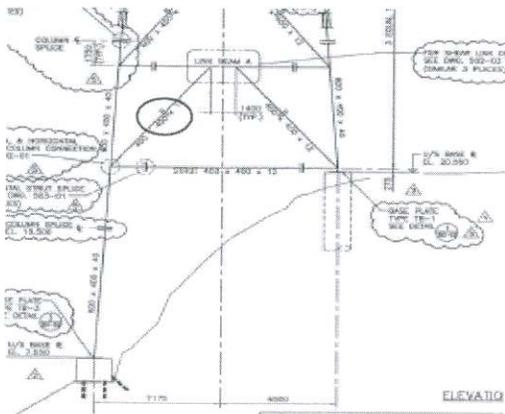
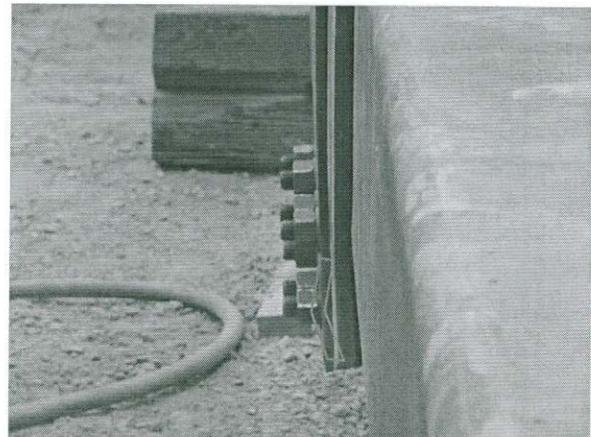
- Note
 - Noticed that a couple of bolts are less turned due to the rotation of bolt and mentioned Ed, a foreman, regarding it. ABF corrected them before the erection.
 - Requested an access to the splice zone while ABF crews torque bolts. Ed refused to give the access.
 - ABF crews snug-tighten the plates which were bended outward and inward (see Figs 6 and 7 for locations and photos taken).
 - 2 hours O.T.

Figs 5 and 6. Location of the plate and the condition after snut-tighting. The red line indicates the previous configuration of the plate approximately.

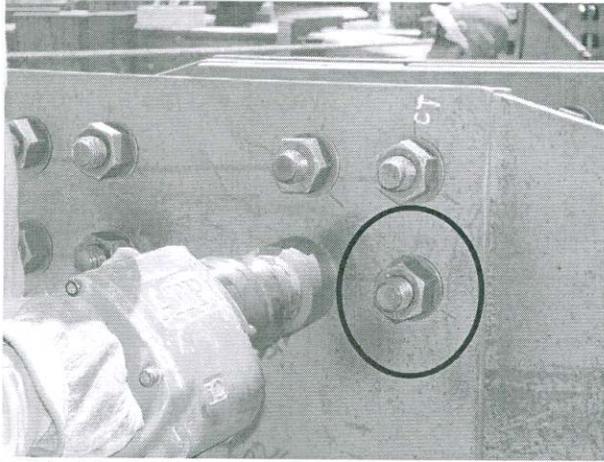
Fig 7. The bolt inside the blue circle is rotated during the turning operation.
