Job Stamp 04-0120F4 SFOBB SAS

Assistant Structure Rep.'s Daily Report

Location & Description of Operation	SAS-Temporary towers, Tower A & B Erection
Weather	HI: 67 F Low: 55 F Partly cloudy

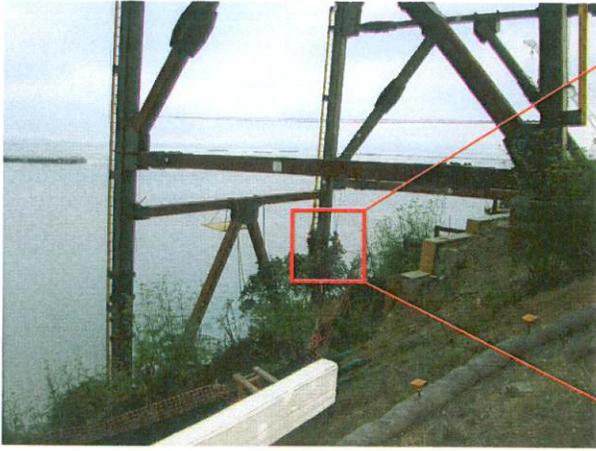
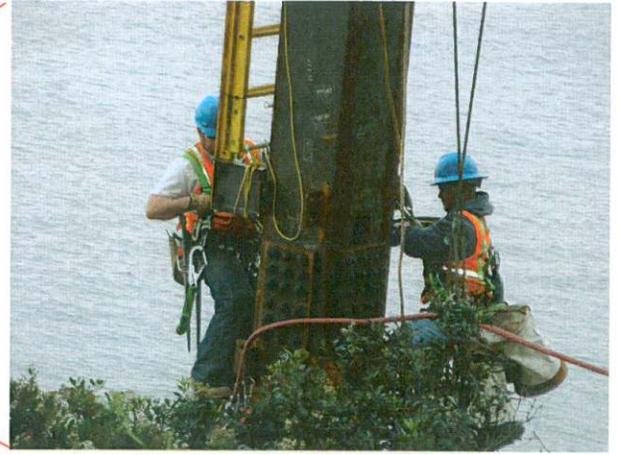
- Daily activity of contractors
 - Continued to pretension the bolts at the splice zone after the erection (see Figs 1 and 2).
 - Started to assemble the second section, which has two link beams and install bolts (see Figs 3, 4 and 5).

Figs 1 and 2. ABF continued to pretension bolts at the splice zone after the erection.

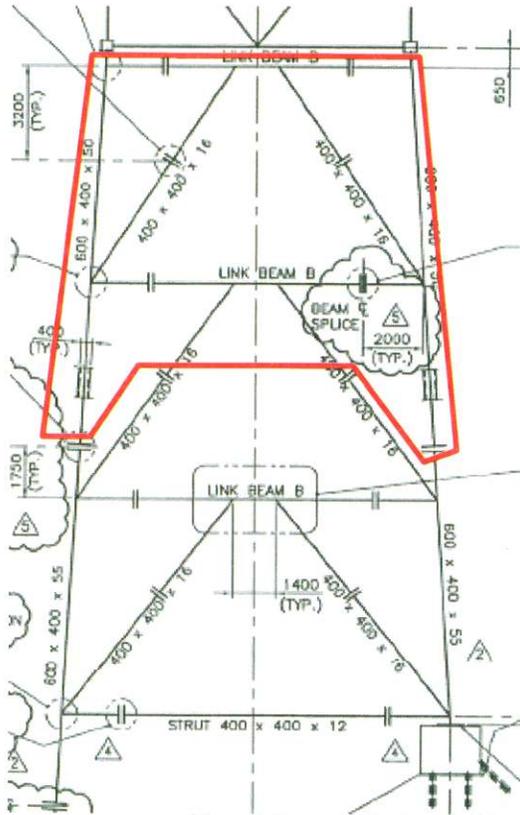
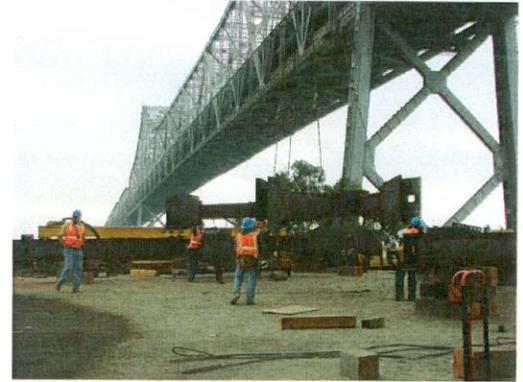
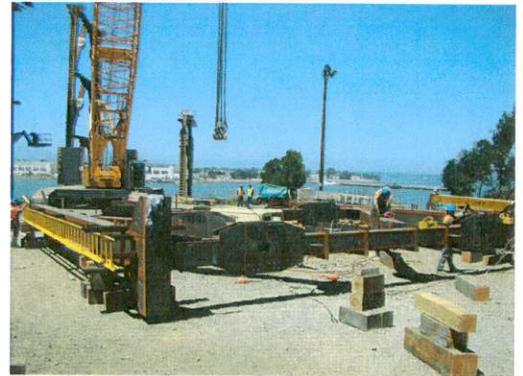
Figs 3 through 5. Assembled the second section of the tower B west line.

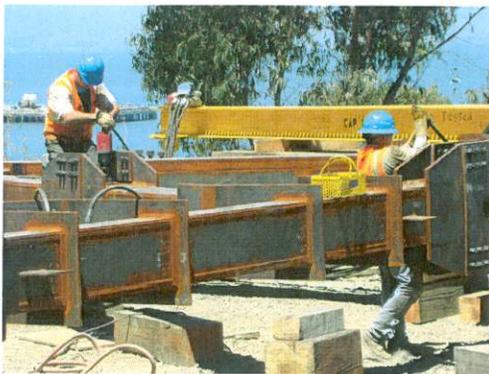
- Installed and pretensioned bolts (see Fig. 6).
 - See Art Pannu's diary for additional contractors' activities and comments.
- Note
 - Tony Sherwood from Smith Emery Company and I looked at the bolts pretensioned after the erection (see Fig 7). See Figs 1 and 2 for the location. All bolts at the location are half-turned except for one. It is located at west side plate and marked with white marker. Ed knows about it.

Fig 6. Snug-tight and pretension bolts.

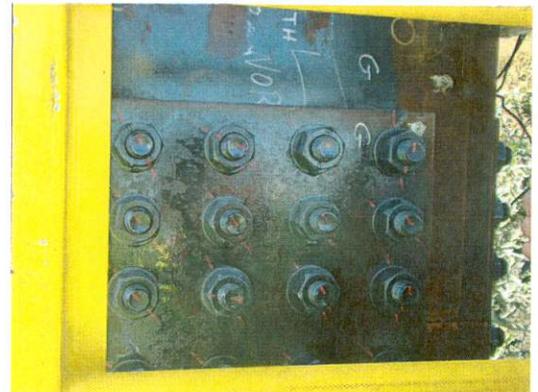
Fig 7. Tony and I inspect bolts pretensioned after the erection.

- The bolt with a white mark at the west plate of the first splice zone (from the bottom) of tower B west line north column should be turned (see 07/30/08 diary for more information).

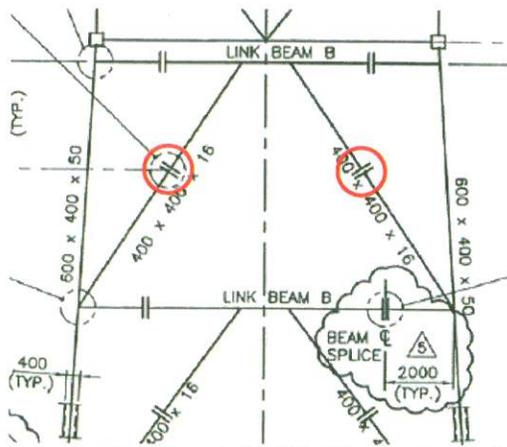
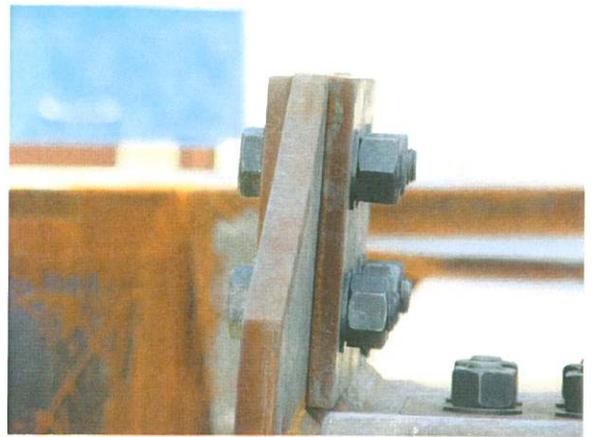
- ABF flipped the bolt at the location where the bolt size turns out shorter (see Figs. 8 and 9) and put it back to the original, because a 90-degree impact wrench cannot turn the nut. In conjunction with this one, communicated with Art regarding the reuse of A490. It can be reused because it is not pretensioned (see Art Pannu's diary for more information).

Figs 8 and 9. ABF flipped the bolt at the location where the bolt size turns out shorter.

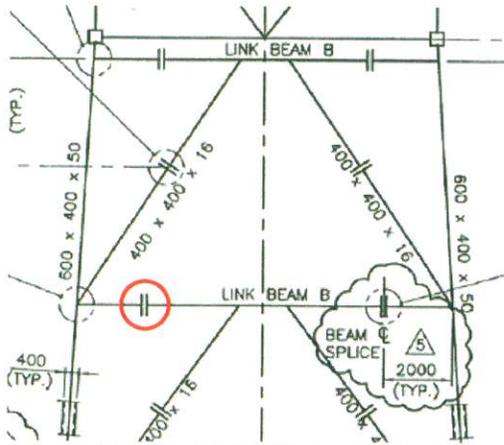
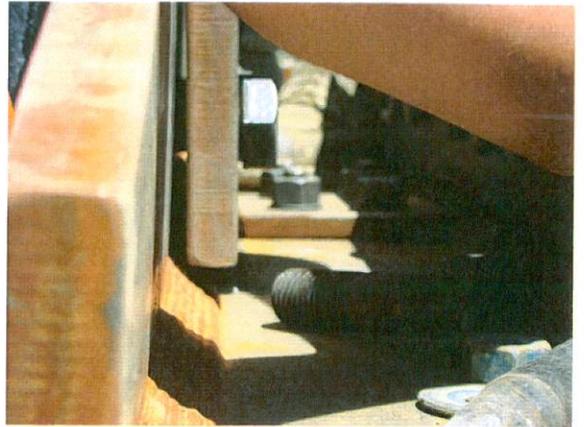
- The weld size becomes large so that the plate cannot be firmly contacted (see Figs 10 and 11). It is grinded little bit.
 - Dan is on-site from 10:00 to 11:00. Tony Sherwood is on-site whole day.

Figs 10 and 11. The weld size becomes large so that the plate cannot be firmly contacted.
