Job Stamp 04-0120F4 SFOBB SAS

Assistant Structure Rep.'s Daily Report

Location & Description of Operation	SAS-Temporary towers, Tower A & B Erection
Weather	HI: 74 F Low: 54 F Partly cloudy

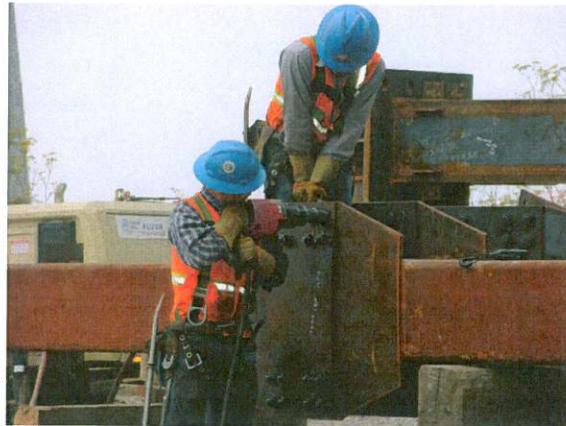
Fig 1

- Daily activity of contractors (ABF)
 - Continued to pretension bolts of the tower AE on the ground (see Fig. 1)
 - Grinded holes of the base plate of the north column of the tower AE (see Figs 2 through 4). Fig 5 shows the location.
 - Erected the lower portion of the tower AE (see Figs 5 through 7).
 - Start to assemble the lower portion of the tower BE. All bolts are pretensioned on the ground (see Figs 8 through 10).
 - Deliver tower members and link beams (see Fig 11).
 - See Art Pannu's diary for additional contractors' activities and comments.

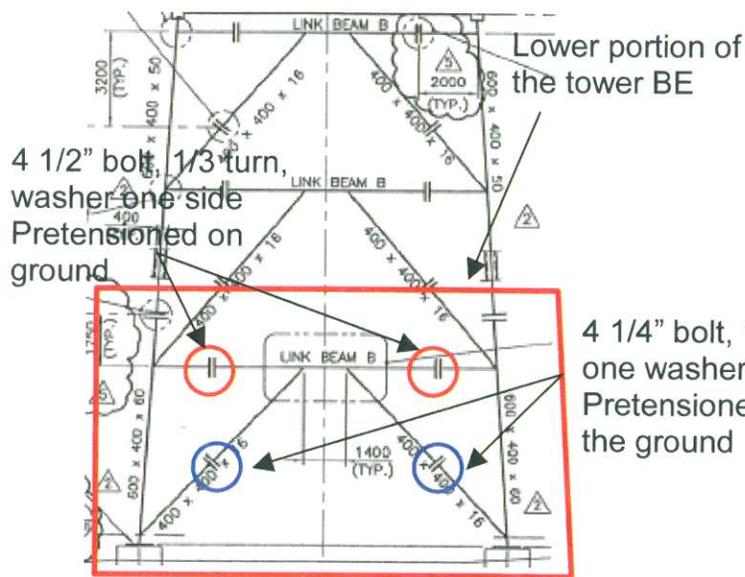
Fig 8

- Note
 - ABF increased the bolt size (from 4inch to 4 ¼ inch) at the brace splice zones of the tower BE to avoid that the shear plane is located at either run out or thread regions. See blue circles of Fig. 8. The bolt size is 4 inch at the same locations of the tower BW.
 - Superintendent Dan is on site from 06:30 to 06:45, 09:00 to 10:30 and 12:00 to 12:30.
 - Mark and Art checked the thickness of the diagonal bracing and confirmed that it is within tolerance.
