Job Stamp 04-0120F4 SFOBB SAS

Assistant Structure Rep.'s Daily Report

Location & Description of Operation	SAS-Temporary towers, Tower A & B Erection
Weather	HI: 87 F Low: 55 F Partly cloudy

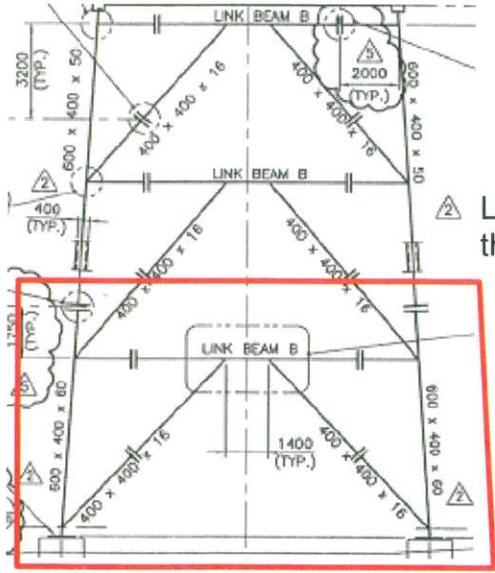
Fig 1

Lower portion of the tower BE

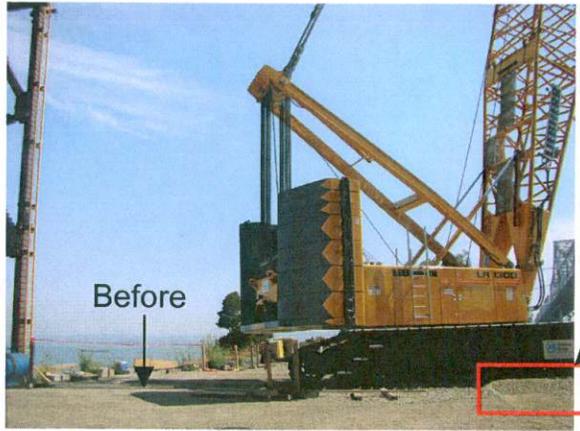
Fig 4.

Gravel delivered on site

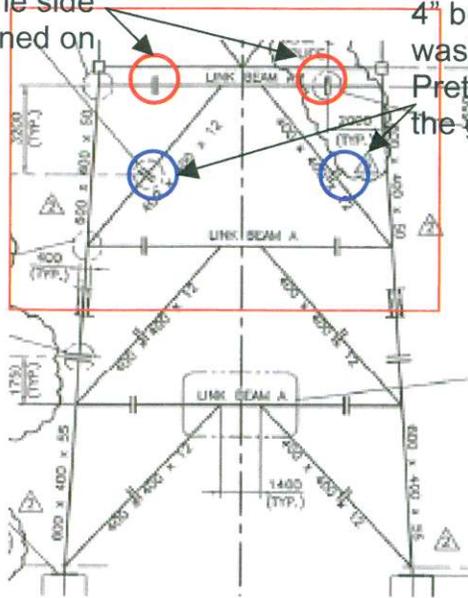
Fig 6

4" bolt, 1/3 turn,
washer one side
Pretensioned on
ground

4" bolt, 1/3 turn,
washers each side
Pretensioned on
the ground
