Job Stamp 04-0120F4 SFOBB SAS

Assistant Structure Rep.'s Daily Report

Location & Description of Operation	SAS-Temporary towers, Tower A & B Erection
Weather	HI: 81 F Low: 59 F Partly cloudy

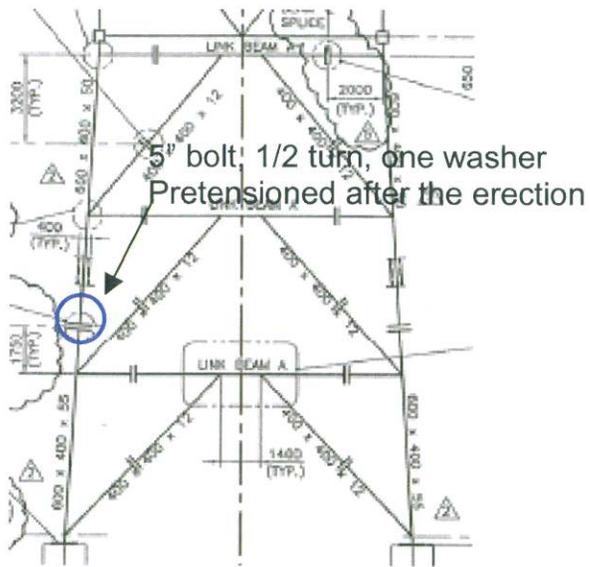
Fig 1

- Daily activity of contractors (ABF)
 - Continued to pretension bolts of the tower AE after the erection. See Figs 1 and 2.
 - Performed survey on the elevation of the tower AE (see Fig 3).
 - Placed a platform of tower AE for field drillings (see Fig 4).
 - Placed a working platform/guard rail (see Fig 5)
 - Start to assemble the upper portion of the tower BE (see Figs 5 and 6). One more vertical member needs to be delivered. Bolts at the locations shown in Fig 6 are installed and snug-tightened.
 - See Art Pannu's diary for additional contractors' activities and comments.

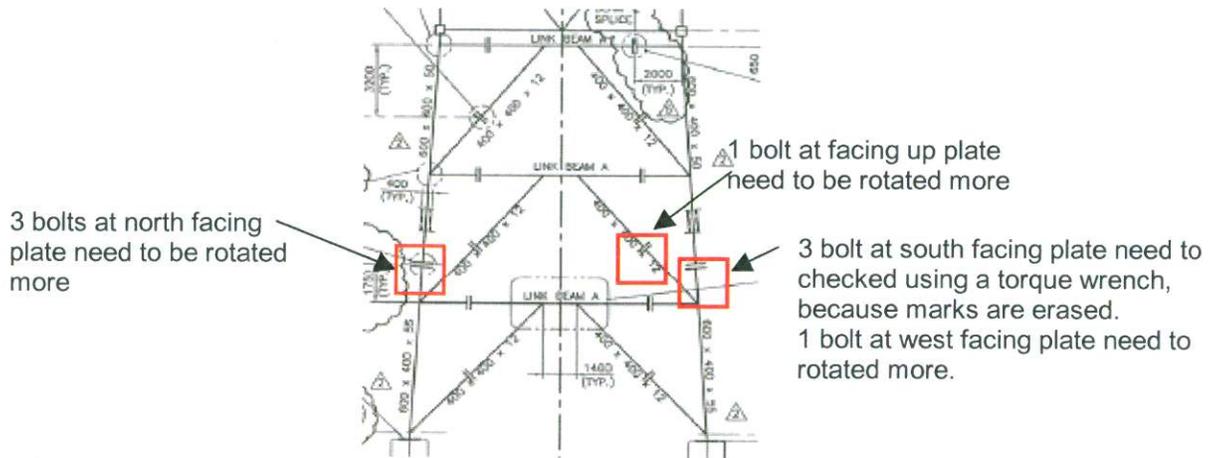
Fig 7.

- Note
 - Tony, QA from SE company and I inspected bolts pretensioned after the erection (Tower AE). Noticed that a few bolts are either rotated more or checked with a torque wrench (see Fig 7). ABF fixed the problems except for the bolts, which need to be checked with a torque wrench.
 - 2 hours O.T.
