TOLL PROGRAM/DIST. 4 CONSTR.

Job Stamp:
04-SF-80-13.2/13.9 04-0120F4
SFOBB SAS
San Francisco Co. in San Francisco
Fm 0.6 km to 1.3 km East of Yerba Buena
Tunnel East Portal

ASSISTANT RESIDENT ENGINEER'S DAILY BRIDGE REPORT

Location: W2 Cap Beam
Remark: lost deck/ironwork
Weather: overcast AM
Hi 64F/ Lo 55F

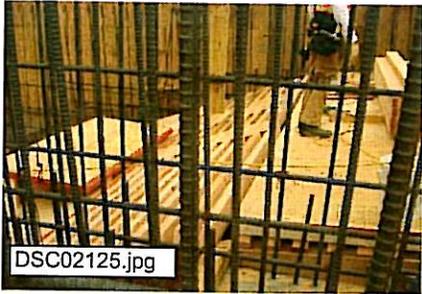
ABF has almost completed the southwest void lost deck. They need a few more panels and the four inch fillet to do (as of 09:45 - DSC02125). They have closed up the northwest access hole in the side formwork (DSC02126) and have started to mobilize the northwest lost deck supports from below. Towards the afternoon, winds started to pick up and the prefabricated supports were becoming un-controlable when lowering to the void. In the southwest void, they completed the remaining panels and were working on the four inch fillet. The survey crew was there to give them grades for the placement of the supports.
