Job Stamp:
04-SF-80-13.2/13.9 04-0120F4
SFOBB SAS
San Francisco Co. in San Francisco
Fm 0.6 km to 1.3 km East of Yerba Buena
Tunnel East Portal

ASSISTANT RESIDENT ENGINEER'S DAILY BRIDGE REPORT

Location: W2 Cap Beam	Weather: overcast
Remark: lost deck/ironwork	Hi 62F/Lo 56F

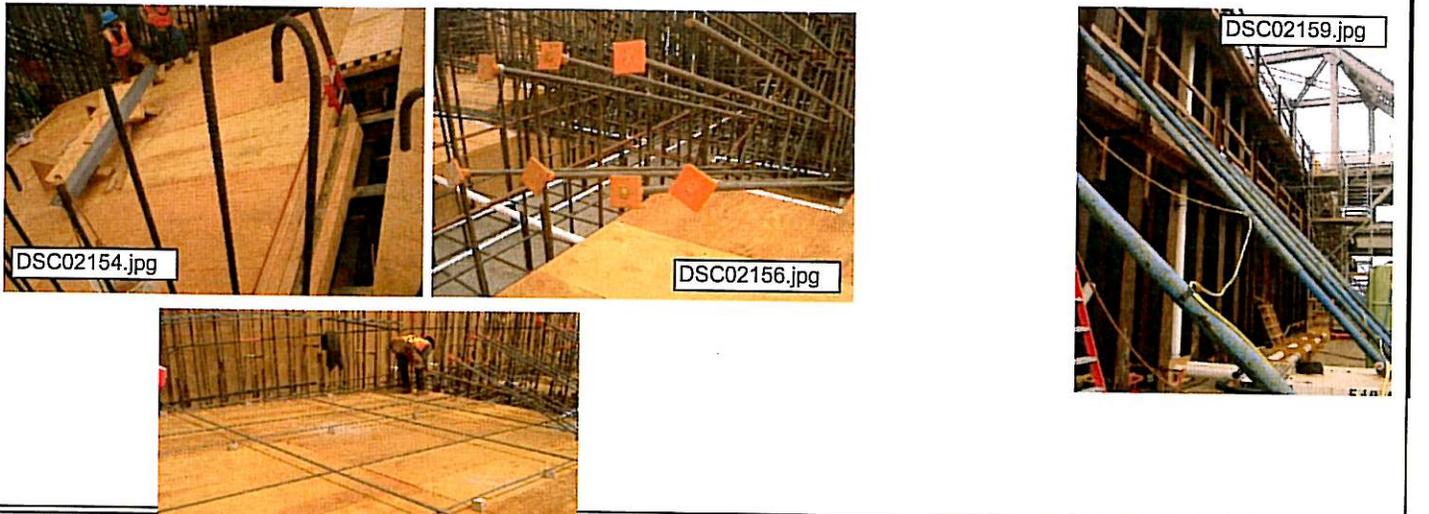
RPS has resumed work on the longitudinal diaphragm. They have started layout of the bottom mat and have started placing steel for the bottom mat (DSC02160). We told them that they had the wrong size dobe block for the clearances. They were placing 3" dobe blocks under a burried bar before placing the #25's on top.
