Job Stamp:  
04-SF-80-13.2/13.9 04-0120F4  
SFOBB SAS  
San Francisco Co. in San Francisco  
Fm 0.6 km to 1.3 km East of Yerba Buena  
Tunnel East Portal

**ASSISTANT RESIDENT ENGINEER'S DAILY BRIDGE REPORT**

Location: W2 Cap Beam  
Remark: ironwork  
Weather: overcast AM/clear PM  
HI 63F/Lo 53F

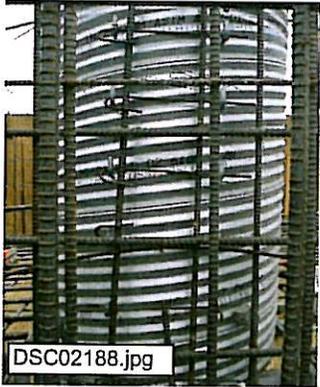
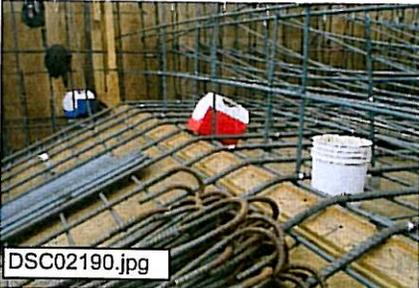
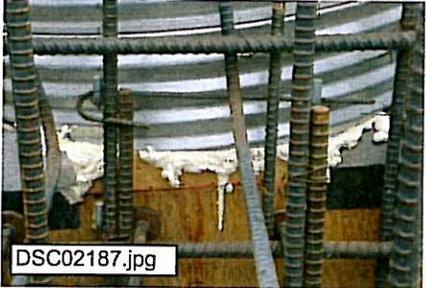
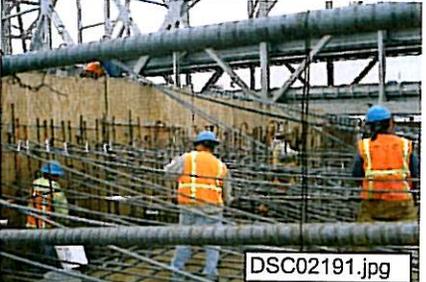
ABF - continues to set the position of the manhole openings. They are making adjustments. Ladder rungs have been set. Voids between the CMP and lost deck have been filled with foam (DSC02187&8). They have also started placing tie-back rods longitudinally in the forms.  
RPS is continuing to place ironwork for the deck. The #43 transverse bars have been placed except for those on the south/north sides of the manhole. The #25 longitudinal bars (4 mats) have been started on both sides of the intermediate transverse diaphragm (DSC02191). The spacing of these bars have been placed correctly at the bottom where the vertical template bars are. The top spacing has yet to be done and therefore not determined if placed correctly. At the end of the shift, the northeast void was further along than the rest. None of the other bays had these longitudinal bars at the correct vertical spacing.  
Bob (RPS general foreman) knows little about the project. The RFI RPS sent to CT was unknown by Bob. He did not know who decided to place the #43 bars with the bend (DSC02190). He did not know about the 4 meter tail that was recommended to remedy the situation. He did not know about the bars around the 100mm fillet.
