TOLL PROGRAM/DIST. 4 CONSTR.

Job Stamp:
04-SF-80-13.2/13.9 04-0120F4
SFOBB SAS
San Francisco Co. in San Francisco
Fm 0.6 km to 1.3 km East of Yerba Buena
Tunnel East Portal

ASSISTANT RESIDENT ENGINEER'S DAILY BRIDGE REPORT

Location: E2 Crossbeam	Weather: overcast AM
Remark: sandblast/formwork	HI 65F/Lo 56F

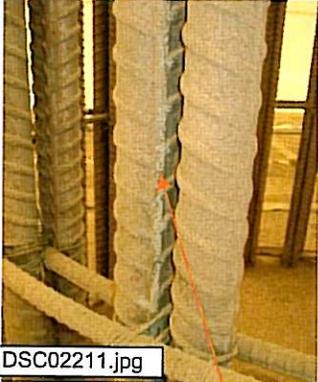
DSC02211.jpg

ABF requested for CT to buy off the sandblasting of the zinc coating at 1230. Upon survey of the sandblast, Saman (CT) determined that 95% of the job was adequate. There still remained portions of steel where the coating remained. DSC02211 and DSC02212 shows two vertical strips of zinc coating that were not removed.

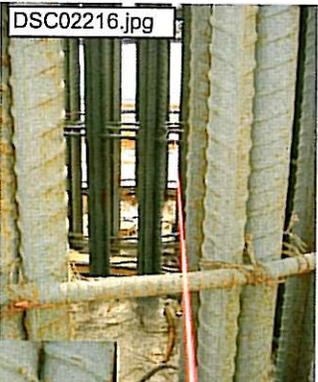
DSC02216.jpg

An ABF survey crew had set the locations of ducts that would be running through the E2E column cage area. If the stringlines (representing center of ducts) are correct, a large number of pier ironwork will need to be cut in order to clear the prestressing ducts.
