Job Stamp:
04-SF-80-13.2/13.9 04-0120F4
SFOBB SAS
San Francisco Co. in San Francisco
Fm 0.6 km to 1.3 km East of Yerba Buena
Tunnel East Portal

ASSISTANT RESIDENT ENGINEER'S DAILY BRIDGE REPORT

Location: E2 Cross Beam/Pier 7	Weather: clear/warm
Remark: formwork/ironwork	Hi 87F/Lo 62F

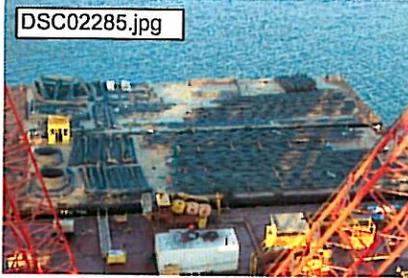
Two barges of ironwork were mobilized to E2 from Pier 7 early this morning (DSC02285). The ironwork for the E2 cross beam was started today. They cut all ties for the hoops around the north column cage (E2W) and started preparation for welding the #57 bar that they mistakenly cut (DSC02288). There was however no QC hired by ABF for the welding; therefore, there was not welding performed today. CT's Mark Baker (CWI) was on site but was not needed. The clearance below the main #57 bars is correct. They are using three-inch dobs and a #13 buried bar; 75+13+#25 stirrup = 113 mm. 25s
The width of the stirrups is also correct for the width of the cross beam. The markings in yellow paint for the layout of the horizontal #36s inside the stirrups is correct ~250mm. I noticed that they were placing the east leg of the stirrups parallel with the panel edges. Since these bars are

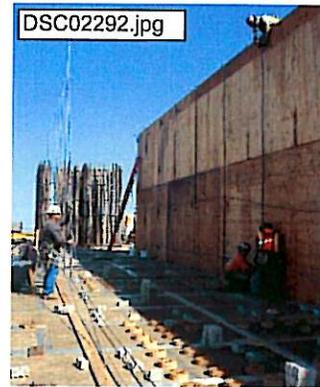
Formwork at Pier 7 continues for PT blockouts on north and south end of cross beam. Blockouts on the soffit were also being nailed at E2.
