Job Stamp 04-0120F4 SFOBB SAS

Assistant Structure Rep.'s Daily Report

Location & Description of Operation	SAS-Temporary towers, Tower A & B Erection
Weather	HI: 70 F Low: 58 F Partly cloudy

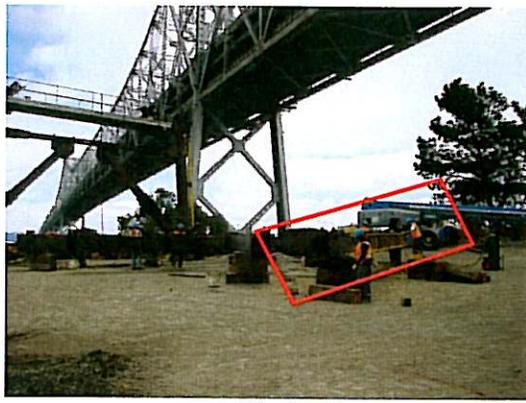
Fig 1

- Daily activity of contractors (ABF)
 - Delivered one vertical member, which consists in upper portion of the tower BE (see Fig 1).
 - Installed, snug-tightened and pretensioned bolts on the ground (see Figs 2 and 3)
 - Erected upper portion of the tower BE (see Figs 4 thru 7).
 - See Art Pannu's diary for additional contractors' activities and comments.

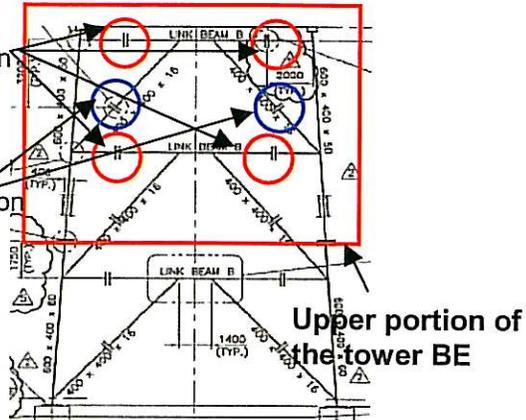
Fig 2

4 1/2" bolt, one washer,
1/3 turn, pretensioned on
ground

4 3/4" bolt, one washer
1/3 turn, Pretensioned on
ground

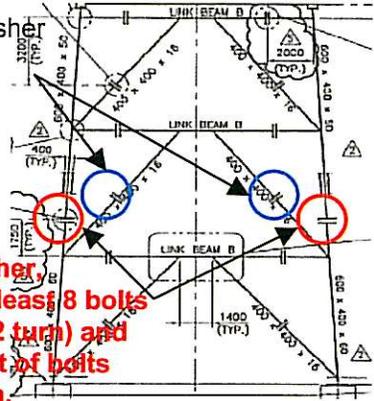
Fig 8

- Note
 - After the erection, snug-tighten bolts located at the bracing and pretensioned 8 bolts of each plate located at splice zone of vertical members (see Figs 8 thru 12).
 - A few bolts need to be torqued more. ABF fixed them before the erection (see Figs 13 and 14).
 - No field work in the Y.-B. island on this Wednesday and Thursday due to concrete pour of W2, scheduled on Thursday.

5" bolt, one washer,
pretensioned at least 8 bolts
of each plate (1/2 turn) and
snug-tighten rest of bolts
after the erection.

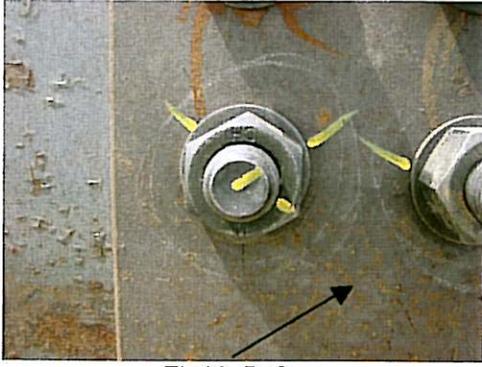
Fig13. Before

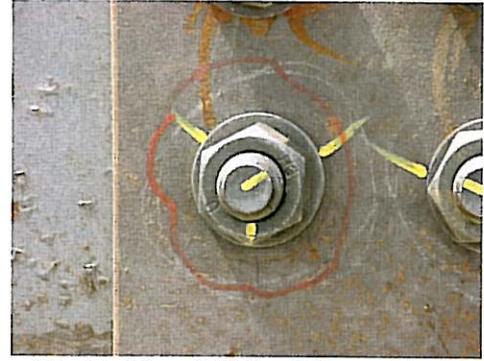
Fig 14. After ABF fixed the problem.
