Job Stamp 04-0120F4 SFOBB SAS

Assistant Structure Rep.'s Daily Report

Location & Description of Operation	SAS-Temporary towers, Tower A & B Erection
Weather	HI: 72 F Low: 58 F Partly cloudy

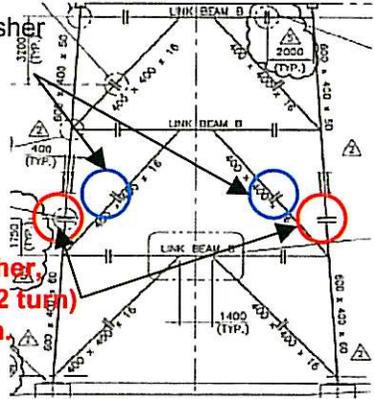
Fig 1

- Daily activity of contractors (ABF)
 - Pretensioned bolts of the tower BE upper portion, which are not pretensioned on Tuesday (see Figs 1 and 2).
 - Truss members are delivered (see Figs 3 and 4)

4 1/4" bolt, one washer
1/3 turned after
erection

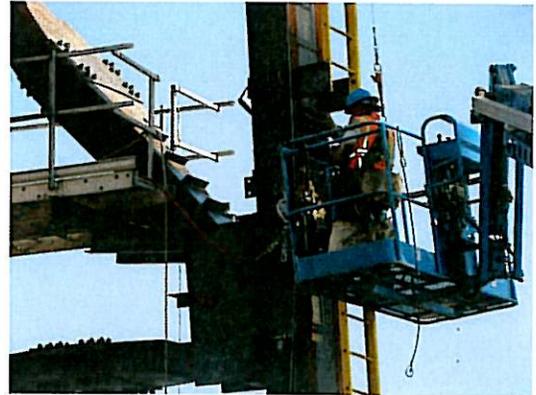
Fig 2

5" bolt, one washer,
pretensioned (1/2 turn)
after the erection.

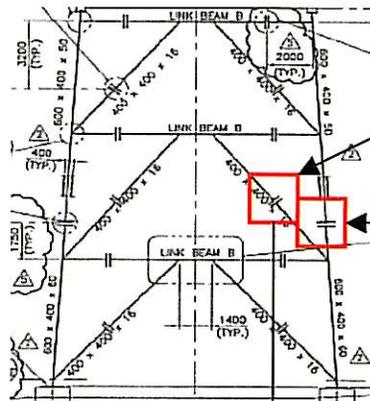
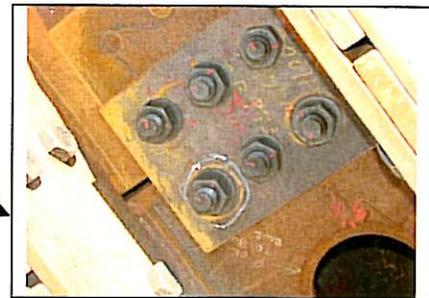
- See Art Pannu's diary for additional contractors' activities and comments.
- Note
 - Inspected bolts pretensioned after the erection and noticed 4 bolts, which are less turned. They are marked. Inform a foreman Ed regarding it (see Fig 5).

1 bolt at the plate facing
west need to be rotated
more

2 bolt at the plate facing north and 1
bolt at the plate facing east need to be
rotated more.

- The bolts at various locations of tower BE need to be rotated more (see first bullet item of Note in conjunction with Fig 5 of 08/22/2008 diary)
