Job Stamp 04-0120F4 SFOBB SAS

Assistant Structure Rep.'s Daily Report

Location & Description of Operation	SAS-Temporary towers, Tower A & B Erection			
Weather	HI: 72 F	Low: 58 F	Partly cloudy

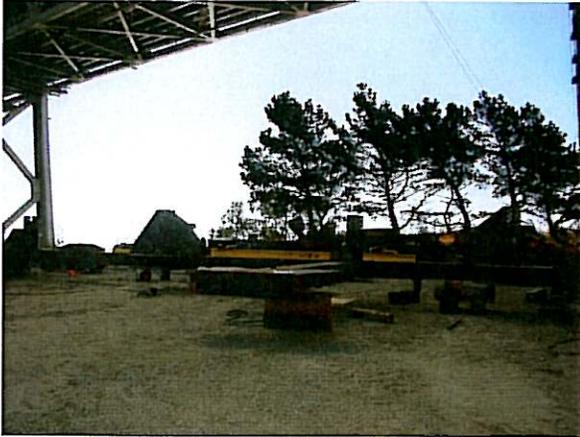
Fig 1

- Daily activity of contractors (ABF)
 - Delivered truss members and walk-way (see Figs 1 and 2)
 - Assembled north-side vertical truss member (see Figs 3 and 4)

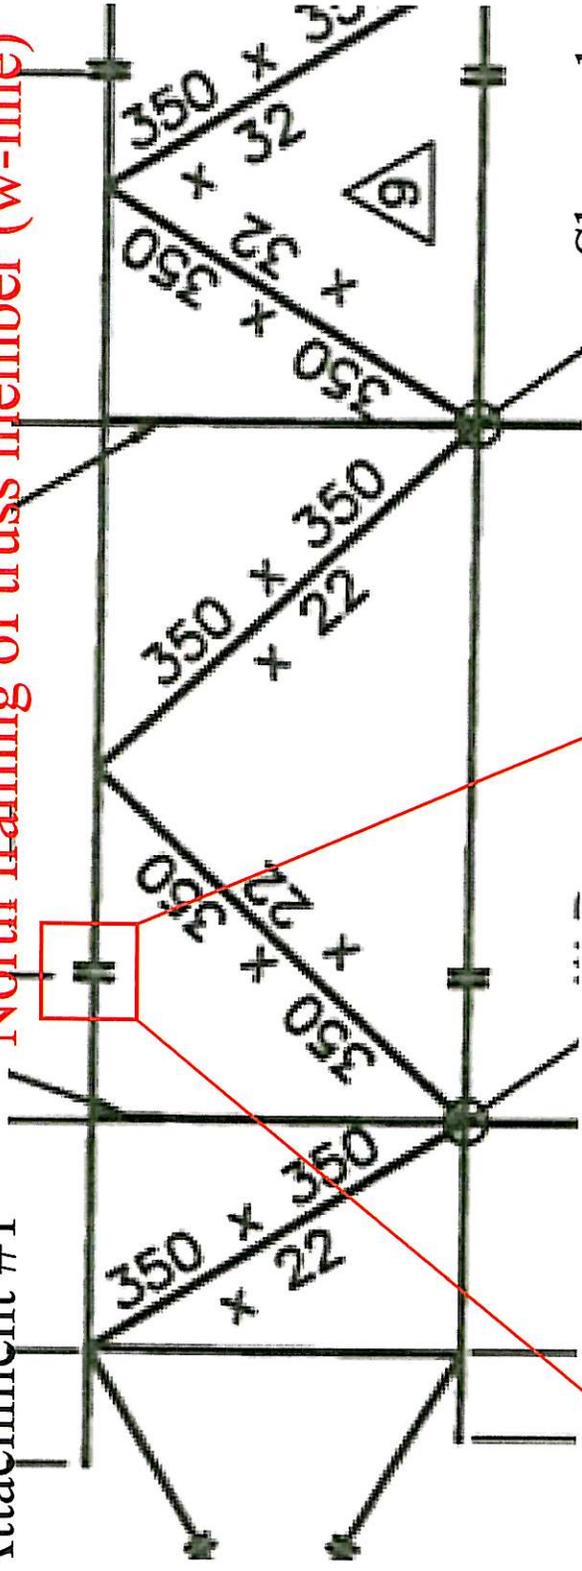
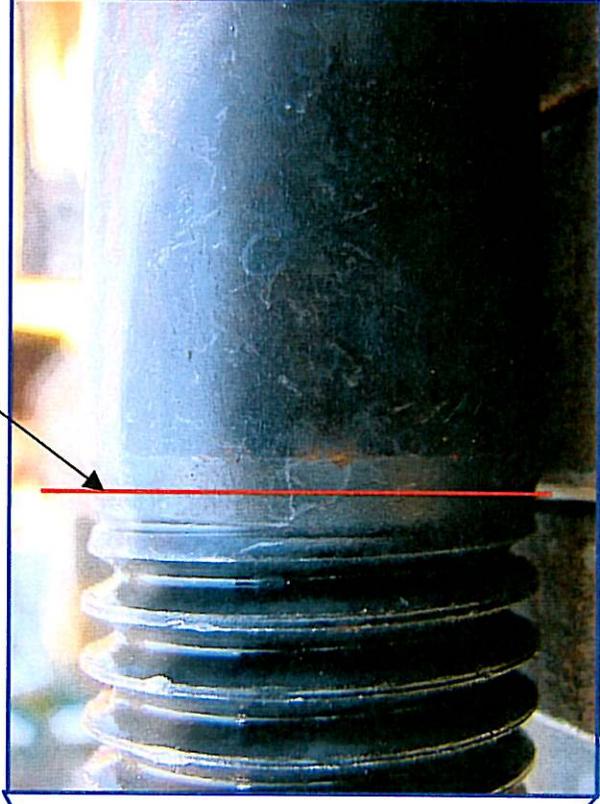
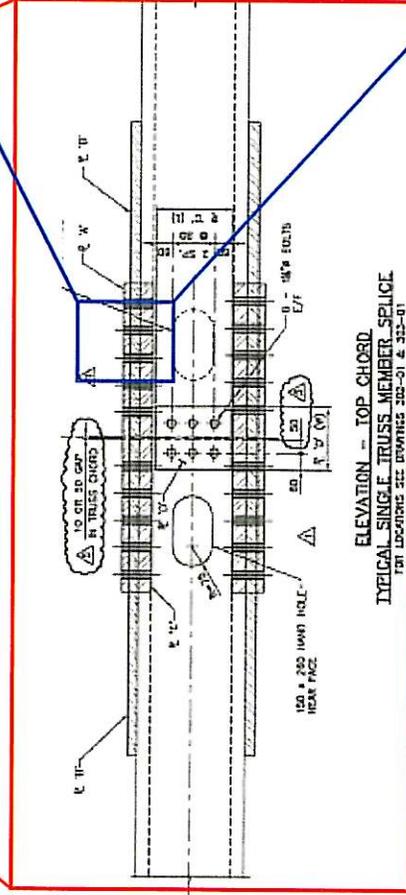
Attachment #1

- See Art Pannu's diary for additional contractors' activities and comments.
- Note
 - Noticed that shear plane is located at either run-out or threaded region of bolts at various locations (see attachments #1 and 2). Inform Dan and Ed regarding them. They refused to correct them.

Shear plane

- Shear plane is located at run-out.
- Total number of bolts is 48

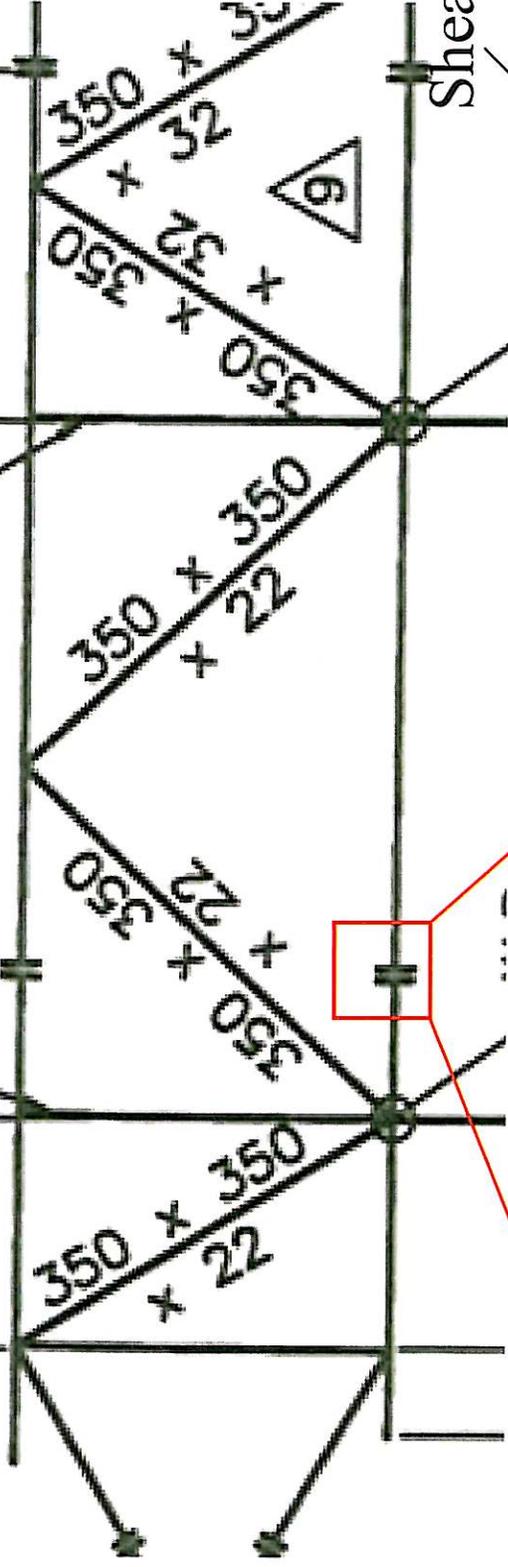
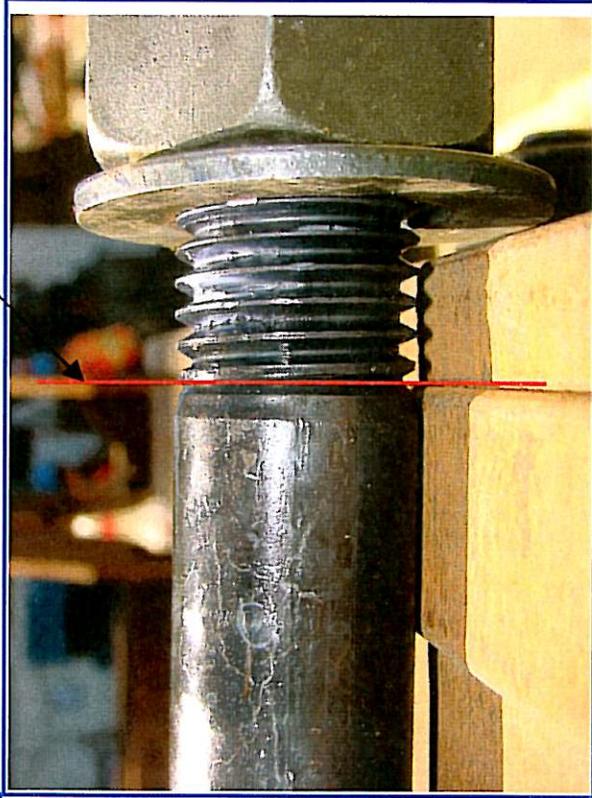
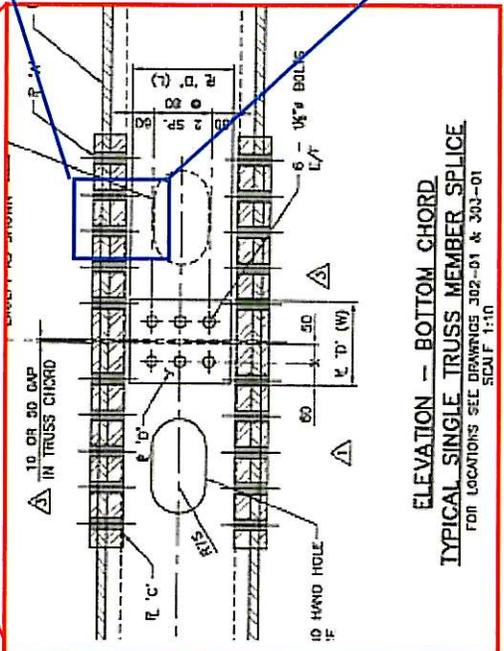
Attachment #2

Shear plane

- Shear plane is located at thread region.
- Total number of bolts is 48

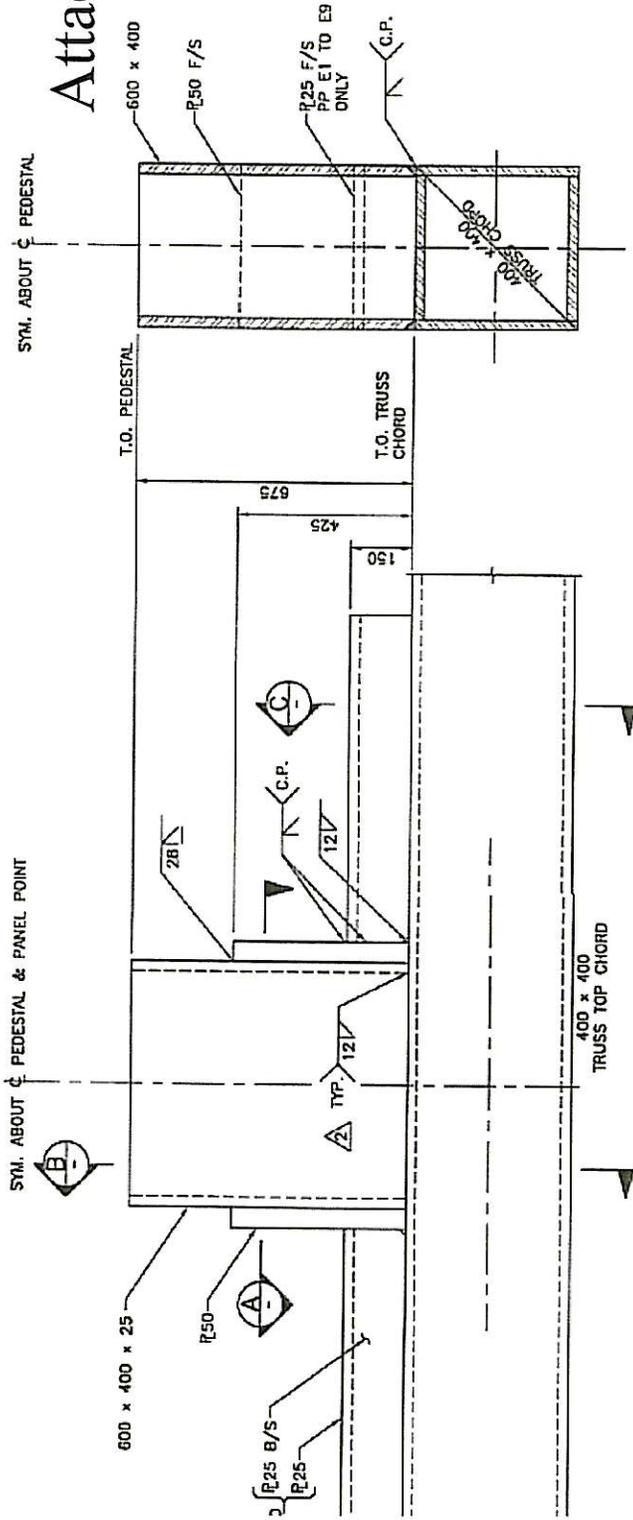
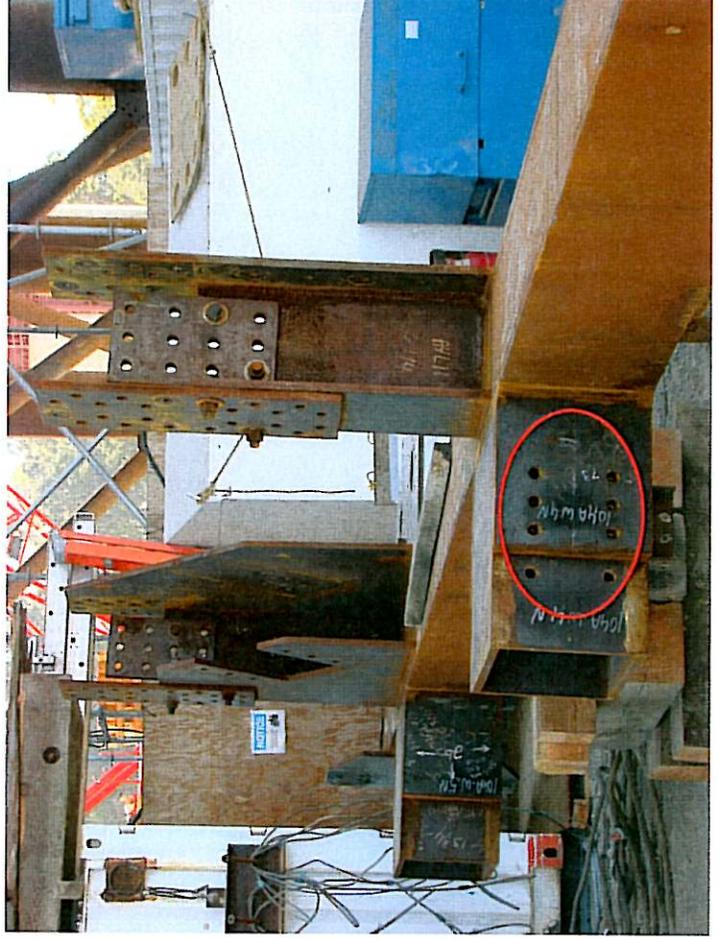
Attachment #4

- The pedestal has 8 holes on each side, while design plan shows no holes (see attachment #4).
 - 2 hours O.T.
- Punch list
 - The right top bolt of the east side plate of the tower A west line should be turned more (see 07/22/08 diary for more information).

- DWG 602-01 doesn't show any hole, while actual pedestal has eight holes on each side.
