Job Stamp
04-0120F4
SFOBB SAS

Assistant Structure Rep.'s Daily Report

Location & Description of Operation	SAS-Temporary towers, Tower A & B Erection
Weather	HI: 72 F Low: 58 F Partly cloudy

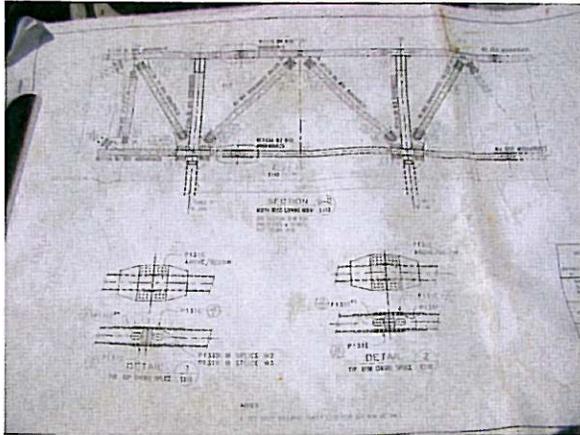
Fig 1

- Daily activity of contractors (ABF)
 - Assembled north-side vertical truss member (see Figs 1 and 2)
 - Installed and snug-tighten and pretensioned bolts using an impact wrench for the bottom and top vertical truss bracings, and the bottom and top splice zone. After snug-tightening, ABF turned a nut using an impact wrench according to Turn-of-Nut method. See attachment 1 and Figs 3 and 4
 - Installed bolts for other locations such as the bottom and top horizontal bracings (see attachment 1 and Figs 5 thru 14).
 - See Art Pannu's diary for additional contractors' activities and comments.

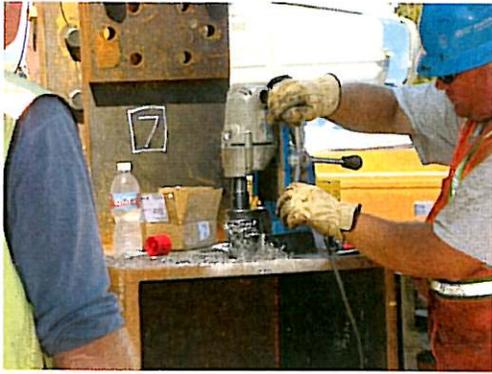
Fig 15

- Note
 - Communicated with Mark regarding that shear plane is located at either run-out or threaded region of bolts at various locations (see the attachments 1 and 2 of 08/25/2008 diary).
 - ABF drilled hole on pedestals for the erection purpose (see Fig 15)
 - The holes of the pedestal are used for the erection purpose (see Fig 16).
 - 2 hours O.T.
