Job Stamp
04-0120F4
SFOBB SAS

Assistant Structure Rep.'s Daily Report

Location & Description of Operation	SAS-Temporary towers, Tower A & B Erection
Weather	HI: 81 F Low: 58 F Partly cloudy

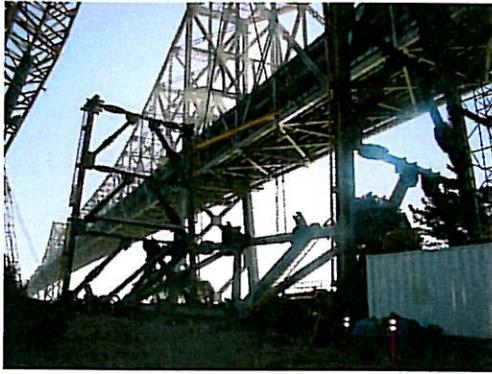
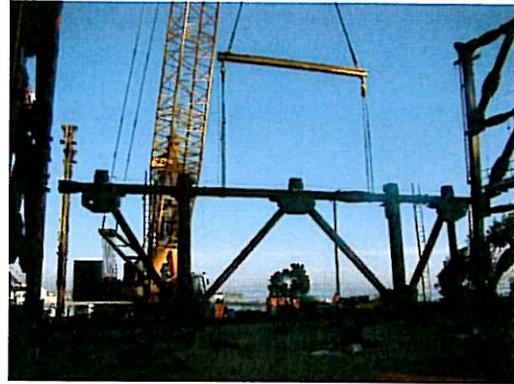
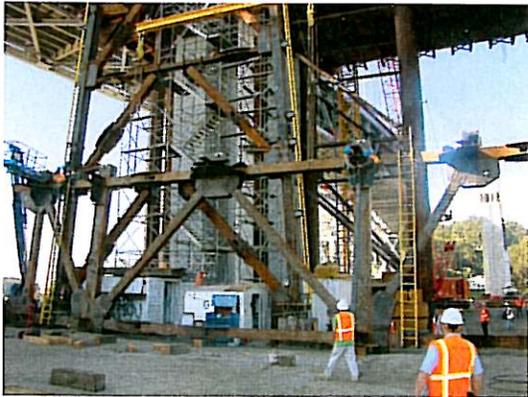
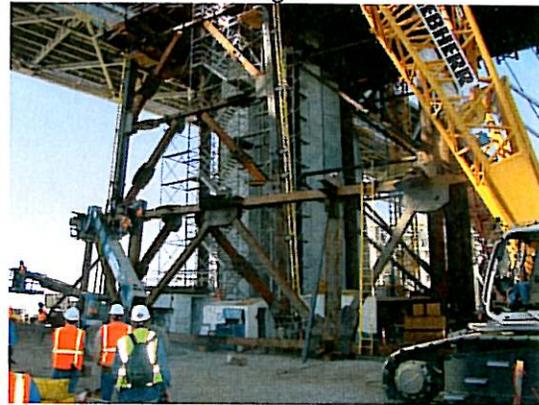
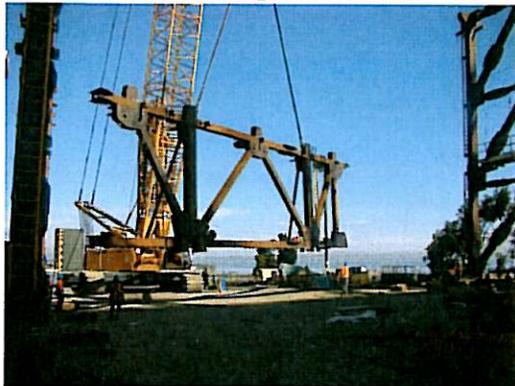
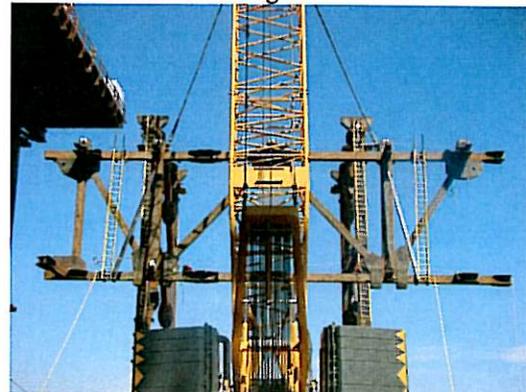
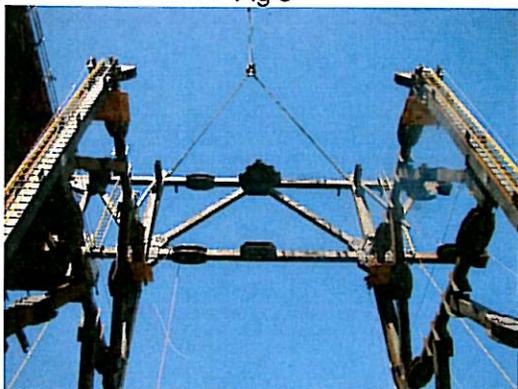
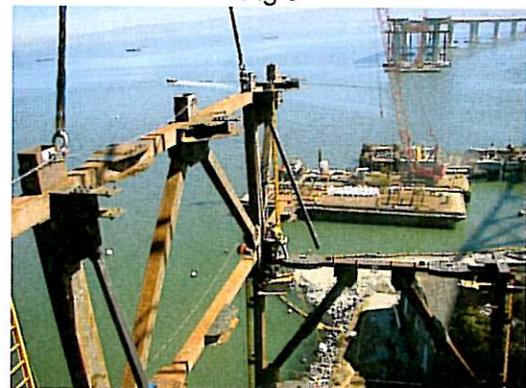
- Daily activity of contractors (ABF)
 - Erected the north frame of west line truss. See Figs 1 thru 8 for the erection sequences.
 - Continue to bring truss members (see Fig 9).
 - See Art Pannu's diary for additional contractors' activities and comments.

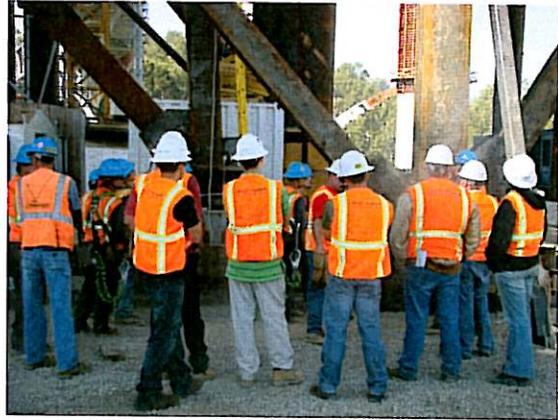
Fig 10

- Note
 - Superintendent Dan asked me not to write on irons. I told him that it is necessary. Art called me that it is recommended to write just CT on irons not to give any confusion to the contractor.
 - John and other ABF engineers show up in the field due to the erection of the truss (Fig 10).
 - ABF has safety meeting before erecting the truss (see Fig 10).
 - Mark asked me to call him if John, ABF engineer, shows up in the field and asks questions to me.
