Job Stamp
04-0120F4
SFOBB SAS

ASSISTANT RESIDENT ENGINEER'S **CONTRACTOR – ABFJV**

EA	04-0120F4
Co-Rte-KP (PM)	SF-080-13.2/13.9 (8.2/8.7)
Structure Rep.	Rick Morrow

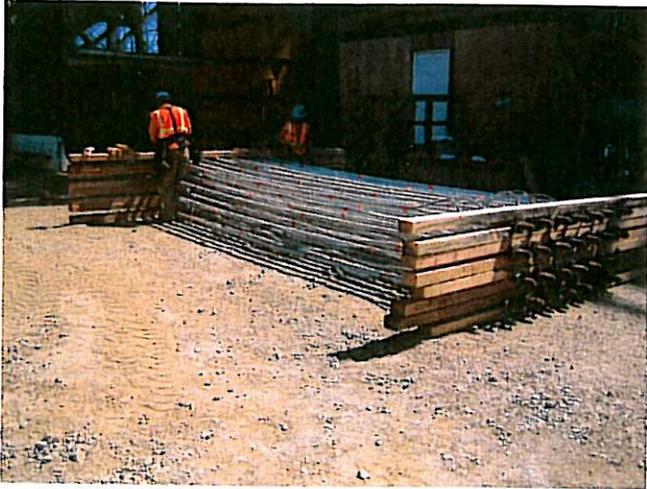
File Name:	Sept-2-2008 W2 Cap 003
Date:	09-02-08
By Int:	M Bruce

Description: Work on the first template for the vertical PT bars continues. Nigel informed me that the bottom plates on the rods are not in the final position. The plates may have to be adjusted due to the #43 transverse bar placement. While looking at the first assembly I saw no dents and it appears that some grout saddles need to be sealed better. Also the grout tubes were labeled VB-93E, VB-66E, VB-48E, and VB-66E from the top to bottom rows.

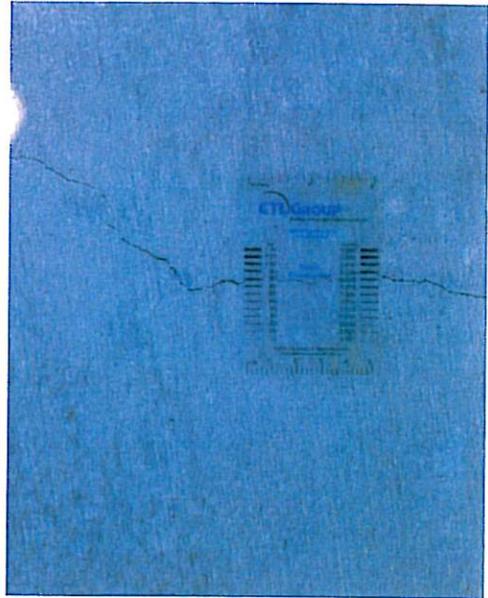
File Name:	Sept-2-2008 W2 Cap 007
Date:	09-02-08
By Int:	M Bruce

Description: Surface crack from pour three which was 0.60mm found in the center of the top slab.

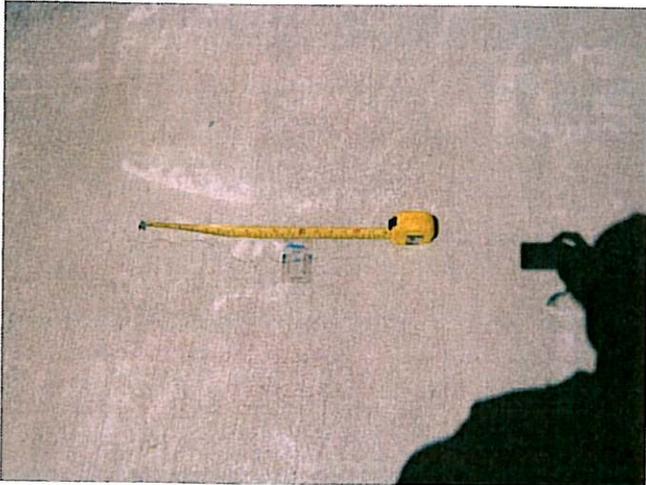
File Name:	Sept-2-2008 W2 Cap 008
Date:	09-02-08
By Int:	M Bruce

Description: Photo of another surface crack in the center that measured 0.60mm wide and 400mm long.

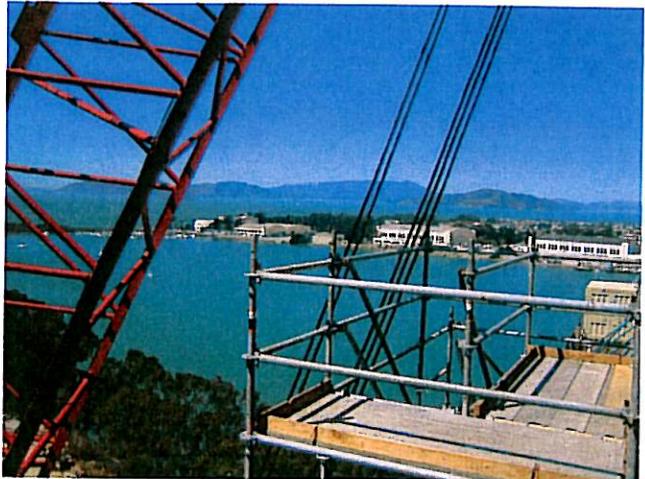
File Name:	Sept-2-2008 W2 Cap 010
Date:	09-02-08
By Int:	M Bruce

Description: While placing the east bulkhead vertical forms the cables attached to the boom of the Manitowoc 4100W came close to being tangled with the stairs from the soffit to the top of pour 3. Nigel was seen watching directing this operation, as it appeared that he knew this was a safety issue.
