Job Stamp 04-0120F4 SFOBB SAS

ASSISTANT RESIDENT ENGINEER'S **CONTRACTOR – ABFJV, Subs RPS**

EA	04-0120F4
Co-Rte-KP (PM)	SF-080-13.2/13.9 (8.2/8.7)
Structure Rep.	Rick Morrow

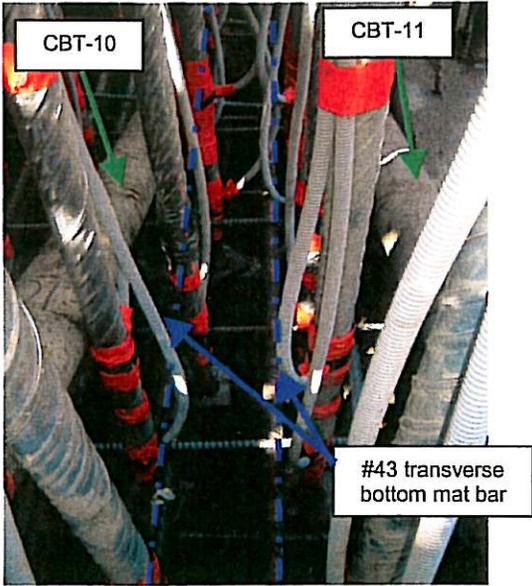
File Name:	Sept-16-2008 W2 Cap 003
Date:	09-16-08
By Int:	M Bruce

- Began adjusting 4"x6" templates supporting the vertical bars at W2E. Discussed the issue with Branden Bedwell, Nigel Lohse, and James Adams regarding the placement of the vertical bars in the field. I basically told them to do the best they can to get the vertical bars within the $\pm 25\text{mm}$ tolerance given by TY-Lin designer James Duxbury. Ron Matin and myself talked to TY-Lin designer Alex Sanjines regarding the current placement of the vertical bars. Alex said that the spacing of the vertical rods submitted via email by Jim Davidson didn't concern him. What did concern him was being able to stress the bars at the top where the plate of the outer perimeter vertical bars (VB-3 to VB-9, VB-18, 27, 36, 45, 54, 63, 72, 81, 90, 99, 108, 117, VB-120 to VB-126) is too close or infringing upon the breakout.

Description: The worst case placement of vertical bars (out of tolerance $\pm 40\text{mm}$) is due to #43 transverse bar placement and the X-strong pipes for CBT-9, 10, and 11 at W2E. Some of the vertical PT bars (VB-71, 80, 89, 98, 107, 116, 125) alternate over the #43 transverse bar, which is directly in line with the theoretical location of the vertical PT bars.

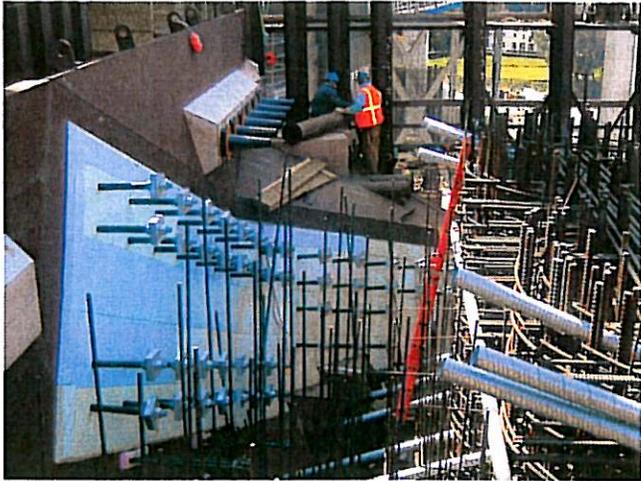
File Name:	Sept-16-2008 W2 Cap 005
Date:	09-16-08
By Int:	M Bruce

Description: Photo of the CBT-4 and CBT-8 pipe placement and the deviation saddle anchor rod installation at W2E.

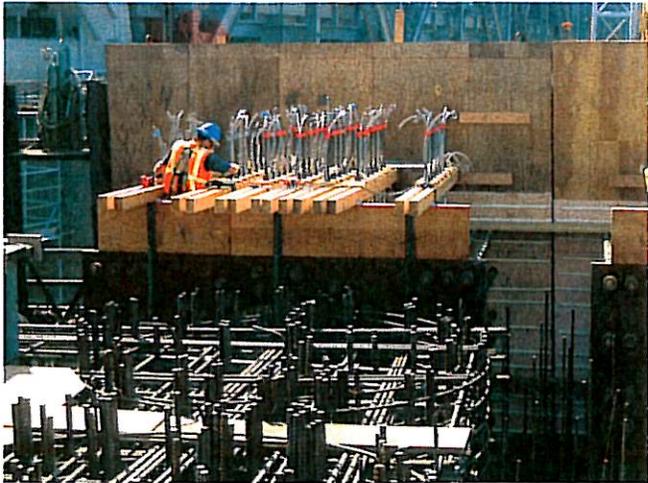
File Name:	Sept-16-2008 W2 Cap 007
Date:	09-16-08
By Int:	M Bruce

Description: Piledriver seen adjusting the 4"x6" templates at W2E to attempt to bring the spacing of vertical bars within the $\pm 25\text{mm}$ tolerance in the North/South or Y-direction.
