04-0120F4 SFOBB SAS

Date: 09/18/2008

ASSISTANT RESIDENT ENGINEER'S **CONTRACTOR – ABFJV, sub Conco**

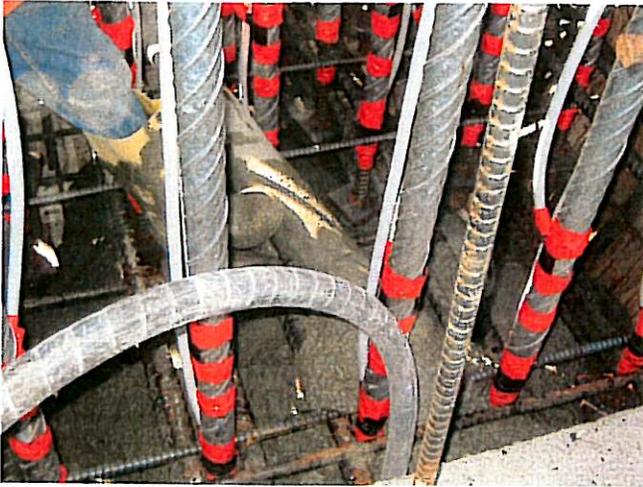
File Name:	Sept-18-2008 W2 Cap 004
Date:	09-18-08
By Int:	M Bruce

Description: Placing concrete in the W2W vertical blackout on the north end. The hose was placed in between the Hinge assemblies on both sides then slick lined as seen in the photo above.

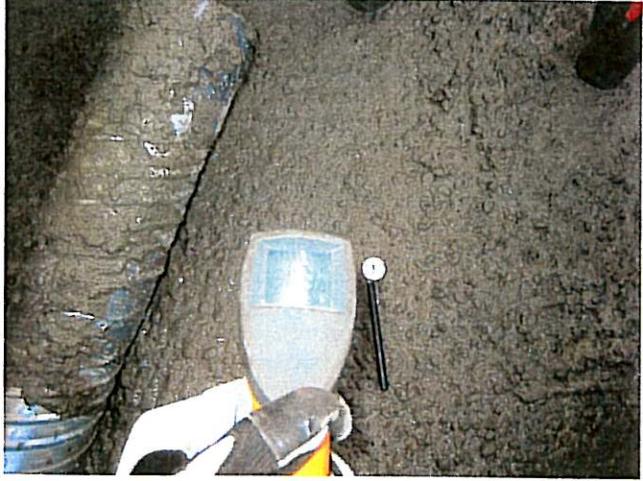
File Name:	Sept-18-2008 W2 Cap 005
Date:	09-18-08
By Int:	M Bruce

09:09			Air temperature at W2W vertical bar blockout = 58°F
09:21	66	W-21B continuity tendon	
09:35	65	W-15B continuity tendon	See photo below.
09:40			Nigel informed me that Rugasol-S has been applied to the surface of the W2E vertical bar blockout. After the concrete lost it's "sheen" then curing compound would be sprayed immediately on the surface. I asked him if he was going to place curing mats on the surface and he said it wasn't necessary.

Description: Concrete temperature of 65°F at W-15B continuity tendon taken at 9:35am. This was compared to the mercury thermometer, which displayed a temperature of 66°F. In general the infared temperature gun has consistently been 1°F below the mercury thermometer for all concrete pours.

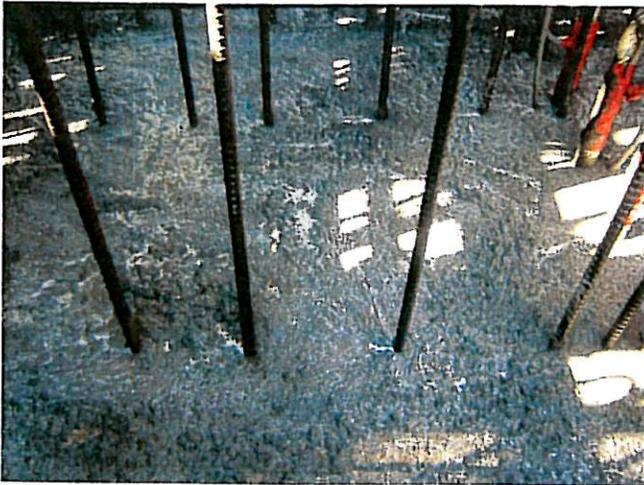
File Name:	Sept-18-2008 W2 Cap 006
Date:	09-18-08
By Int:	M Bruce

09:55	62	W-20B continuity tendon	
10:10	68	In between W-28B and W-29B continuity tendons	
10:17			Done placing concrete at W2W vertical bar blockout.
10:26			Curing compound was sprayed on the W2E vertical bar blockout surface, see photo below.

Description: Concrete surface of the W2E vertical bar blackout after the Rugasol-S and curing compound was sprayed. There appeared to be ponding of the two compounds in the valleys of the roughly finished surface.

12:30	80	In between the vertical bar rows 111-117 and 120-126.	Measurement taken in the sun after curing compound was applied. The concrete surface was hard at this time. I recommended to Nigel that the W2E vertical bar blockout surface should be sprayed again since it appeared that not enough was applied.

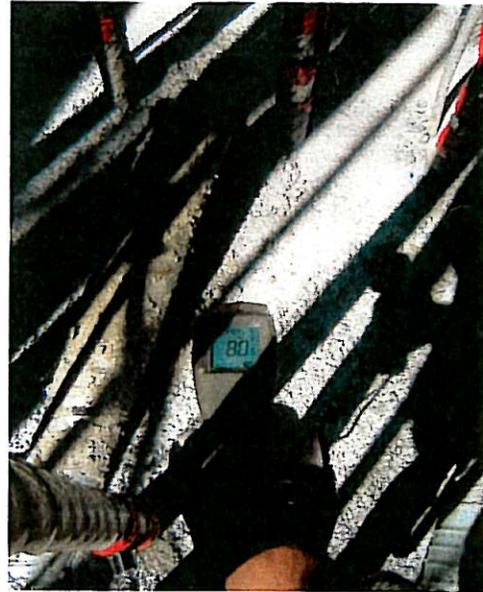
File Name:	Sept-18-2008 W2 Cap 009
Date:	09-18-08
By Int:	M Bruce

Description: W2W concrete surface temperature of 80°F at 12:30 in between the vertical bar rows 111-117 and 120-126. As stated above this area was exposed to the sun after curing compound was applied. Also the concrete surface was hard at this time.
